NATIONAL GALLERY OF ART

**FINAL REPORT  
TO THE  
NATIONAL CENTER FOR PRESERVATION TECHNOLOGY AND TRAINING  
1997 GRANT PROGRAM**

2. Project title: RESEARCH INTO PROTECTIVE COATING SYSTEMS FOR OUTDOOR  
BRONZE SCULPTURE AND ORNAMENTATION. PHASE II.

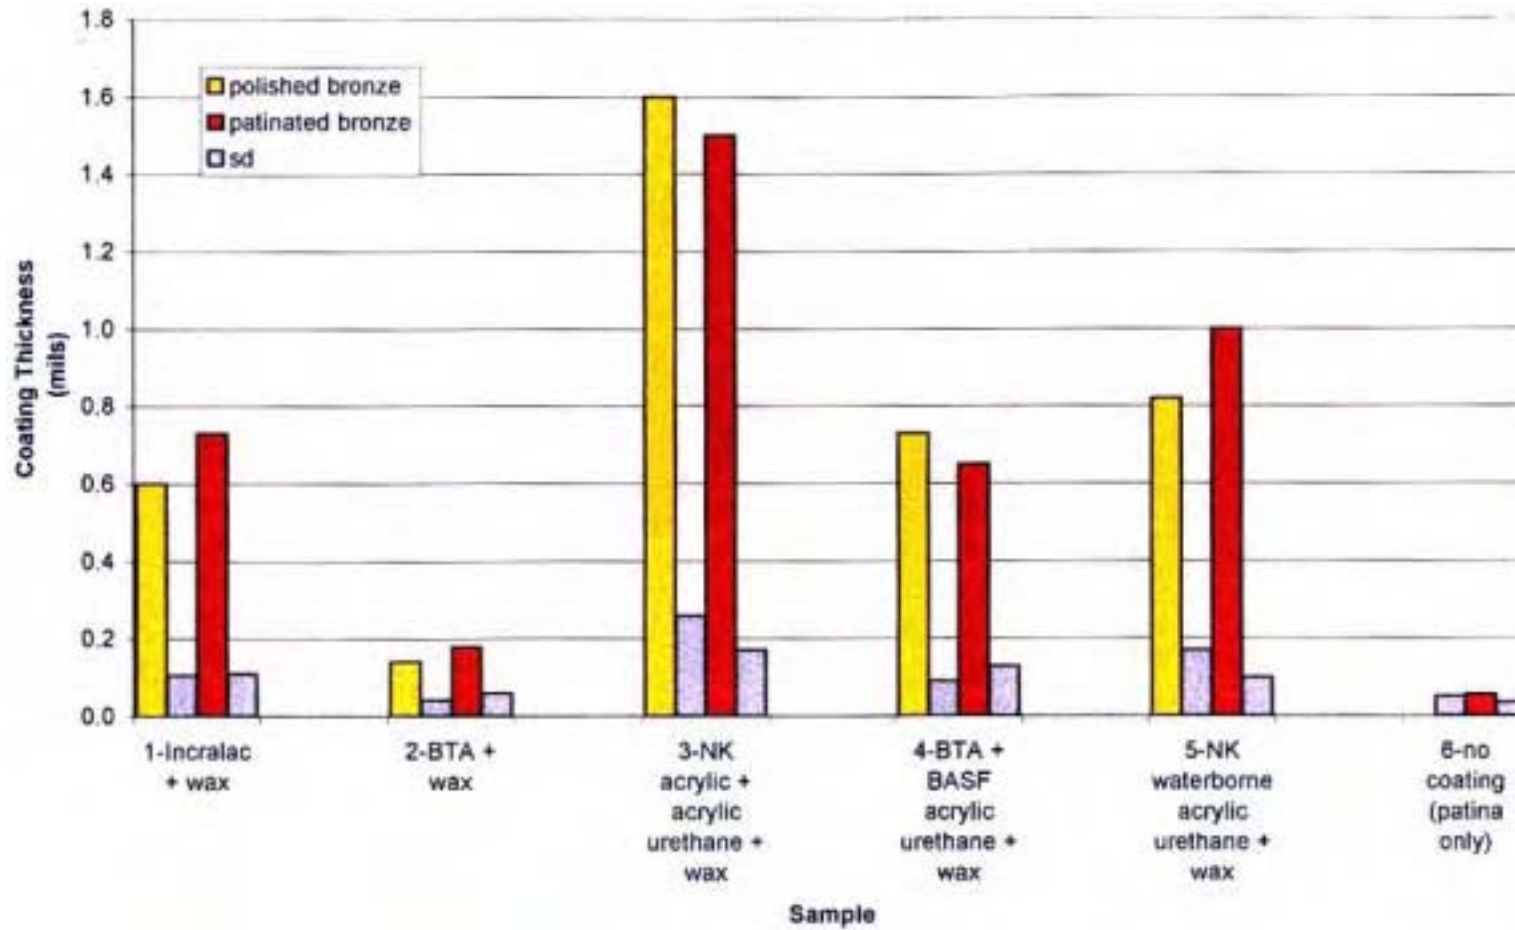
**Figure 4**

Coating thickness and thickness variation for Phase II sample set A are shown in Figures 3,4.

**Coating + Patina Thickness and Standard Deviation (sd)  
on Unweathered 50-year-old Copper Roof Substrates, Phase II  
Sample**

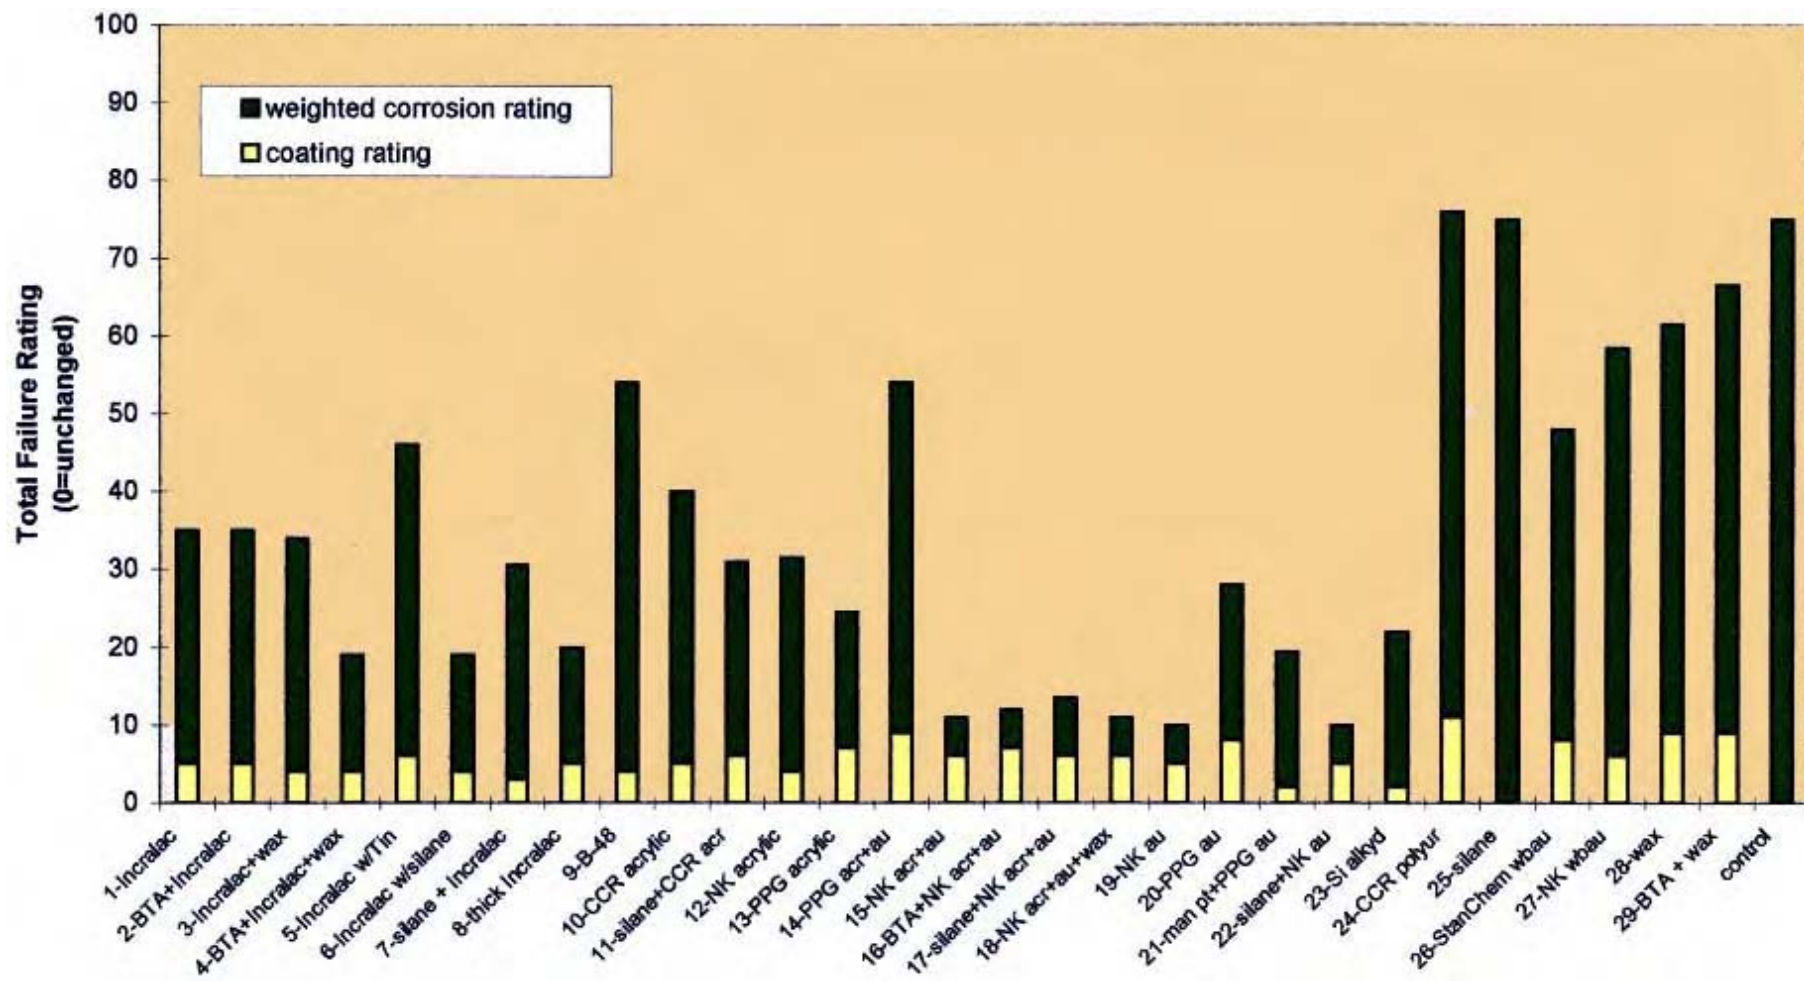
**Figure 12**

Evaluation of coating performance on sample set IC, Phase I involved the procedure described above. Results are shown in Figure 12. After roughly 1.5 years of weathering on the roof of the National Gallery of Art in Washington, DC, samples were generally performing well, with the exception of the wax coatings and some acrylics. Results for some samples are unreliable, however, since several mishaps occurred in which samples were knocked or blown over for uncertain periods of time. Some samples were performing noticeably better in natural exposure than accelerated weathering, however, including Incralac with Tinuvin 292, B-48, and the StanChem waterborne acrylic urethane. Again, results did not show any clear benefit from BTA pretreatment under various coatings, but did suggest a boost in performance from BTA pretreatment coupled with a wax topcoat. In general, results of outdoor weathering after 1.5 years correlate reasonably well with results after 1200 hours of accelerated weathering, assuming the latter are somewhat further along in their aging. This suggests that the acceleration factor in this experiment was about 11:1, i.e., 6 months of accelerated weathering predicted performance roughly equivalent to five or more years of outdoor exposure in a similar climate/urban setting.

**Failure Ratings of Coatings on Polished, Cast Bronze Phase I, After 1.5 Yr. Natural, Outdoor Weathering Based on Visual Evaluation of Coating Appearance, Overall Corrosion, and Corrosion at**

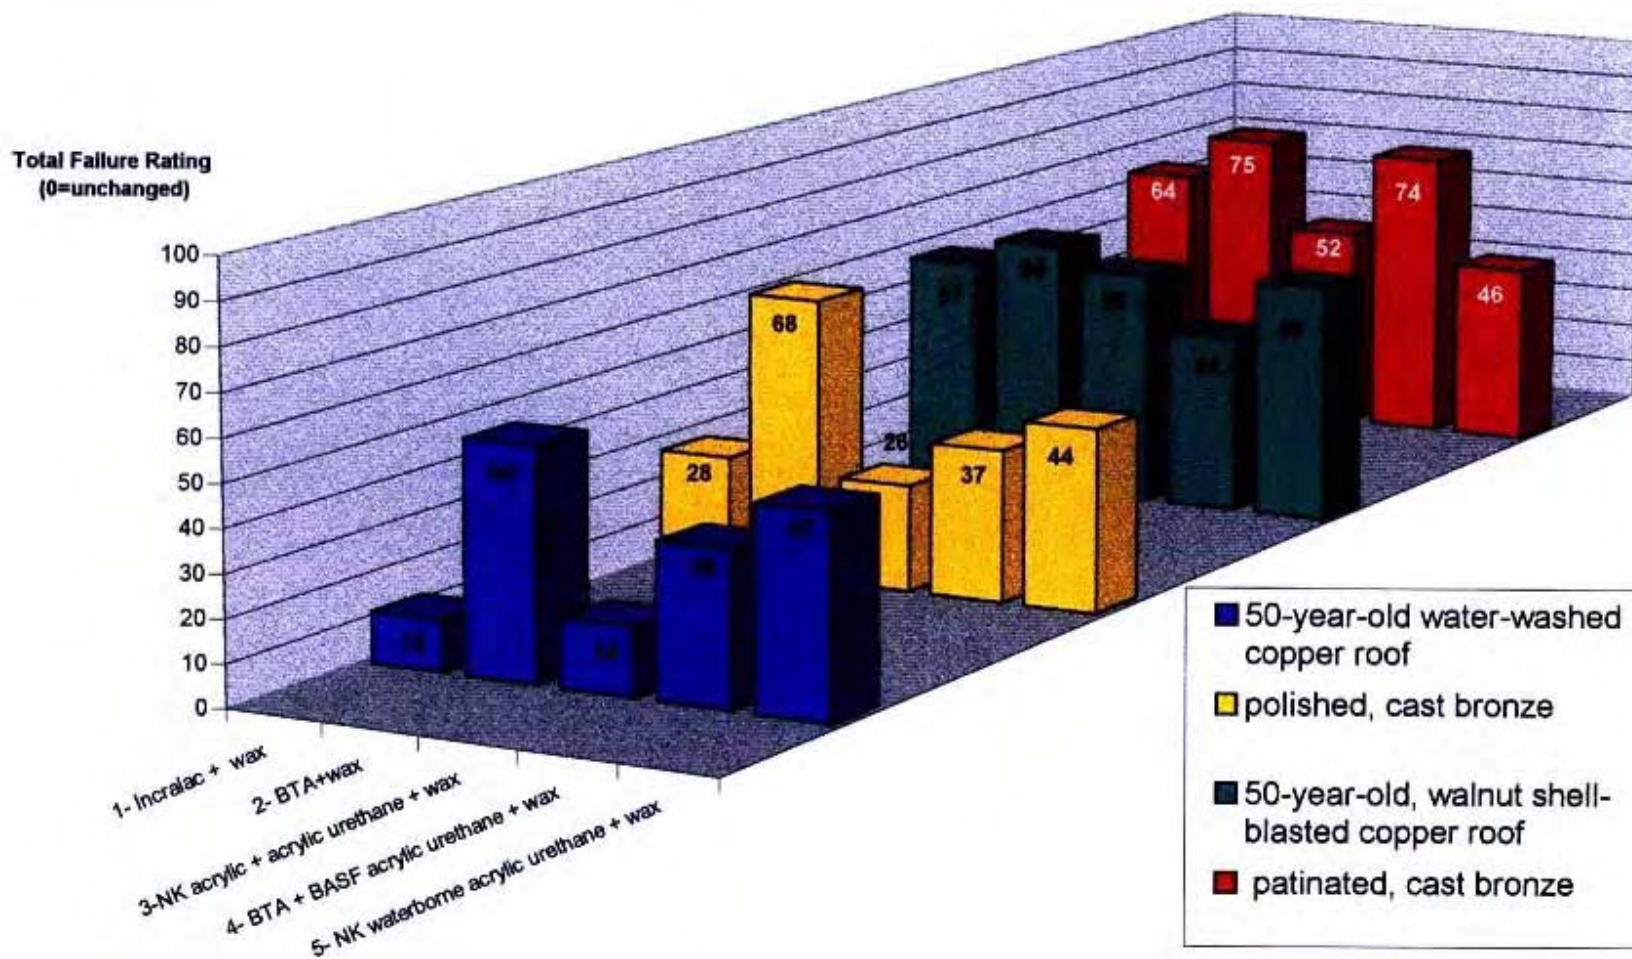
**Figure 14**

In general, corrosion products detected after accelerated weathering were expected, supporting the accelerated weathering methodology used here as reasonable. One exception, however, was the tentative identification of an ammonium salt found on the copper roof, a substrate which tends to most effectively hold water/salts and may be more sensitive to higher concentrations of ammonium ions in the artificial rain solution than are found naturally. Results also generally point out that the artificial patina made for this study, as well as the blasting of the natural brochantite patina, caused substrates to be comparatively less stable to corrosion. This is reflected in the order assumed by the four substrates in the graph of failure ratings, Figure 14.

Preliminary failure ratings for the coatings on these substrates are shown together graphically in Figure 14. These ratings were computed according the procedure in "Experimental Methods;" they appear to reflect the ranking order of coating performance quite well in all but one case: the Nikolas acrylic/acrylic urethane on patinated bronze. This coating peeled severely at the scribe mark, but overall, where still adhered, provided fairly good protection to the patinated metal. In this case, the failure rating formula, which is weighted toward evidence of corrosion, does not reflect the dramatic failure in the coating itself very well.

**Preliminary Failure Ratings  
of Coatings on Bronze and Copper Roof, Phase II,  
after 120 days Accelerated Weathering**

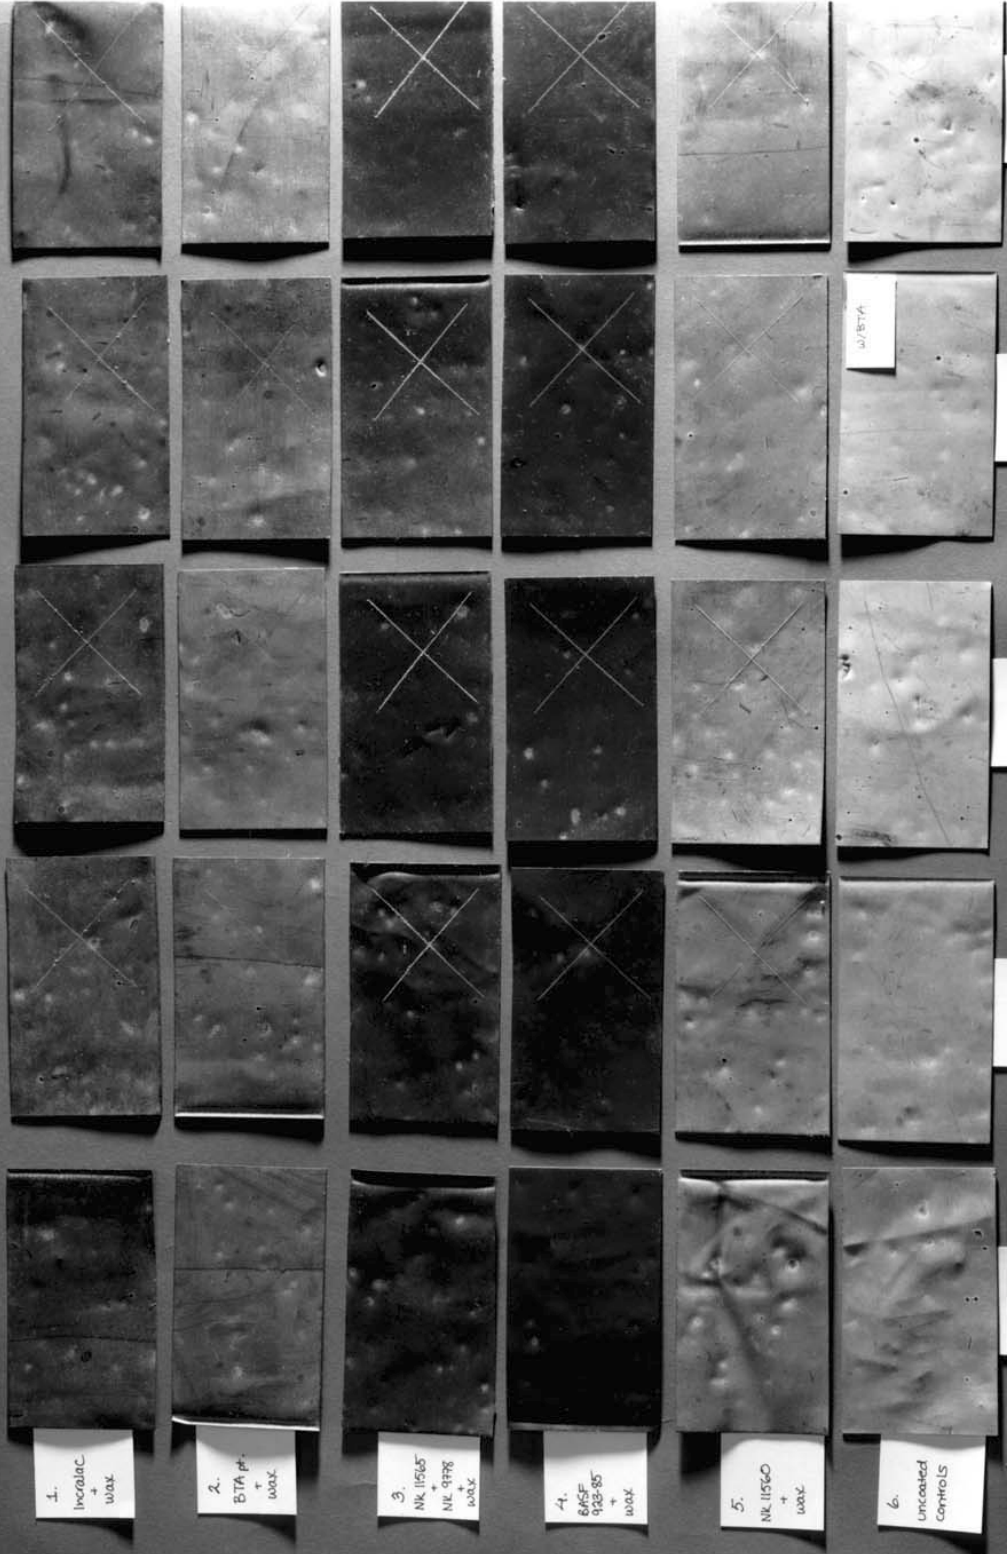
Set III  
50-Year-old  
Copper Roof  
(leached only)

BEFORE WEATHERING

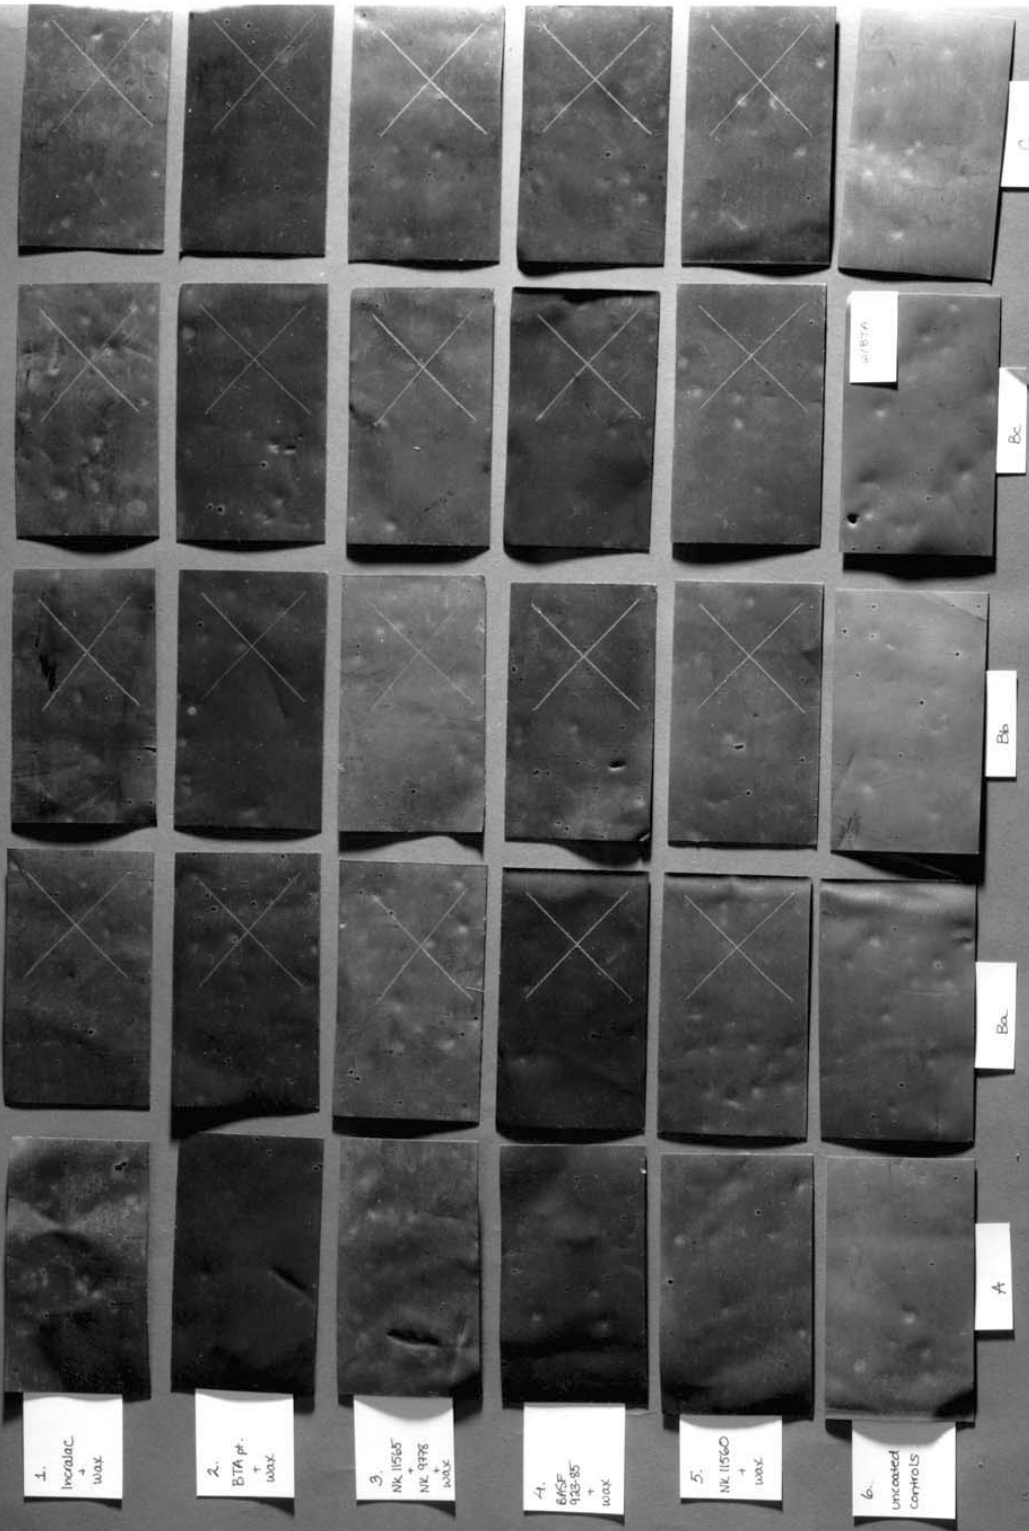
Set IV:  
50-year-old  
Copper Roof,  
Walnut-Spall based

BEFORE  
WEATHERING

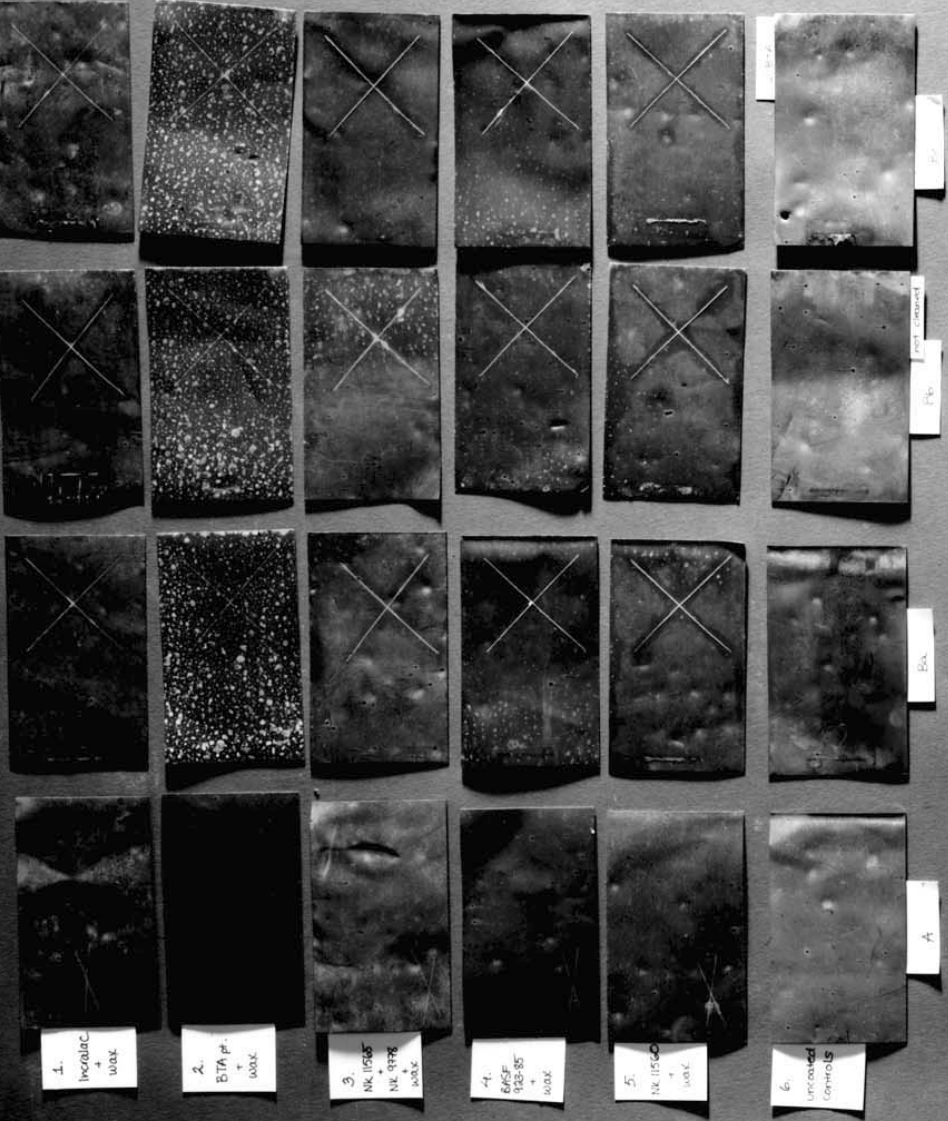
AFTER  
ACCELERATED  
WEATHERING
