# SCIENCE OF TSUNAMI HAZARDS

Volume 23 Number 2

# **EFFECTS OF MEDU AND COASTAL TOPOGRAPHY ON THE DAMAGE PATTERN DURING THE RECENT INDIAN OCEAN TSUNAMI ALONG THE COAST OF TAMILNADU**

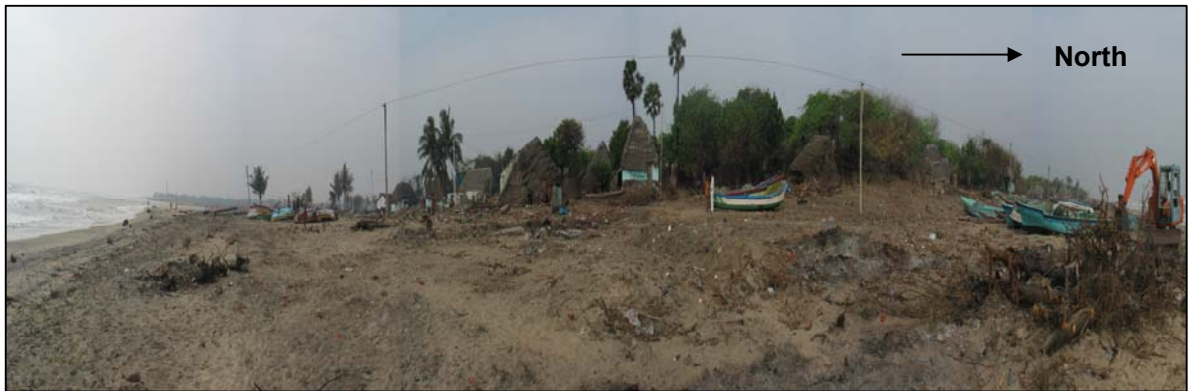
**Figure 10:** A sketch showing the Nabiyarnagar Medu from the left and front side.

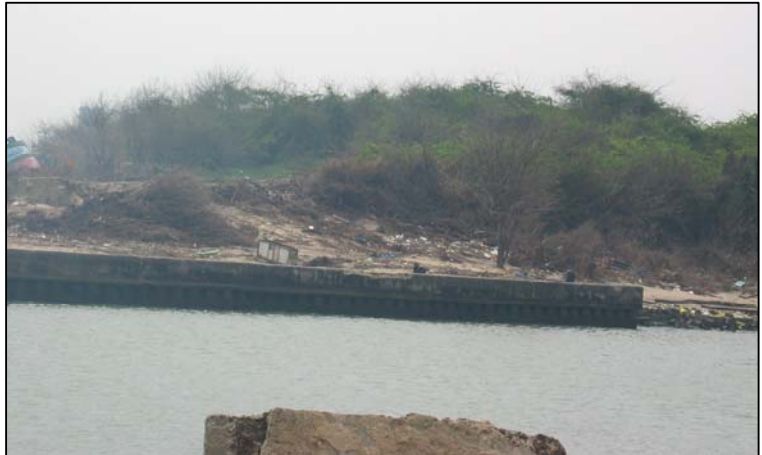
Figure 12 depicts the Nagapattinam Medu, existing just in front of the southern part of the Nagapattinam Port. The height of Medu is around 7 m with respect to the port level. Tsunami crossed the Medu. There is Kaduvaiyar River between port and the Nagapattinam Medu (Fig. 13).

**Figure 12:** Medu in front of the Nagapattinam port.

Lesser damage occurred just behind the Medu, as can be inferred from the figure 13 in which there is lesser damage to wharf in its upper and left corner. Same was the feeling of employees of this port that Medu in front of the port reduced the damage to some extent, particularly to the structures and boats in the Kaduvaiyar River, as reported by Mr. Shajath Ali (Assistant Engineer, Mechanical). On the other hand, Nagapattinam Port suffered heavy damage and it was not in operation for 15 days. Tsunami caused heavy damage to wharfs (Fig. 13), boats (Fig. 6), compound wall and an old jetty constructed in 1972.
