**Progress Report on Los Alamos National Laboratory
Cerro Grande Fire Rehabilitation Activities
One Year After Burned Area Rehabilitation**

LA-UR-02-4921
Issued: August 2002

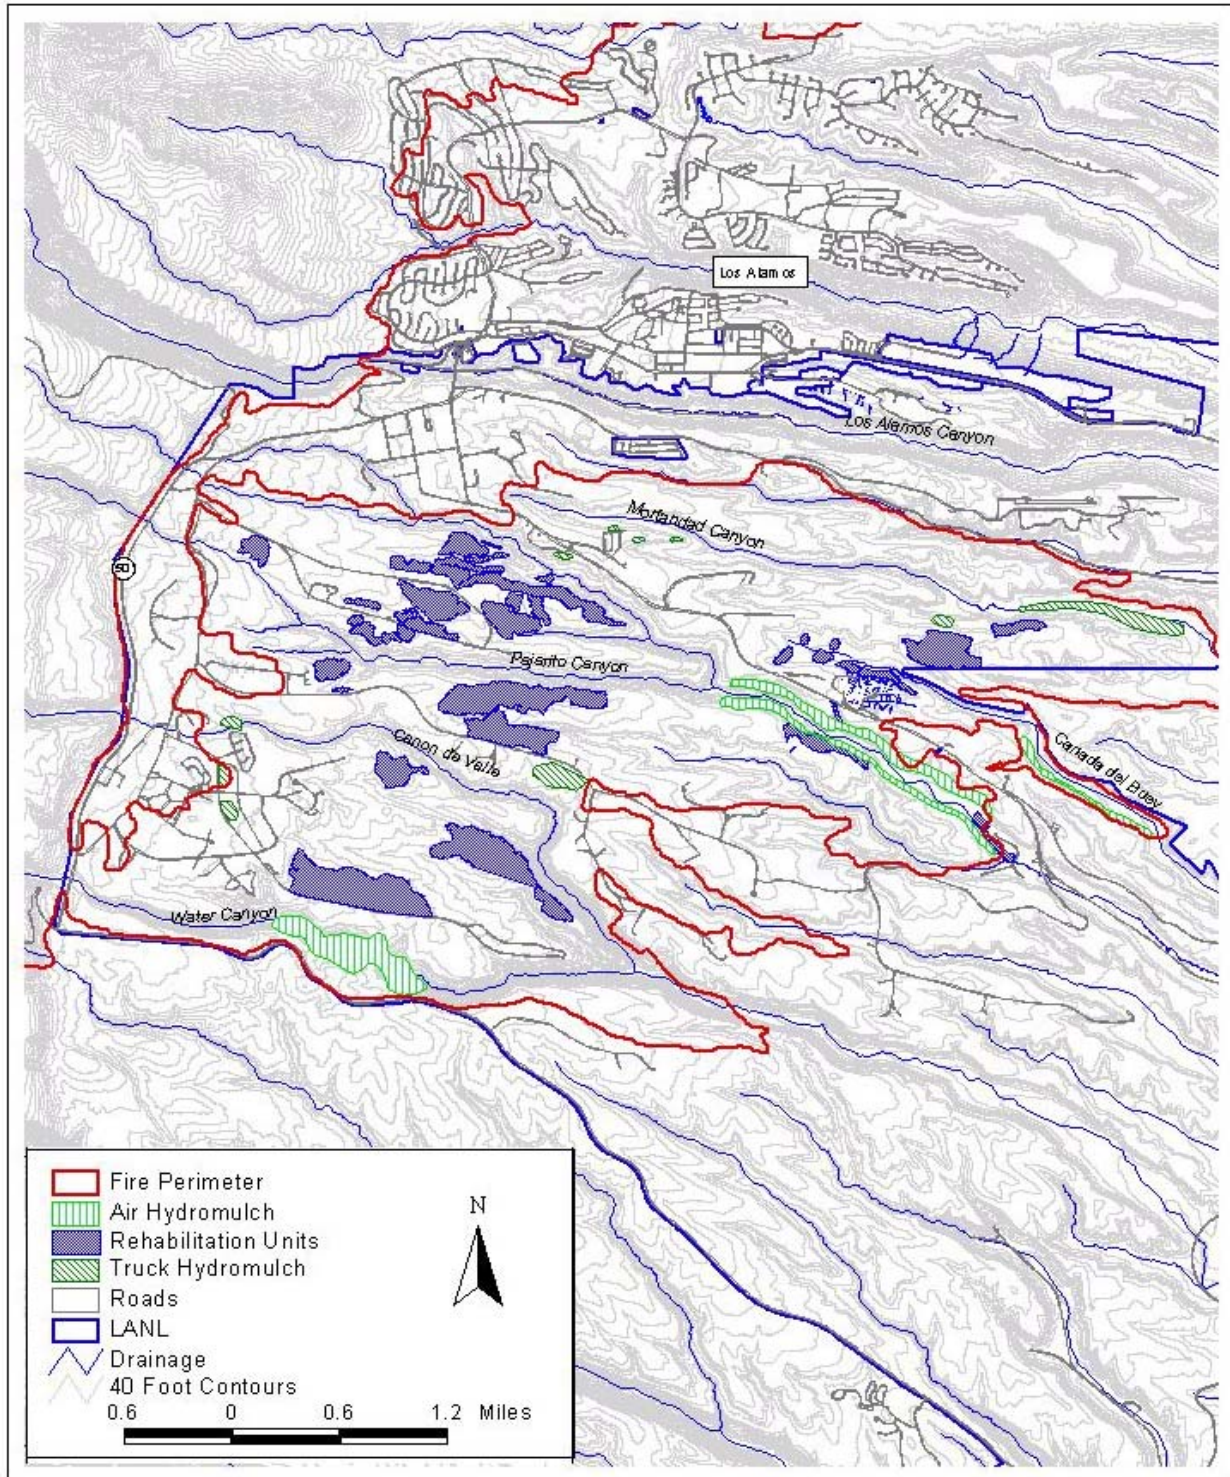
Figure 5. Treatment areas at LANL.

In general, the rehabilitation units are in good to excellent condition. In most of the units the seeded vegetation is established and providing ground cover. Very few wattles were damaged. Most damage was due to poor installation, animals/rodents tearing apart the wattles to get to the straw, and wash outs in some of the channel placements. Field assessments indicated that a high percentage of the wattles filled with sediment; however, due to excellent ground cover and vegetative growth, no further installation and maintenance is warranted for these locations at this time. There was very little evidence of down cutting below wattles or rill erosion on the slopes. Most of the mulch has been incorporated with the vegetation; however, in some areas the mulch has been blown away by spring winds. There are some small areas within the rehab units that could be re-seeded and mulched, but are not of immediate concern. In general the exposed soil in the rehab units has been stabilized by the rehabilitation treatments.

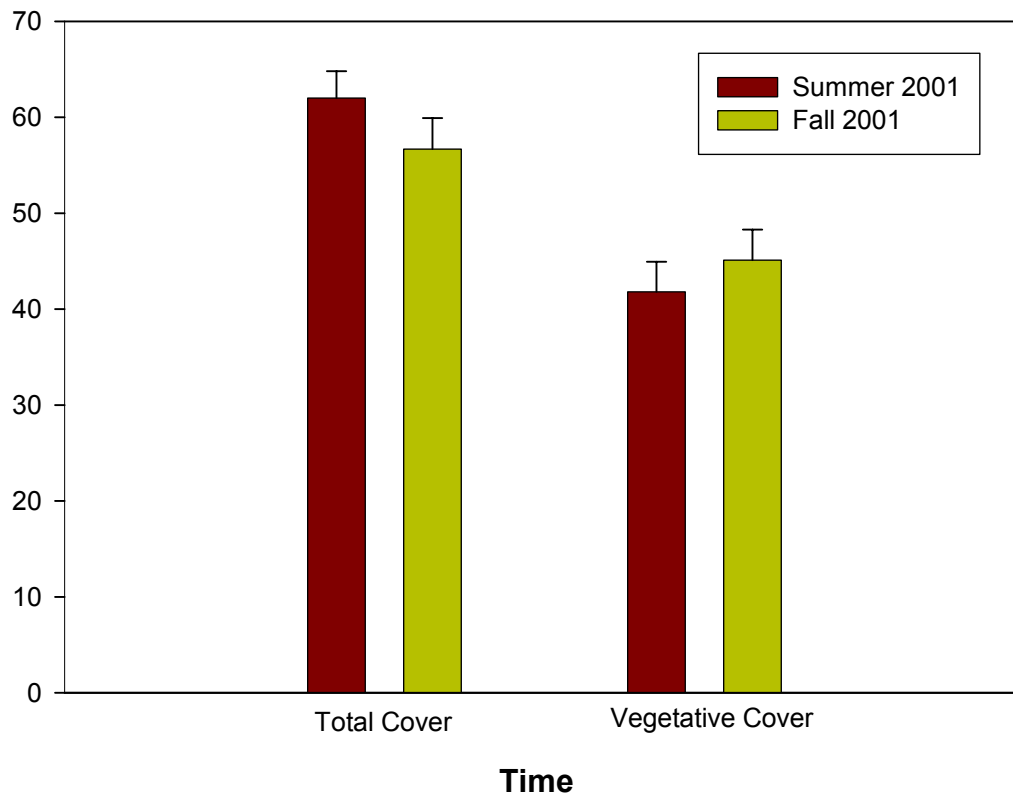
Figure 8. Change in cover on LANL rehab units.

Restoration activities conducted last year were successful in establishing ground cover on areas burned by the Cerro Grande Fire. Figure 8 shows summary data for effective ground cover and vegetative cover. Table 2 details the results of the BART survey. Conditions, with regards to vegetative cover, improved from June to December. The monsoon season was relatively short lived and did not produce significant storms over the burn units on LANL. Effective ground
