Health Hazard Evaluation Report

HETA 90-376-2106 U.S. DEPARTMENT OF HOUSING AND URBAN DEVELOPMENT HATO REY, PUERTO RICO

HAZARD EVALUATION AND TECHNICAL ASSISTANCE REPORT
HETA 90-376-2106
U.S. DEPARTMENT OF HOUSING AND URBAN DEVELOPMENT
HATO REY, PUERTO RICO
APRIL 1991

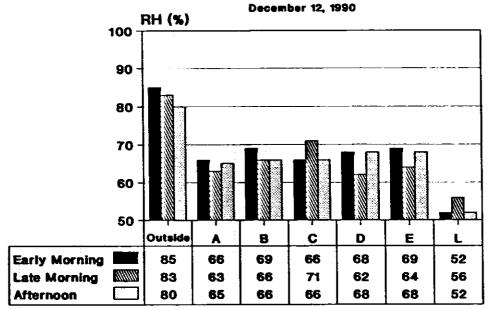
Figure 5a

Air temperature measurements are shown in Figures 4a and 4b. While there was some temperature fluctuation throughout the day in all areas, this variation was generally on the order of a few degrees. For all indoor locations combined, the air temperatures ranged from 70-75.5 degrees Fahrenheit, while outdoor air temperatures ranged from 76 degrees in the morning to 79 degrees in the late afternoon. As shown in Figures 5a and 5b, relative humidity, an indication of the moisture content of the air, ranged from 52-56% on the first floor, 62-71% on the second floor, and 62-71% on the third floor. The outdoor air humidity ranged from 80-85% over the course of the day. While there was very little variation in RH between the second and third floors, the RH measured on the first floor was considerably lower. It should be noted. however, that the first floor space occupied by HUD employees was guite small in comparison to the areas occupied on the second and third floors, requiring a smaller air handling unit. It is unclear from the limited information available, however, whether factors such as the type of unit, chiller water temperature, or the amount of outside air entering or infiltrating the area were important factors influencing the RH.

Relative Humidity-1st and 3rd Floors HUD-Caribbean Area Office, HETA 90-376

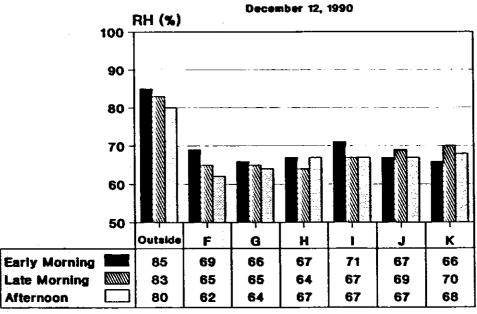
Figure 5b

Relative Humidity-2nd Floor HUD-Caribbean Area Office, HETA 90-376
