NIOSH HEALTH HAZARD EVALUATION REPORT

**HETA #2005-0033-2984 and 2005-0234-2984
Liberty Central School District
Liberty, New York**

November 2005

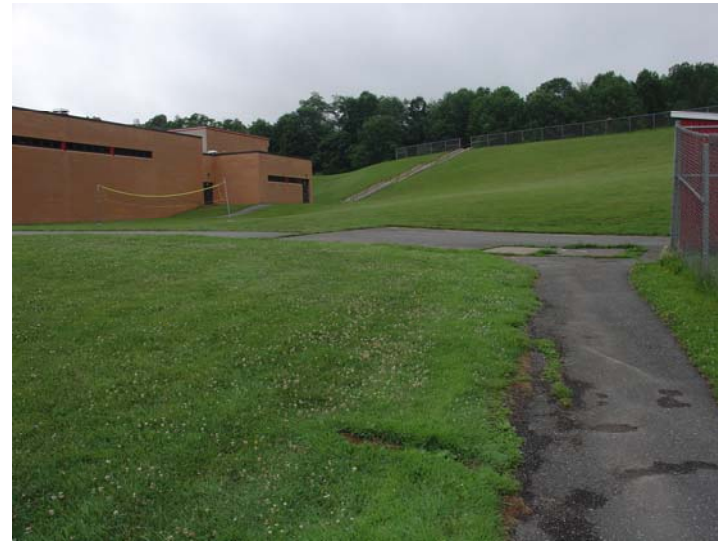
Liberty Middle School is a 90,000-square foot school built in 1991 with approximately 82 employees and 450 students in grades 5-8. This school is located in a residential neighborhood and consists of two buildings – one building contains classrooms and the cafeteria (Figure 3), the other building houses the gymnasium, band rooms, and boiler room. The buildings are constructed of concrete block with a brick veneer. The rubber-membrane and gravel roof is original to the building. The two-story, semi-circular portion of the building extends beyond the classroom building and houses the administrative offices and library. The greenhouse is located on the roof above the library. The buildings are connected to each other and Liberty High School by an enclosed hallway (Figure 4). The classroom building was built into a hill with three floors above grade in the front and two above grade in the back. The gymnasium building is above grade. The school grounds behind the classroom building flood during heavy or long rains. The wall adjacent to

Figure 14. View of the grounds toward the back of the Middle School classroom building.
