NIOSH HEALTH HAZARD EVALUATION REPORT

**HETA # 2003-0346-2969
Salvation Army Harbor Light Center
St. Louis, Missouri**

May 2005

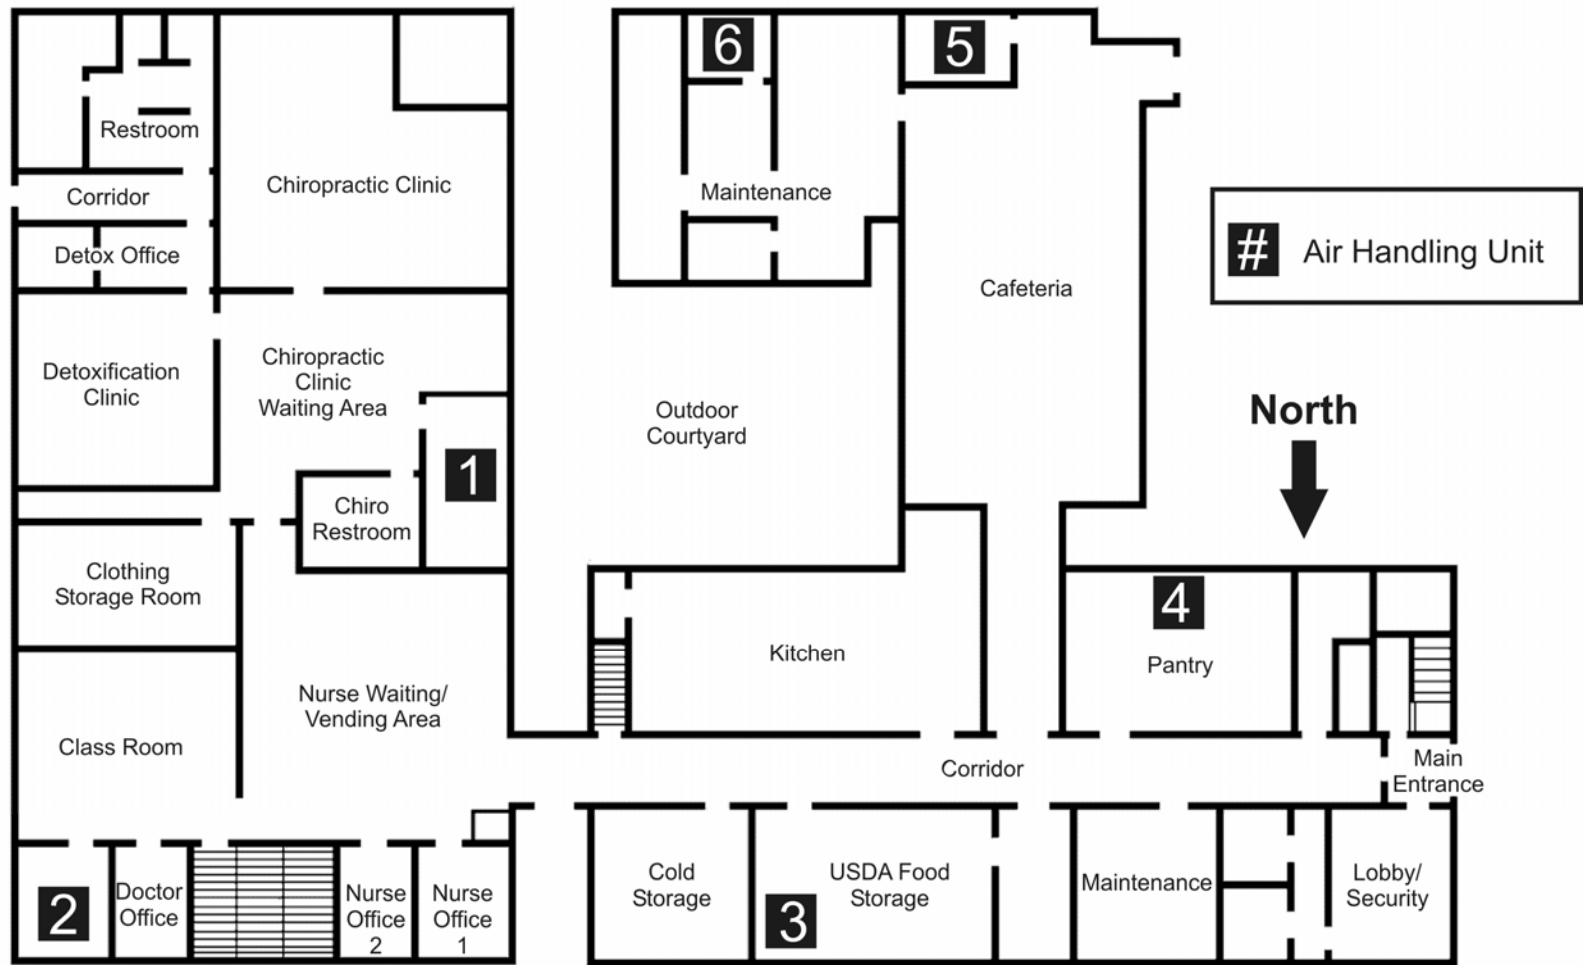
Figure 3. Basic floor plan of the main building first floor, including the locations of AHUs.

Table 2 provides the locations and general information on all 18 AHUs in the main building. Locations of the six AHUs serving the first floor of the main building are shown in Figure 3. These units were generally in need of cleaning, maintenance, and repair. They were typically installed inside small mechanical rooms that were also used for general storage (files, holiday decorations, extra ventilation filters, etc.). The outside surfaces of most AHUs in the main building were covered with dust and debris (Figure 7). Likewise, the inside surfaces were also covered with heavy layers of dirt and debris (Figure 8) and many had debris collected on the heating/cooling coils (Figure 9). Another common problem was stagnant, dirty water in clogged drain pans or drain pans having inoperable pumps (Figure 10). In some cases, it was evident that leaking or overflowing drain

We also collected ventilation measurements from the first floor of the main building during the July 2004 visit. Measurements were collected for each supply vent associated with AHUs 1, 2, and 5 (see Figure 3), which supply air to the main client locations on the first floor. The other AHUs supply air to the food storage areas, kitchen, and maintenance shop, which are generally unoccupied. AHU 1 provides ventilation to the chiropractic clinic, detoxification clinic, and the supporting offices and waiting rooms. AHU 2 supplies air to the medical offices, the nurse waiting/vending area, and the classroom. AHU 5 supplies air to the cafeteria only.

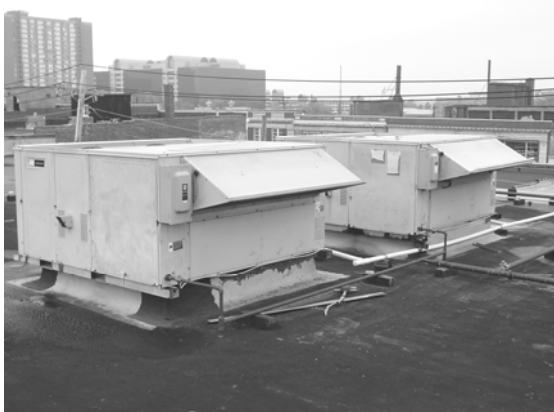
Figure 4. Rooftop AHUs on the annex. Picture shows outside air intakes.

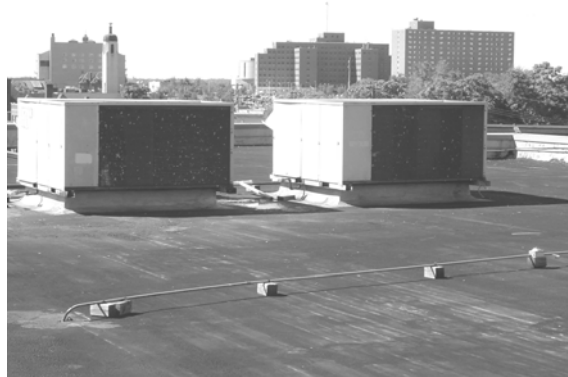
Figure 5. Back side of annex rooftop AHUs.

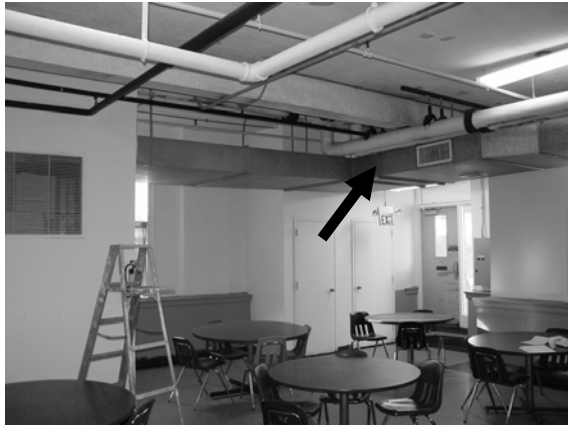
Figure 14. Supply duct work with vents extending from room housing AHU 5 in the main building. A return grille cut into the wall can also be seen on the left.

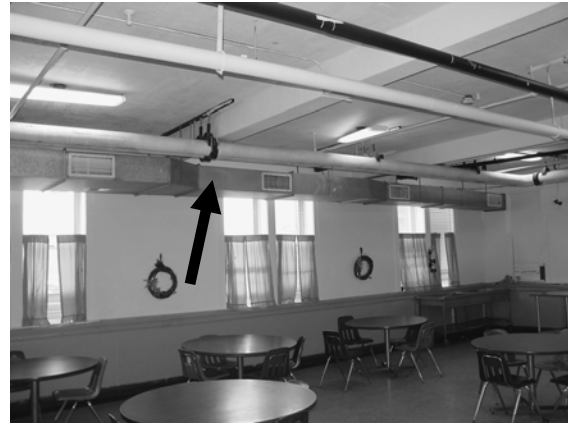
Figure 15. Supply duct work with vents extending along the ceiling of the cafeteria in the main building.

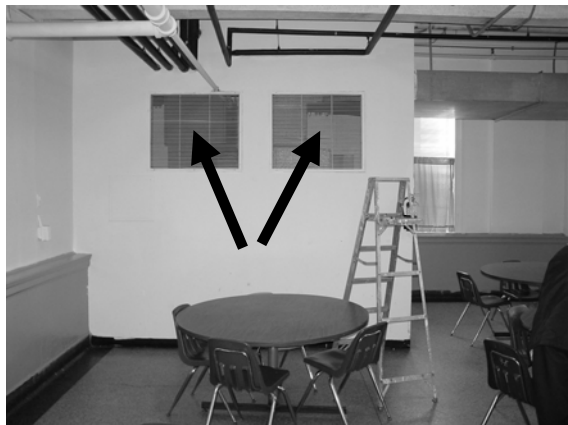
Figure 16. Return grilles through wall into the room housing AHU 5 from inside the cafeteria.

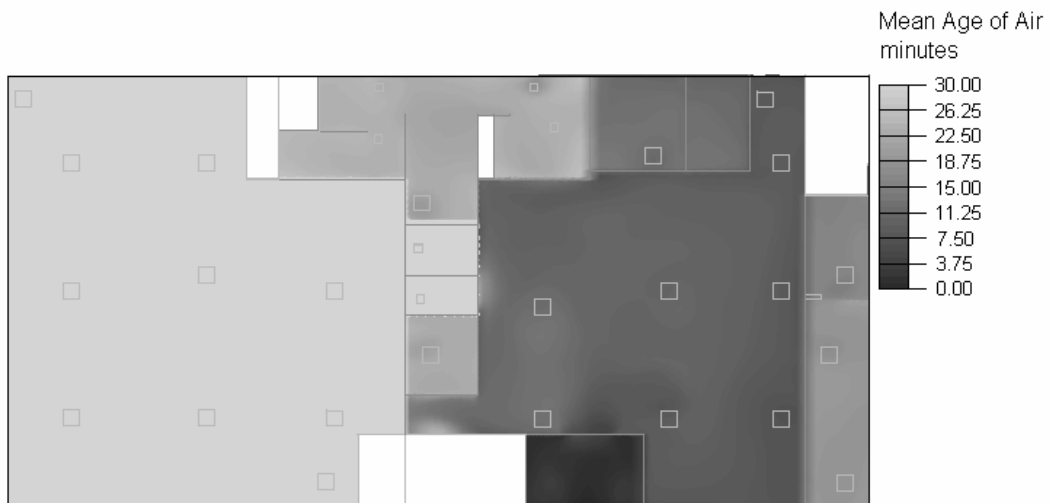
Figure 30 shows the CFD modeling results for the annex first floor based on ventilation measurements from January. Darker shading represents lower mean age of air values, and therefore more ventilation air flow and more outside air. The respite area had a mean age of air of at least 30 minutes. The common area had a mean age of air around 10 minutes. Office 1, Offices 2 and 3, the storage area, and the monitor station all had mean age of air values of around 20 minutes. The mean age of air in the women’s restroom and the laundry room was around 30 minutes. Since no sampling was ever conducted in the annex stairwells, the model was not solved for these areas and they appear bright white. However, the model was solved in the entryway, where the main door is opened and closed frequently. There, the model appears dark black, as the mean age of air was only one or two minutes.

Figure 30. CFD modeling results showing mean age of air (in minutes) at three feet off the floor for the annex first floor in January 2004.

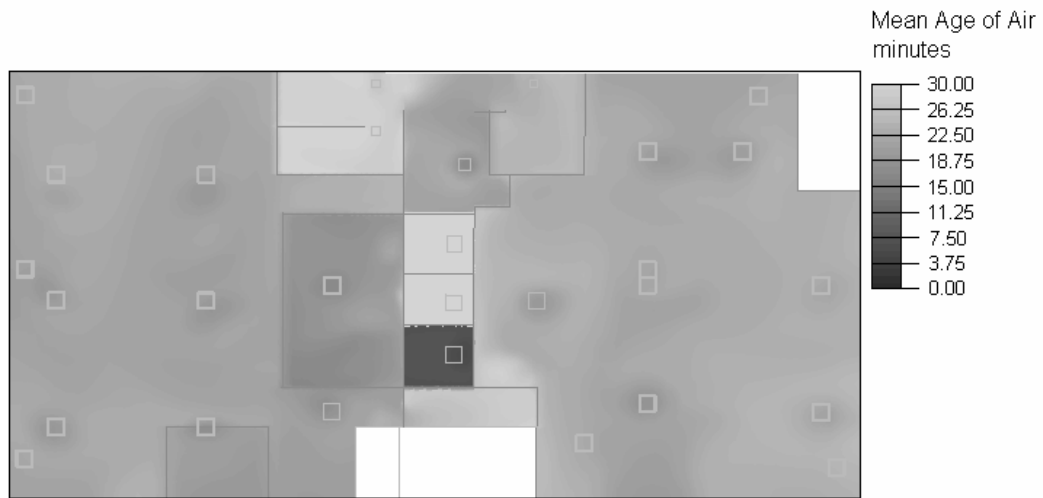
Two similar CFD models were developed and solved for the second floor of the annex. Figure 32 shows the results using the January measurements. The mean age of air for the Level 1 and VA areas was around 20 to 25 minutes. The conference room and Office 4 both had a mean age of air around 20 minutes. Office 1 had a mean age of air of 10 minutes because of the high air flow from the supply vent located there. Offices 2 and 3 show up bright white because there was no air flow (flow rates of zero recorded) from the supply vents in those spaces in January. The restroom on the second floor had mean age of air of 25 minutes and greater, depending on the location. Again, solutions for the stairwells were not solved in the model, so they show up bright white.

Figure 32. CFD modeling results showing mean age of air (in minutes) at three feet off the floor for the annex second floor in January 2004.

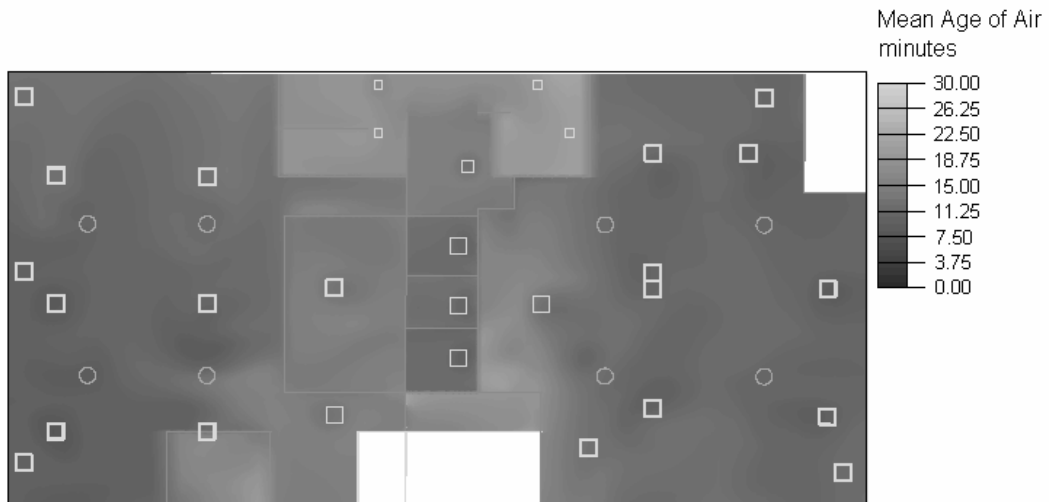
Compared with the January results, CFD model results using the October measurements (Figure 33) shows that the mean age of air was generally reduced nearly everywhere on the annex second floor, meaning there was more air flow and increased outdoor air supply. The lone exception is Office 1, where the mean age of air increased to around 15 minutes because the air flow value measured in October was less than that in January (see Table 6). The Level 1 and VA areas have mean age of air values generally less than 15 minutes. The conference room and Offices 2, 3, and 4 all had a mean age of air around 15 minutes. The restroom on the second floor had mean age of air of 15 to 20 minutes.

Figure 33. CFD modeling results showing mean age of air (in minutes) at three feet off the floor for the annex second floor in October 2004.
