Major Maintenance Report

Tillamook North and South Jetties

Garibaldi, Oregon

December 2003

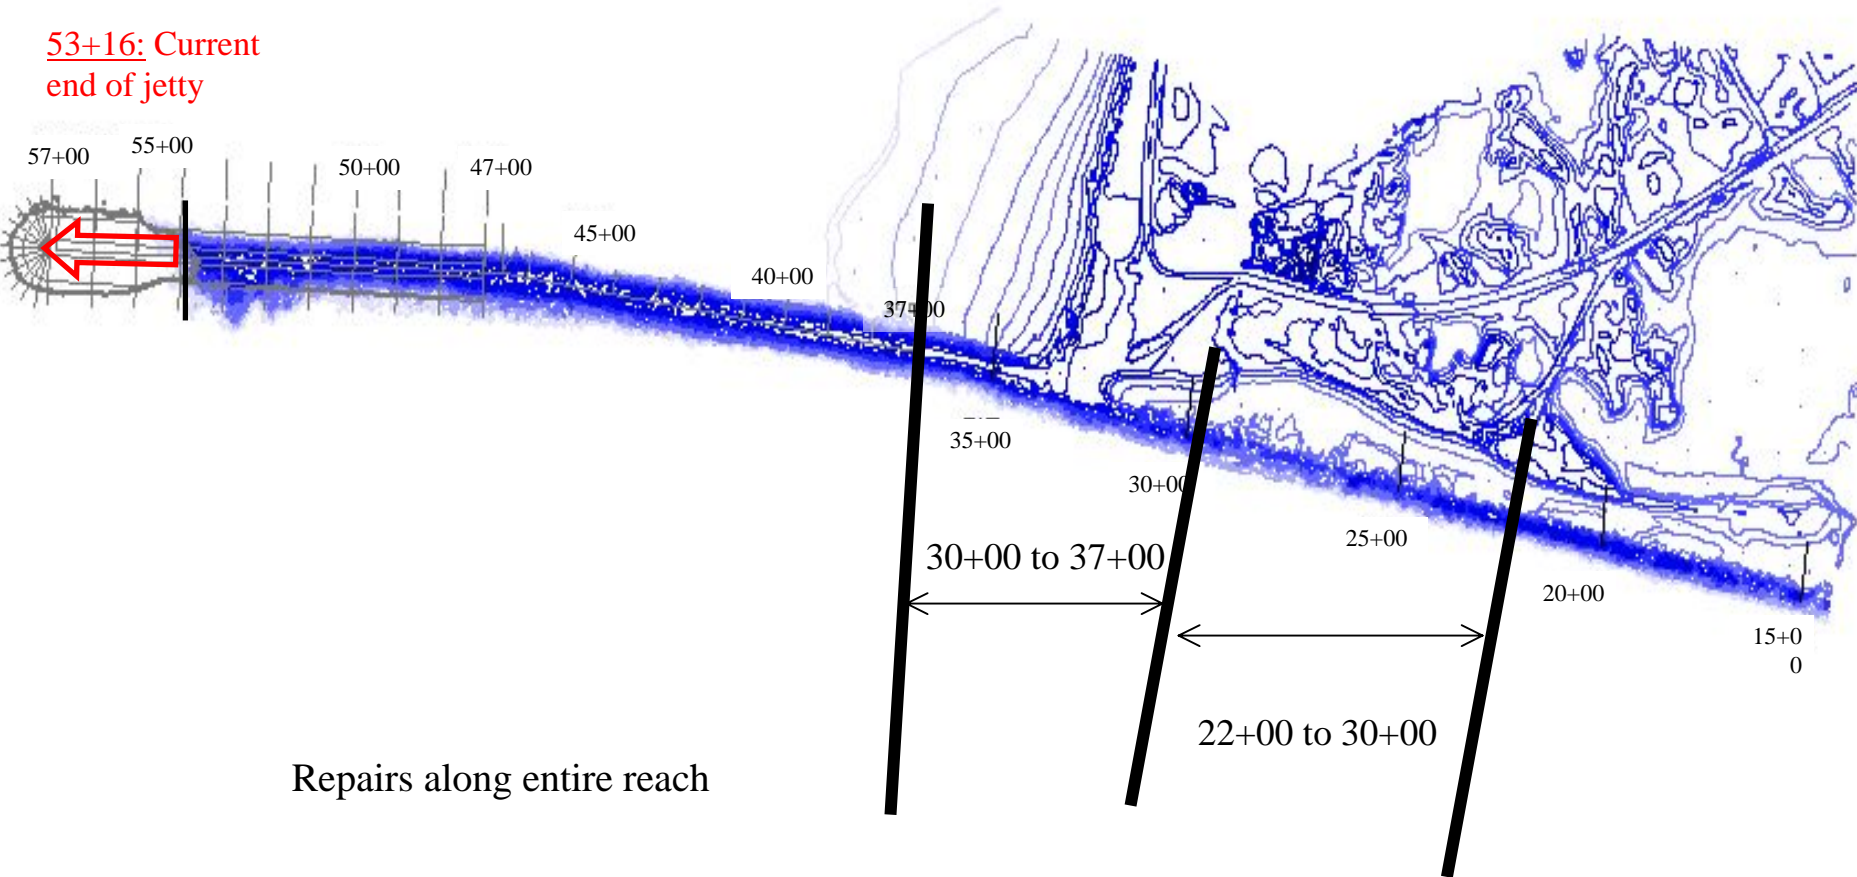
53+16: Current
end of jetty

Repairs along entire reach

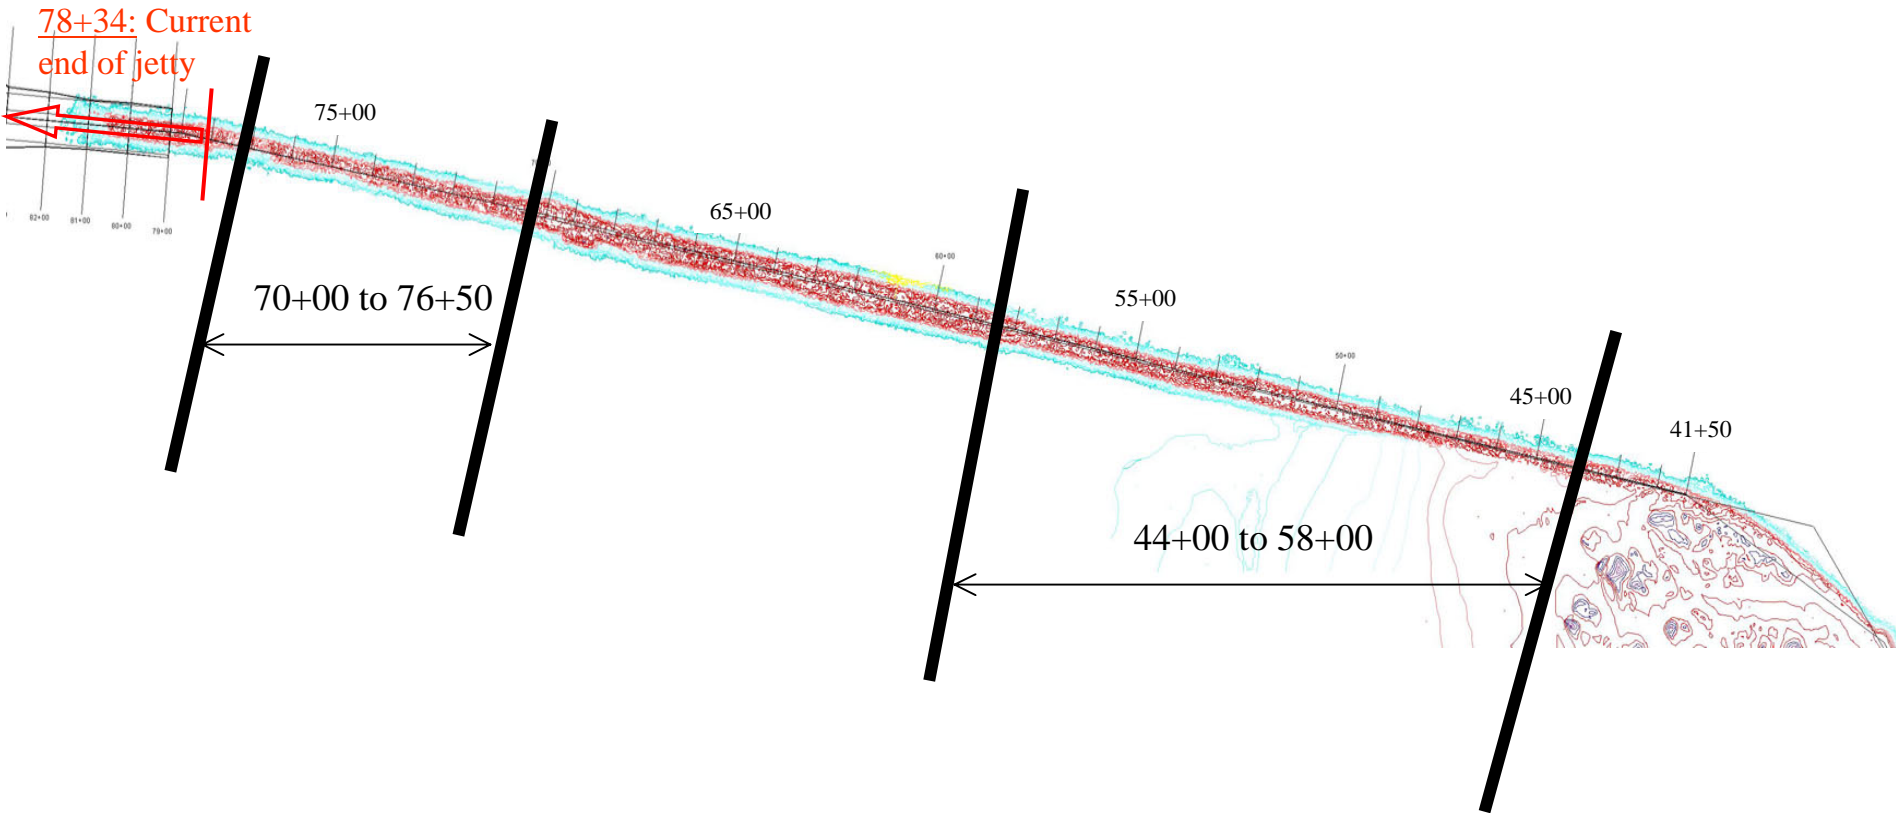
Figure 2-20 South Jetty Trunk Repair Reaches

- e. South Jetty Trunk Repair Design. There are areas along the south jetty that have lost stone and need to be repaired. In general, the original design for the jetty was for an 18 ft MLLW high structure with a 30 ft wide crest and sideslopes of 1:2 above MLLW and 1:1.5 below MLLW. Two damaged areas were identified that are in need of repair, see figure 2-20.

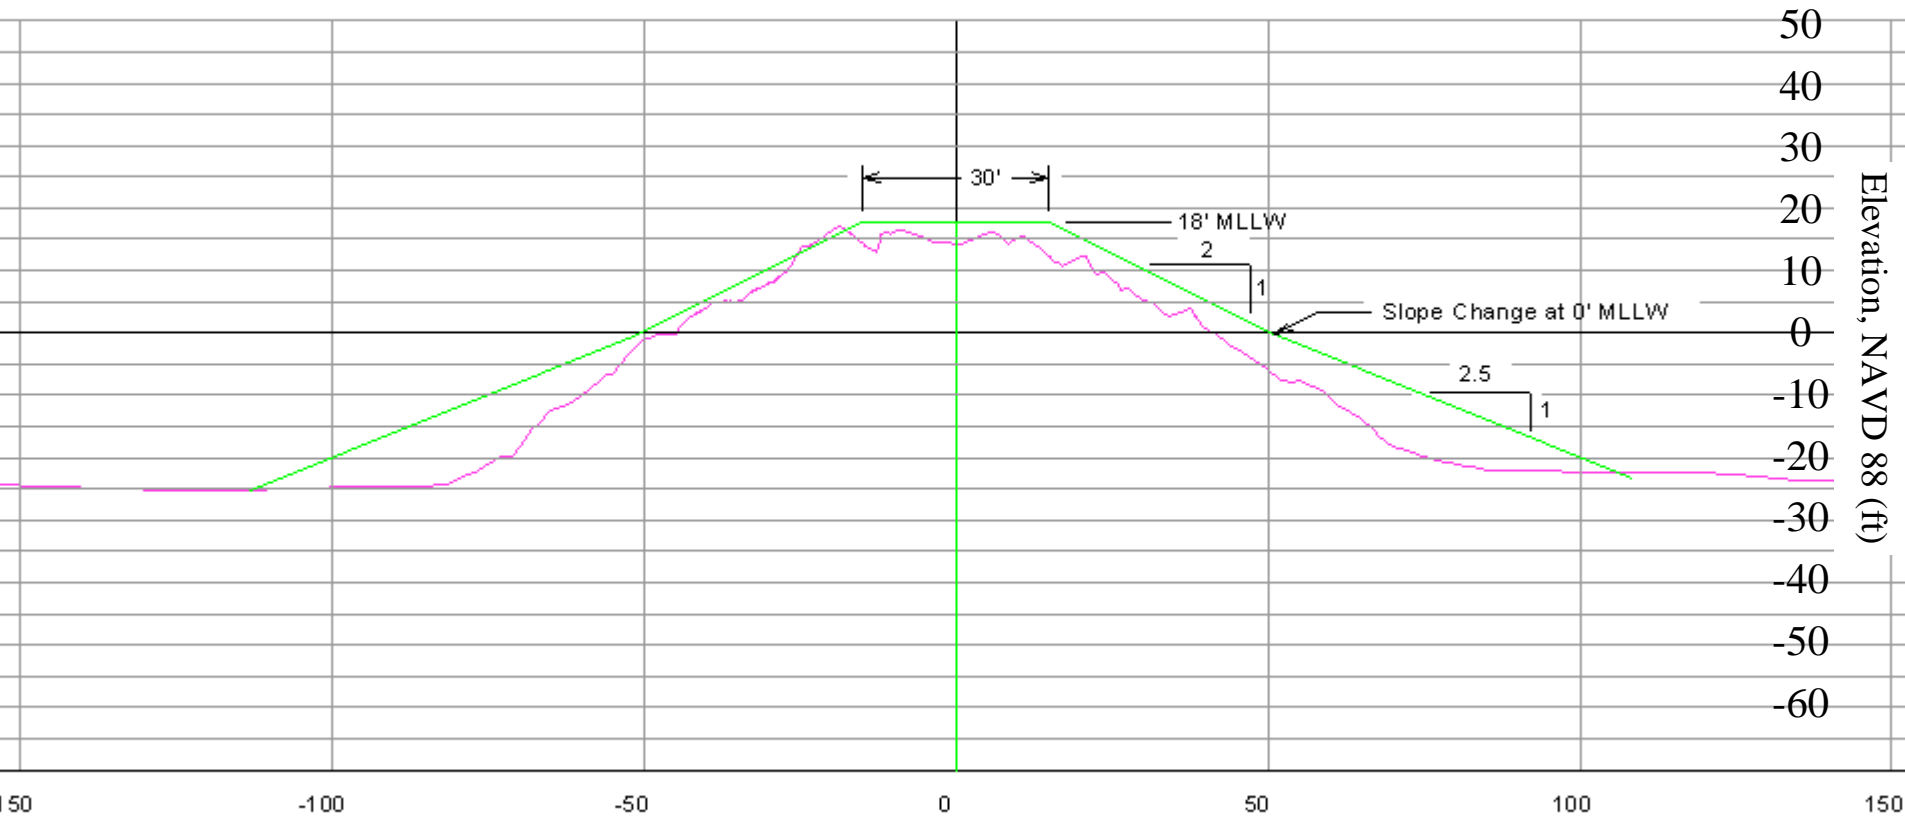
Figure 2-22 Typical Damage and Repair Design for South Jetty STA 70+00 to 74+00

Tillamook South Jetty
Sta. 72+50
