Tillamook Major Maintenance

July 26, 2004

Existing Project Condition

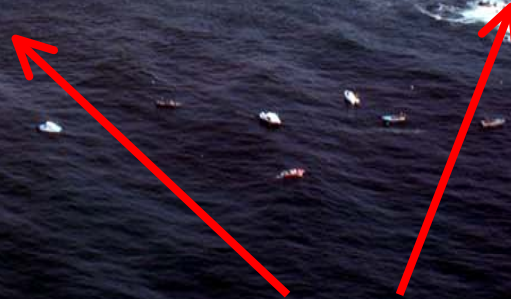
Figure 2.7.2

400' of submerged
North Jetty

Root
Erosion

Weakened North
Jetty along Root

730' of submerged
South Jetty

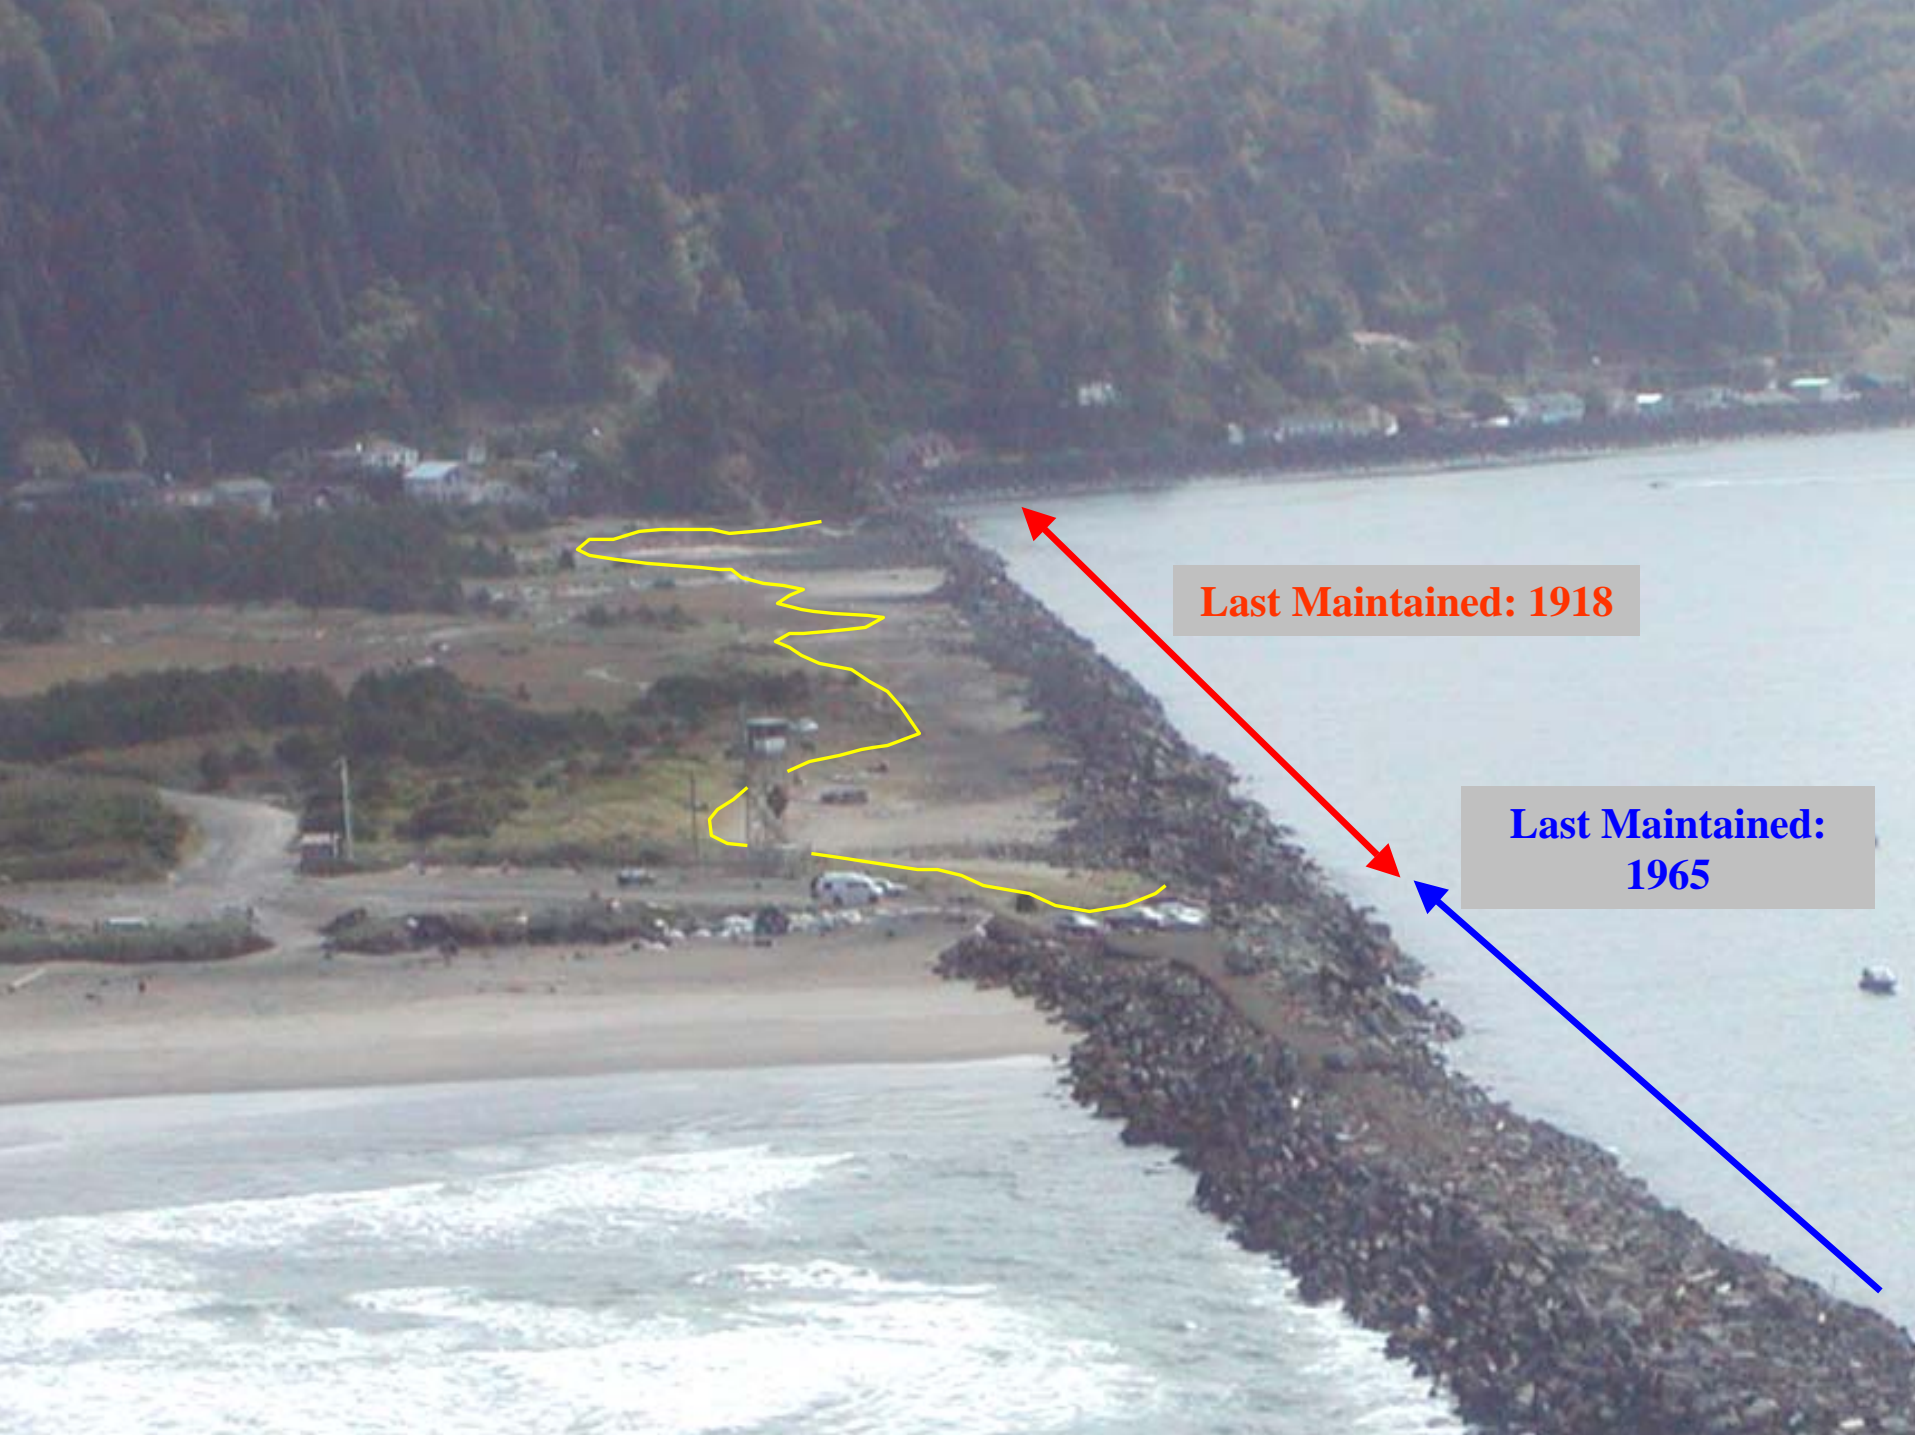
Last Maintained: 1918

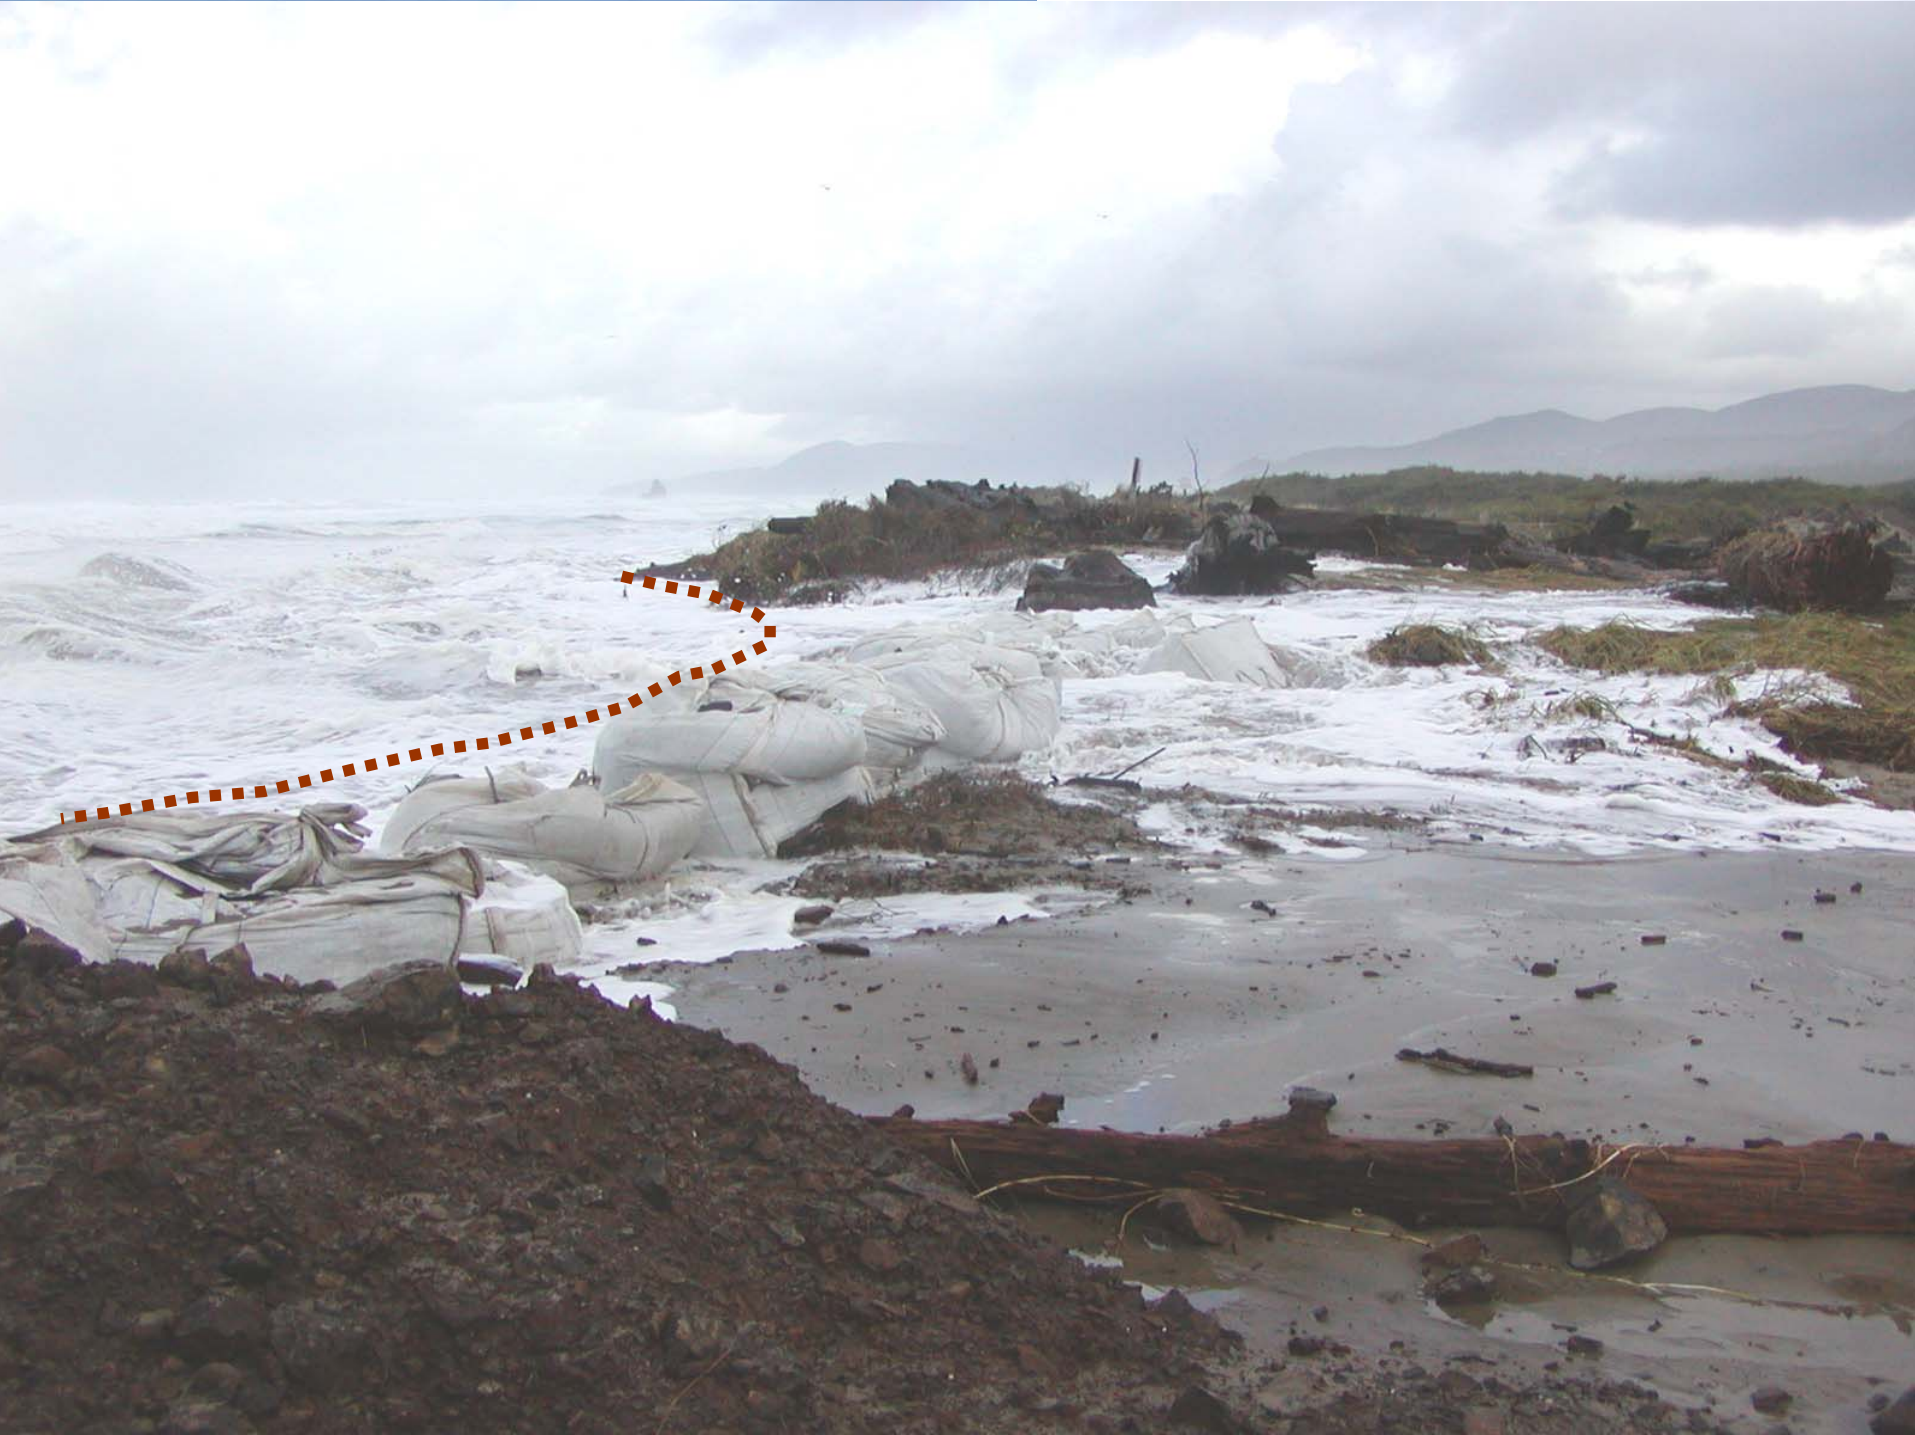
**Last Maintained:
1965**

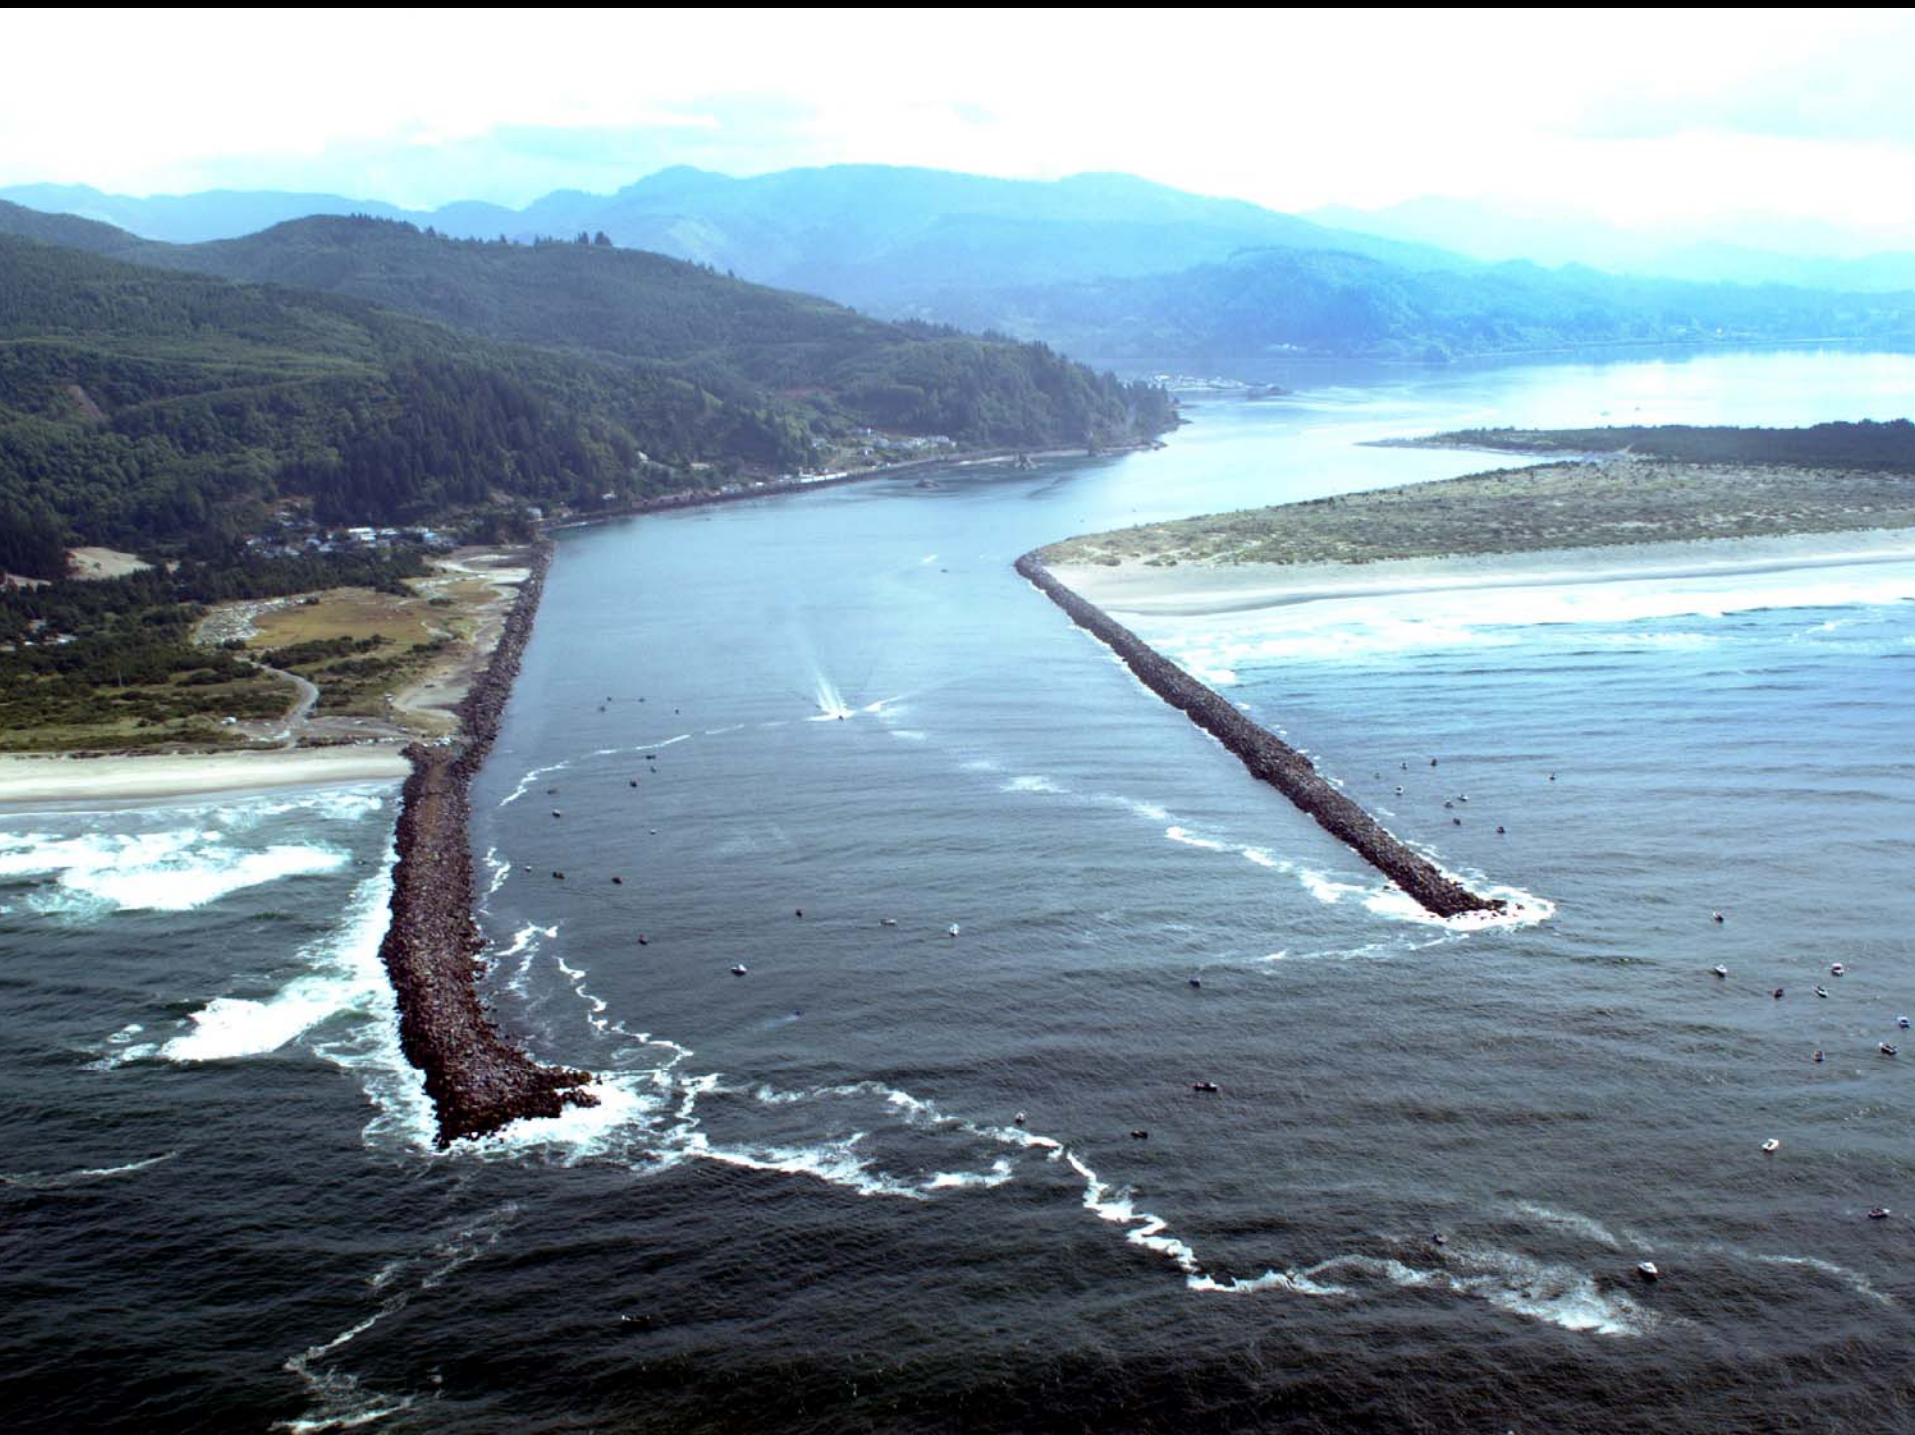
Wave Action & Erosion at North Jetty Root

If this narrow section of beach is breached, the north jetty root will likely fail soon afterward
