## **FACE 82-02: Fall from a Scaffold Involving a Construction Foreman**

### **INTRODUCTION**

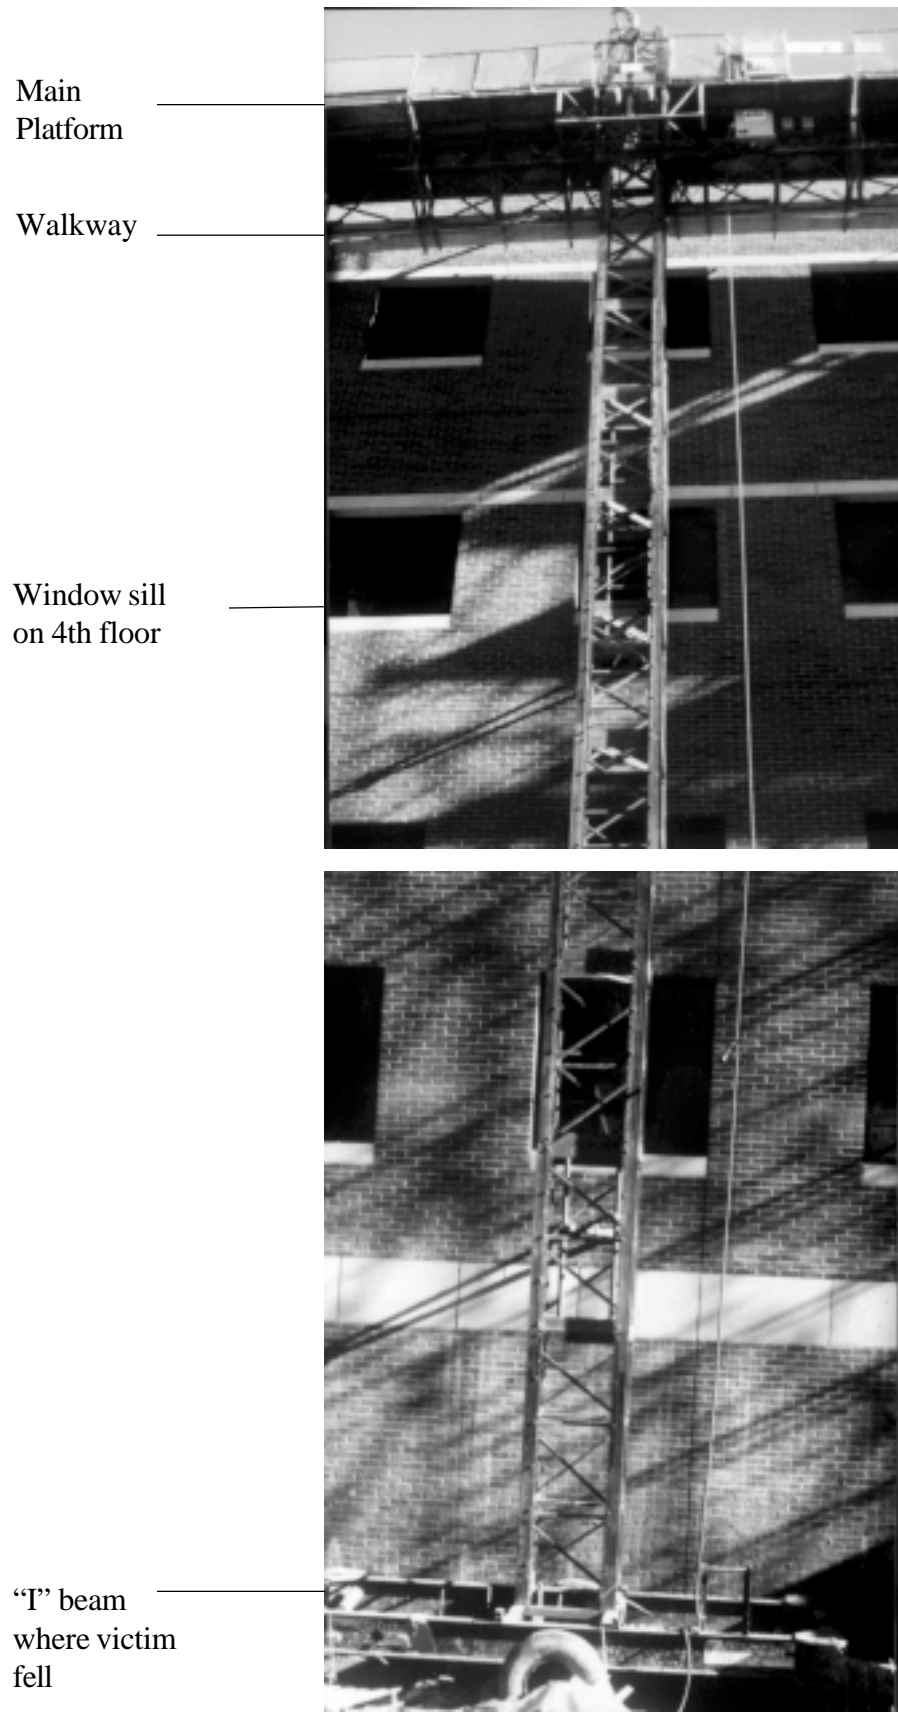
*Figure.*

Workers on this type of work platform (or scaffolding) at positions in front of open areas (e.g., windows, cantilevered sections, etc.), are exposed to a fall hazard. Fall protection consisting of a guardrail or other appropriate fall protection equipment (e.g., safety belt and lifeline) should be provided in accordance with OSHA Standard 29 CFR 1926.451(a)(4), and ANSI Standard A.92.6-90, Self-Propelled Elevating Work Platforms.

***Recommendation #1: Employers should conduct jobsite surveys to identify potential hazards and implement appropriate control measures.***

Discussion: Employers should conduct jobsite and equipment surveys to identify potential worker hazards. Once potential hazards have been identified, appropriate control measures should be recommended and implemented prior to the start of work at any jobsite.
