# THE DALLES HYDROELECTRIC PROJECT

## NORTH AND EAST FISH LADDER RELIABILITY ASSESSMENT REPORT

**The Dalles Dam North Fish Ladder  
Inspection Report**

**The Dalles Dam East Fish Ladder  
Inspection Report**

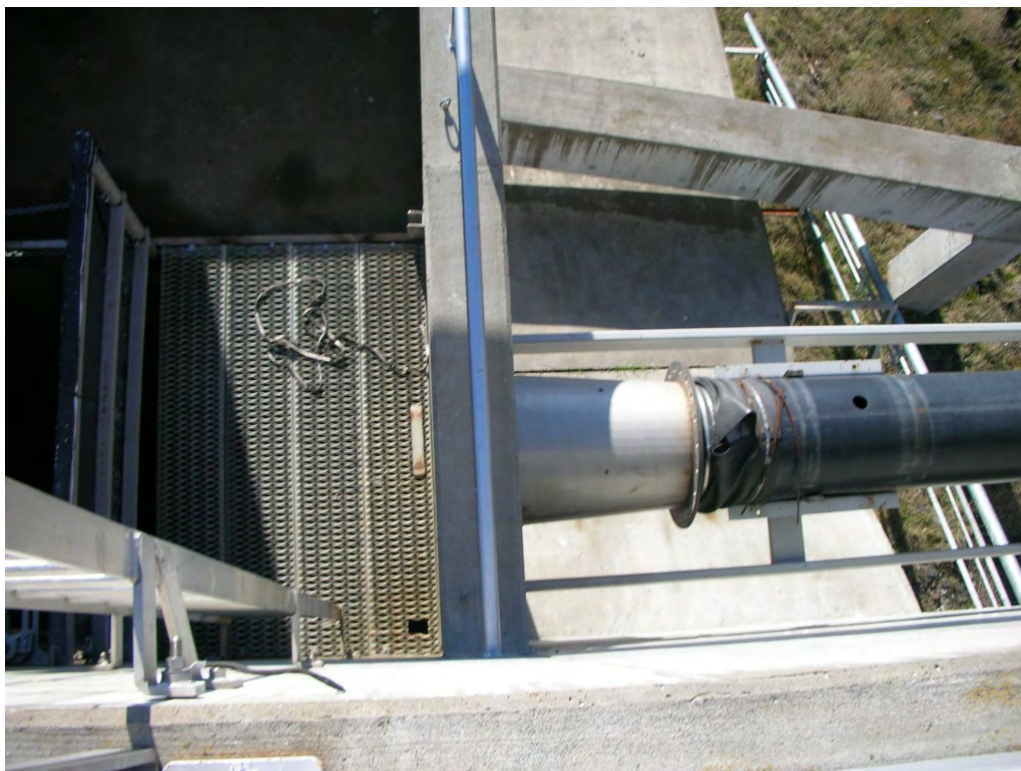
CS-4 Fish Bypass Pipe

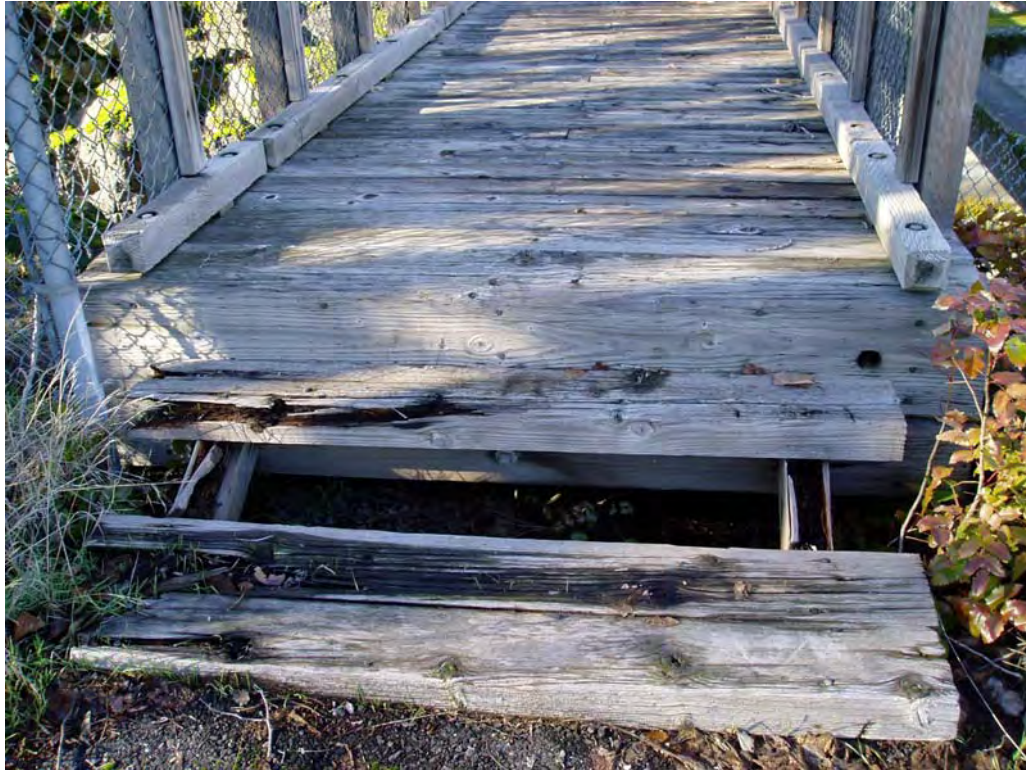
CS-5 Crossover Bridge

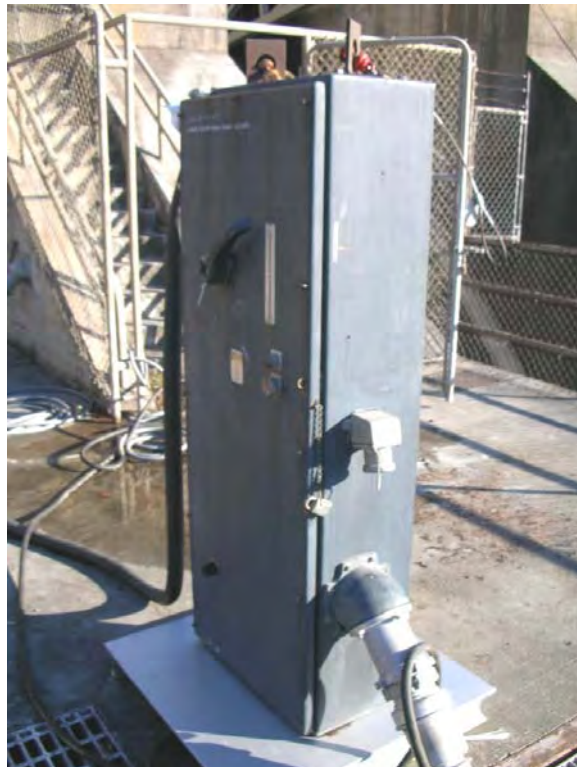
E-1 Dewatering Pump Panel

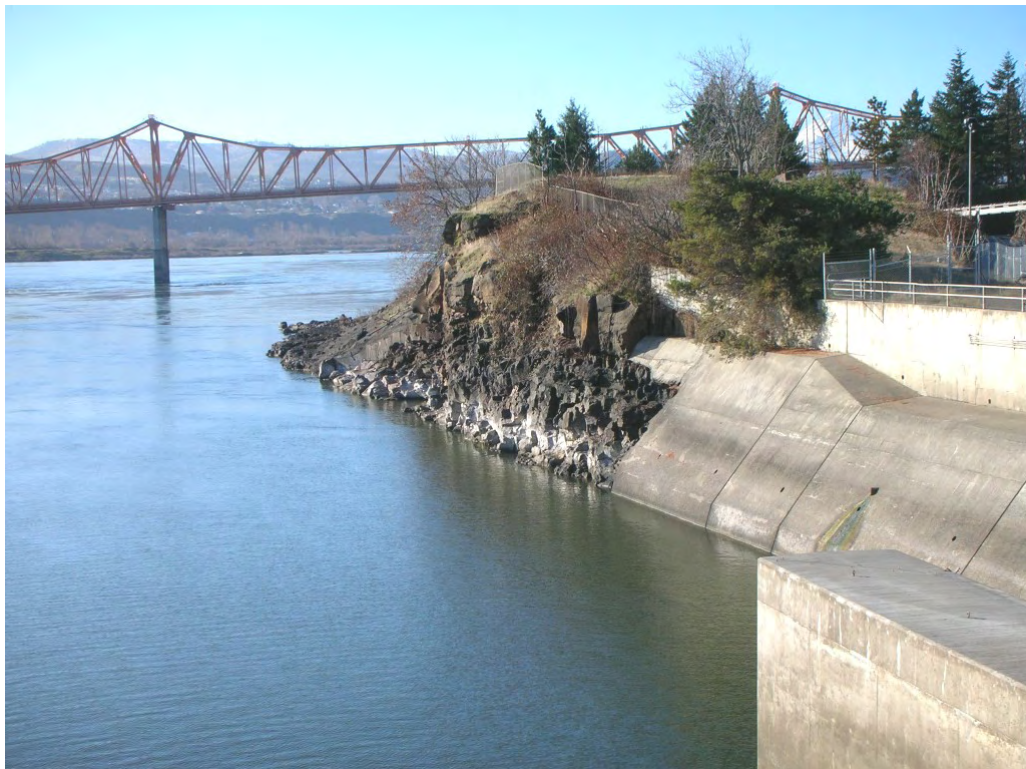
G-2 North Shore View Looking Downstream

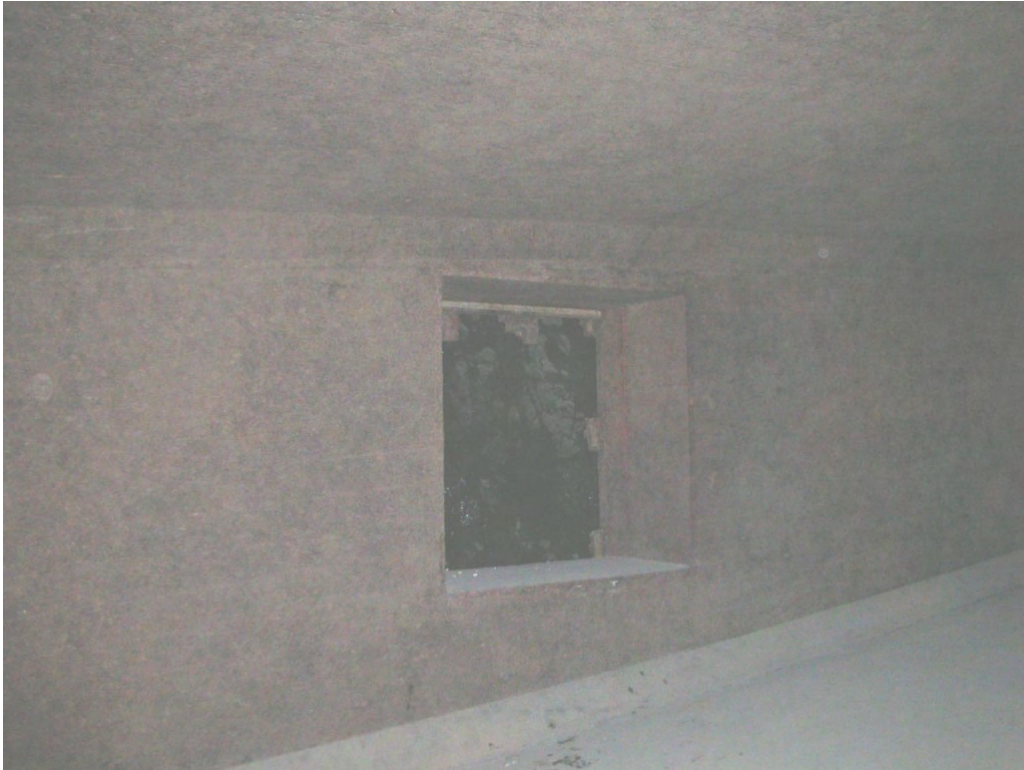
H-1 Diffuser Gate

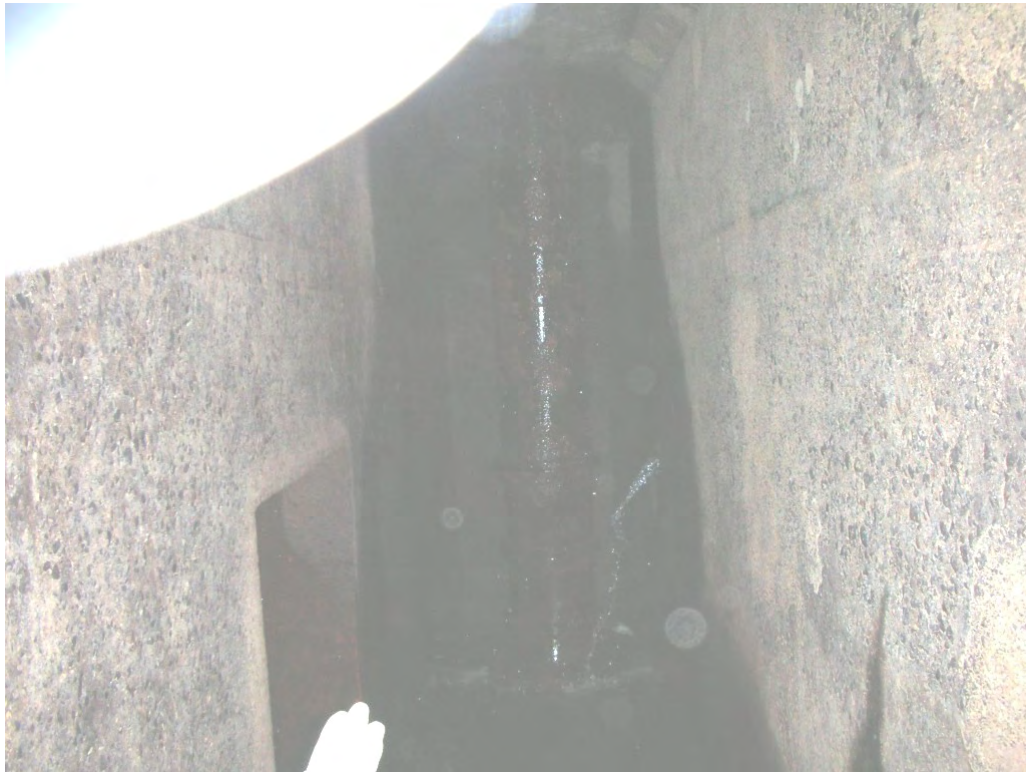
H-3 Conduit Dewatering Pump

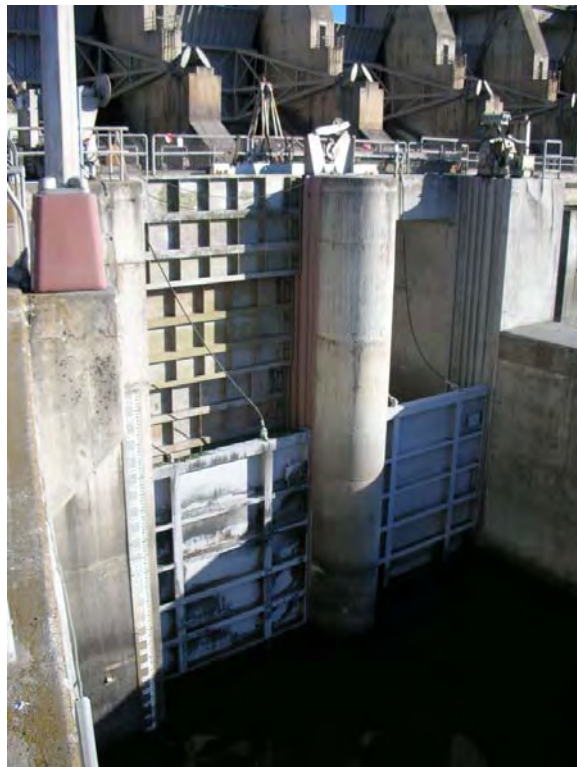
H-4 Entrance Weirs

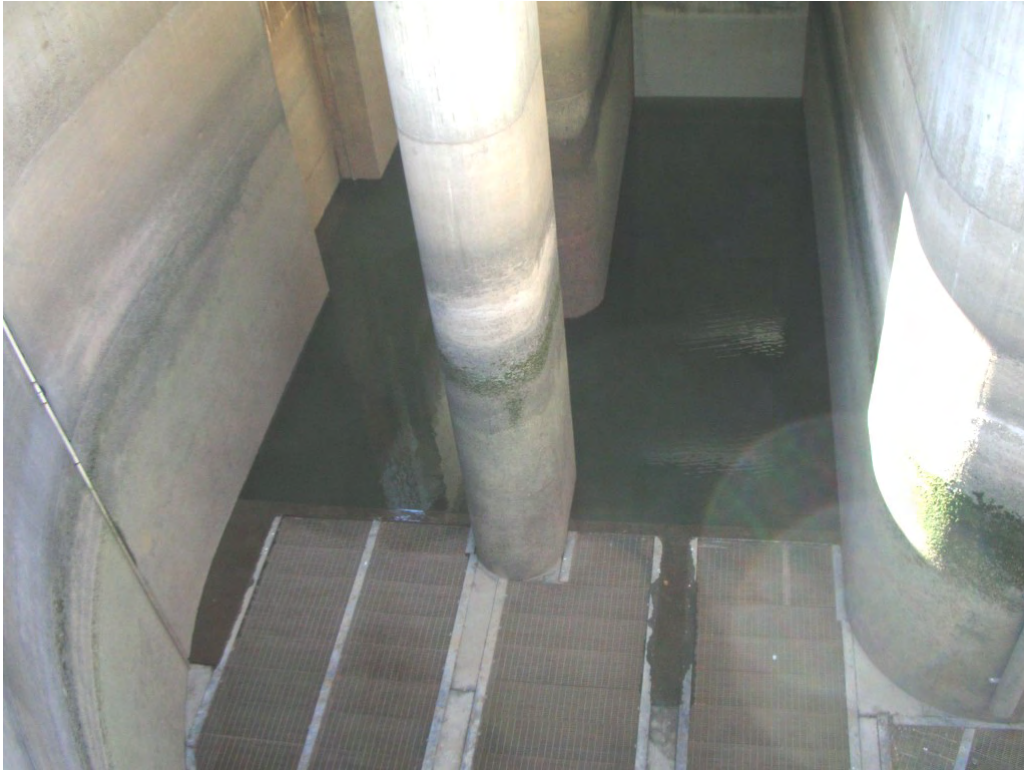
H-5 Entrance Pool Floor Diffuser Grating

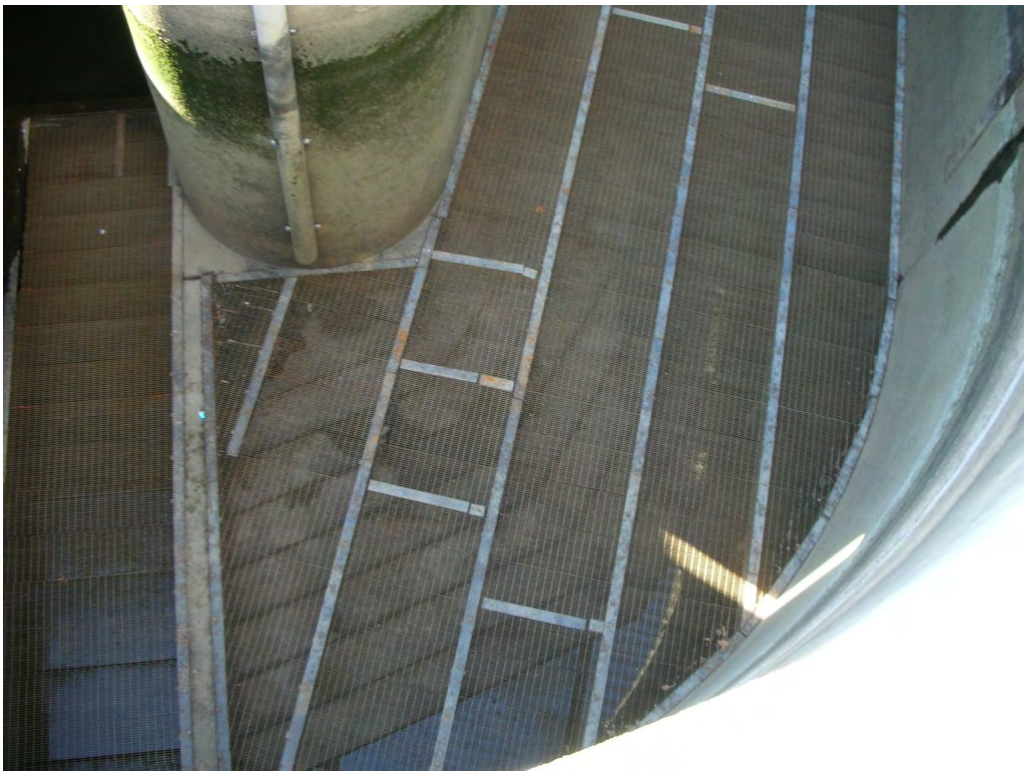
H-6 Entrance Pool Floor Diffuser Grating

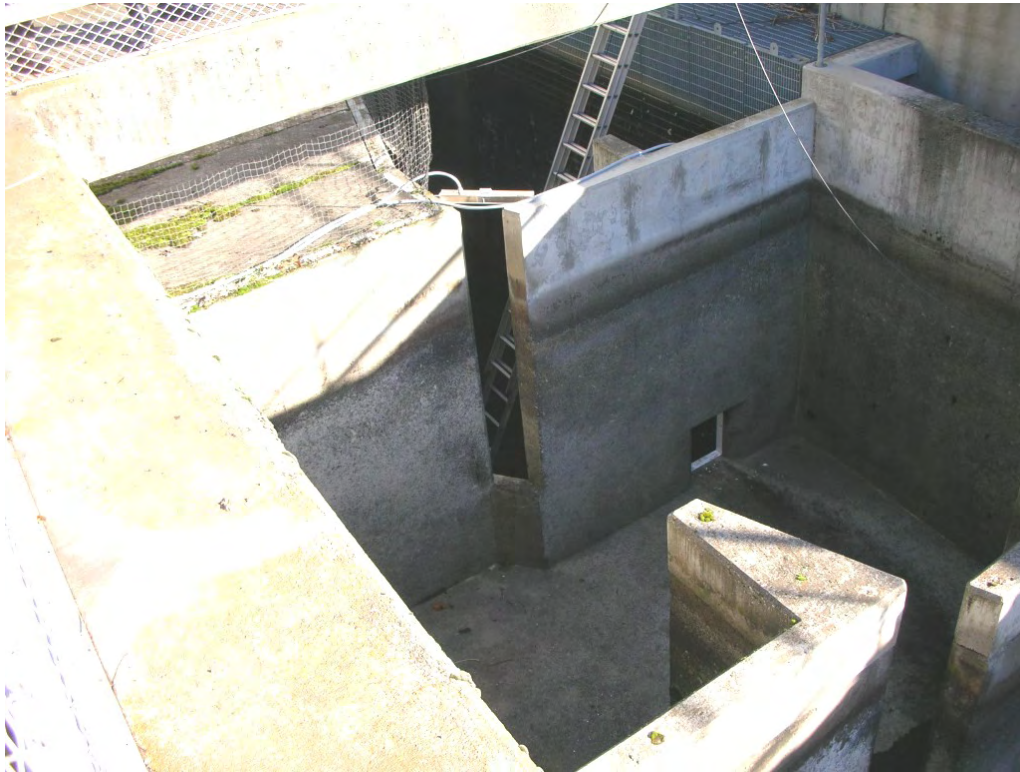
H-9 Exit Section Flow Control Weirs Looking Upstream

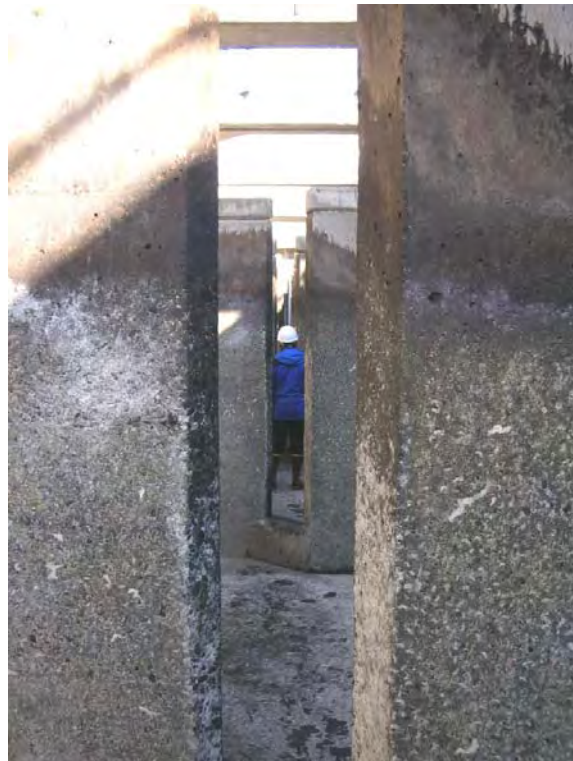
H-10 Vertical Weir Slot Looking Upstream

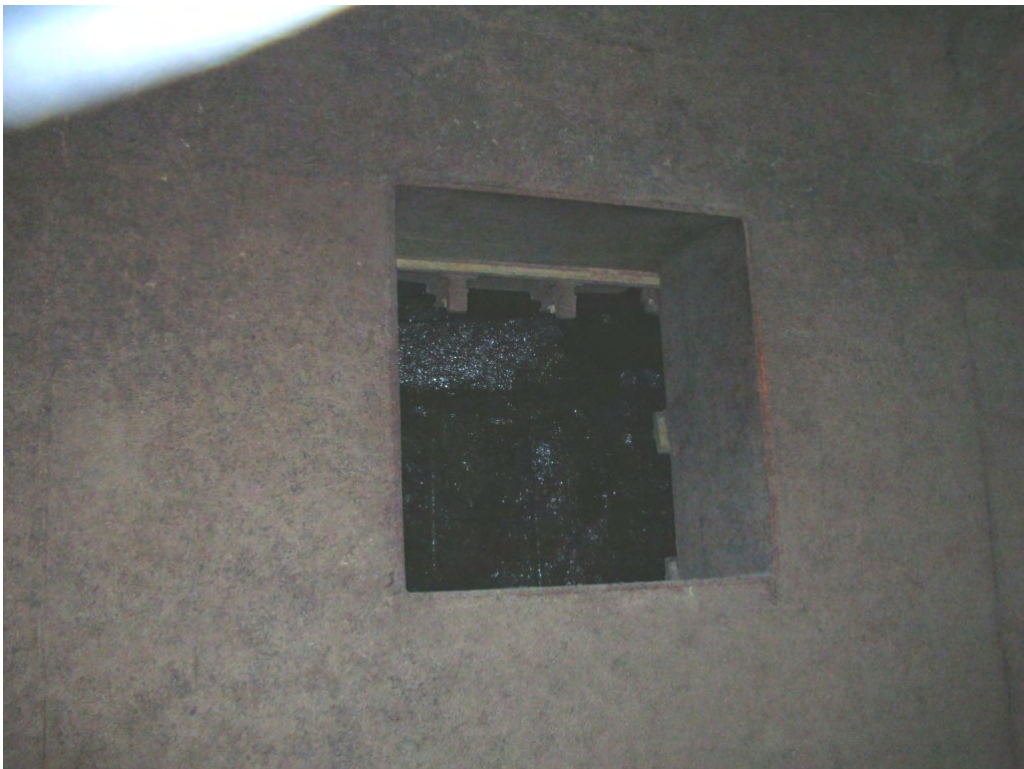
M-1 Diffuser Gate Opening In AWS Chamber

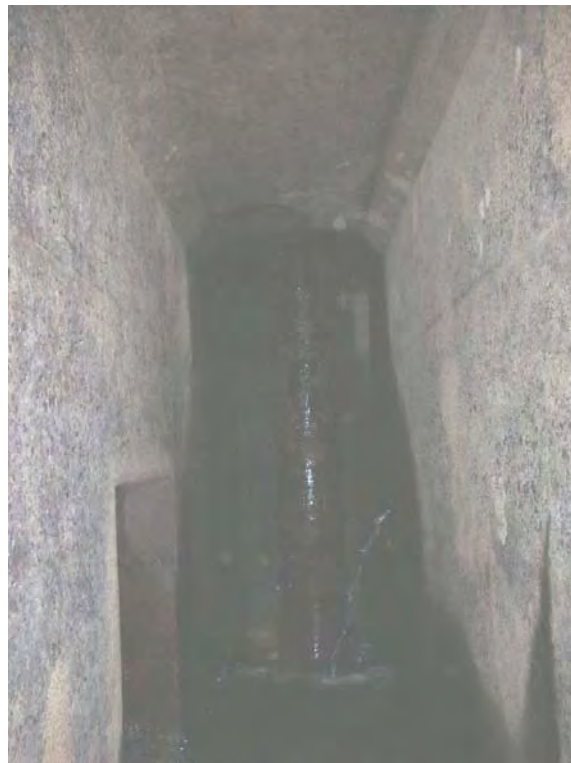
M-3 Conduit Dewatering Pump

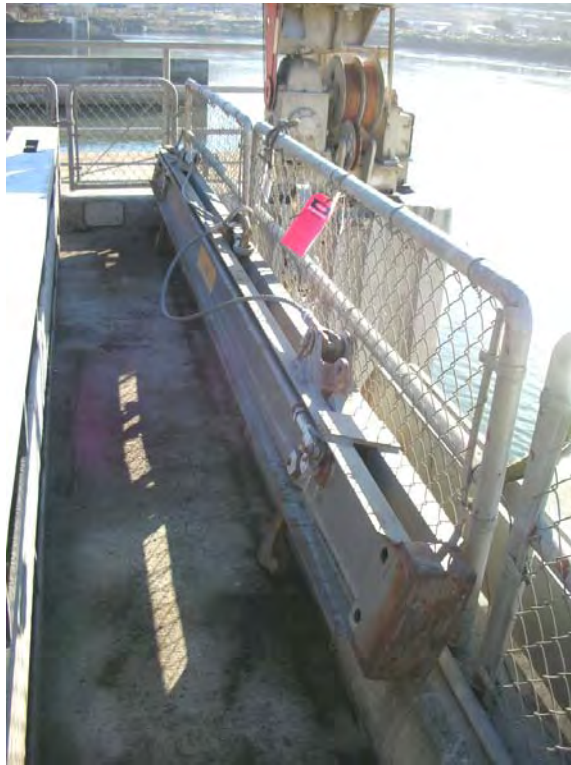
M-4 Entrance Weir Lifting Beam

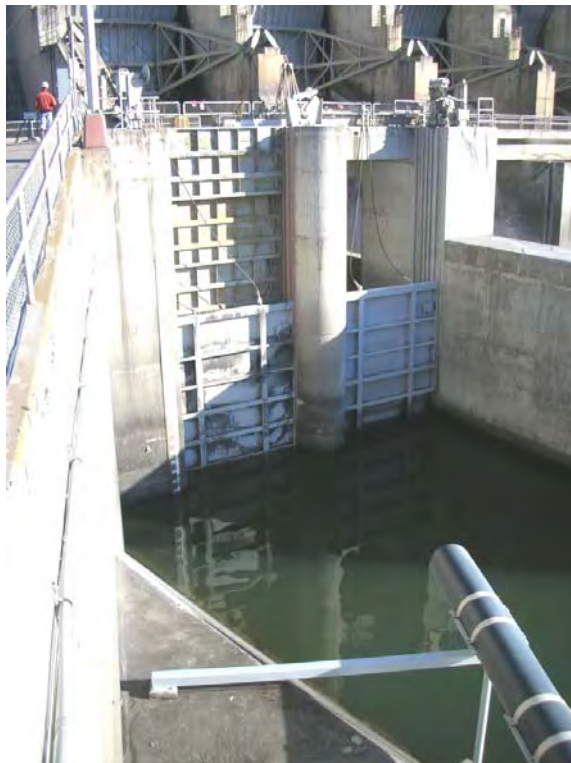
M-5 Entrance Weirs

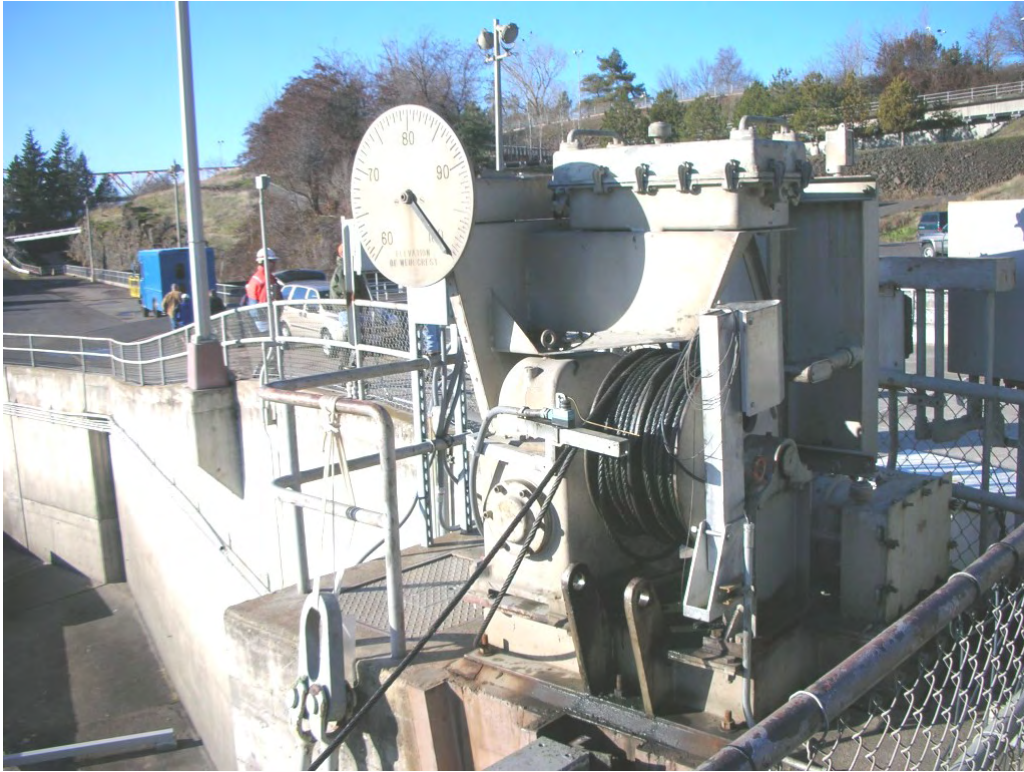
M-6 Entrance Weir Hoist For Gate N-1

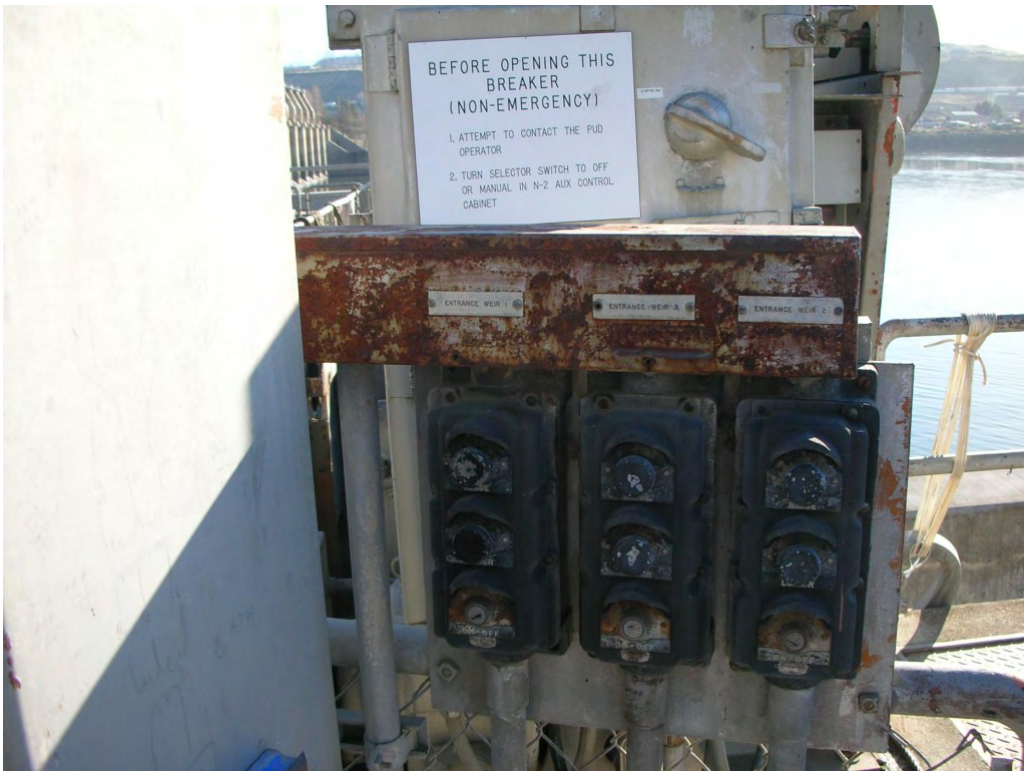
M-7 Entrance Weir Controls

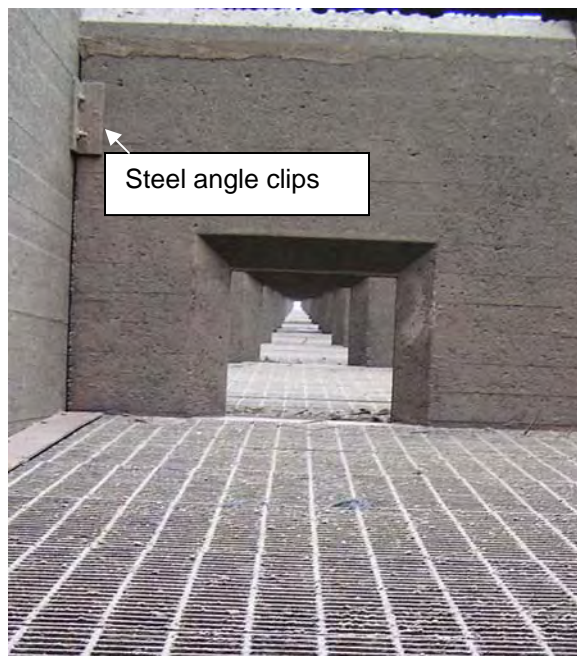
Photo CS-4 – East Fish Ladder Concrete Weir supported by steel angle clips

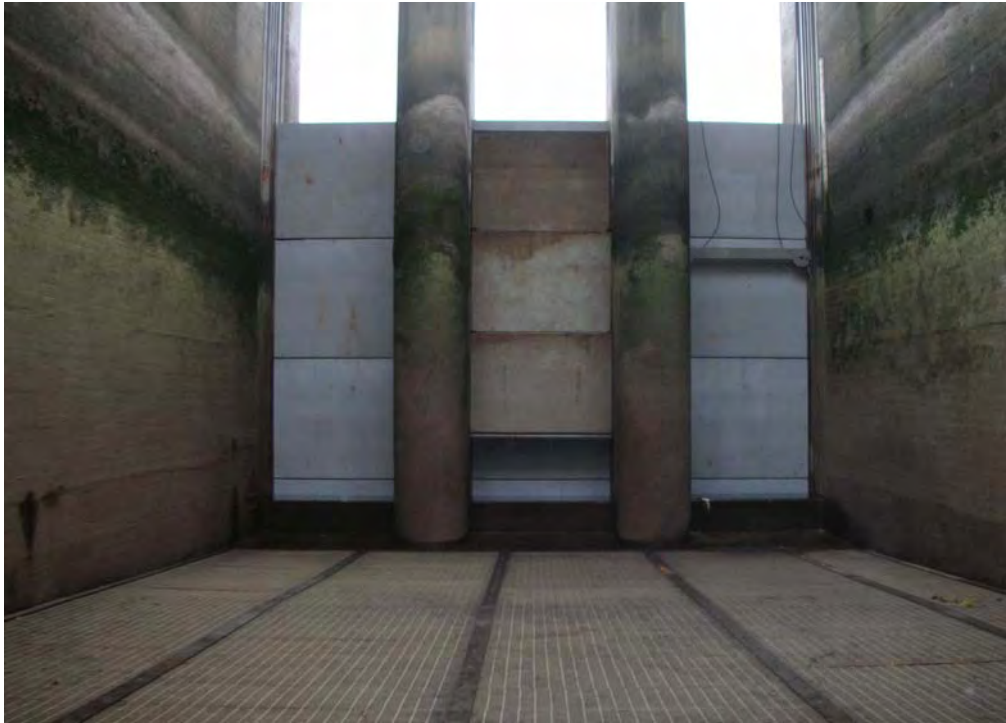
Photo ME-1 Bulkheads present in the three east fish entrance gate openings

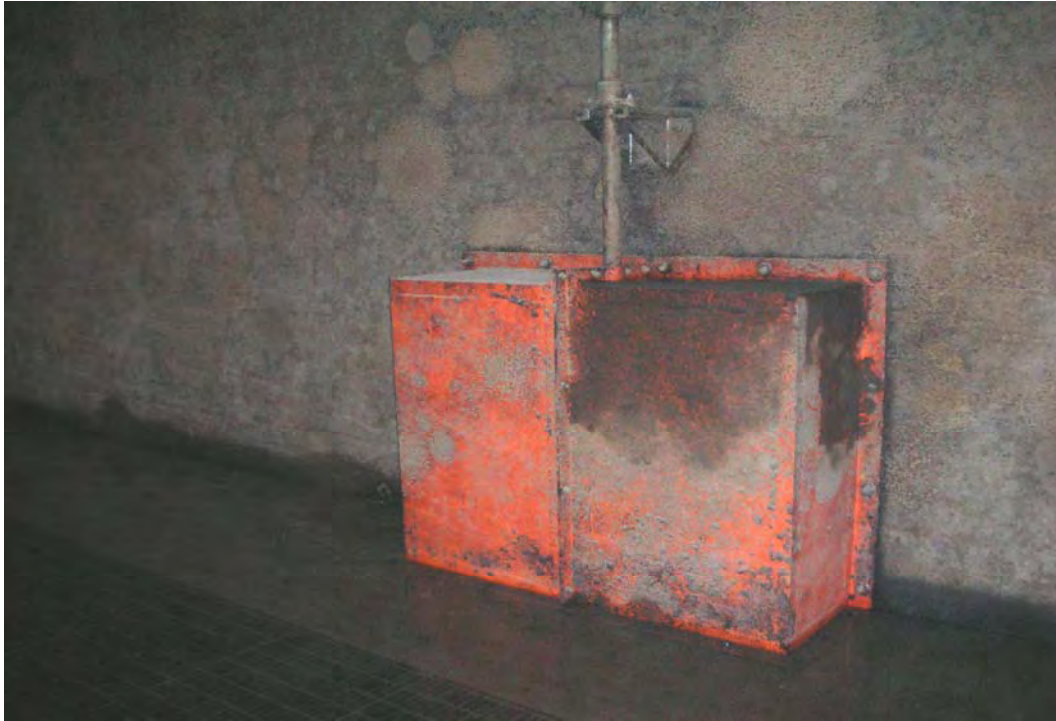
Photo ME-3 Diffuser gates along upstream wall of fish collection channel

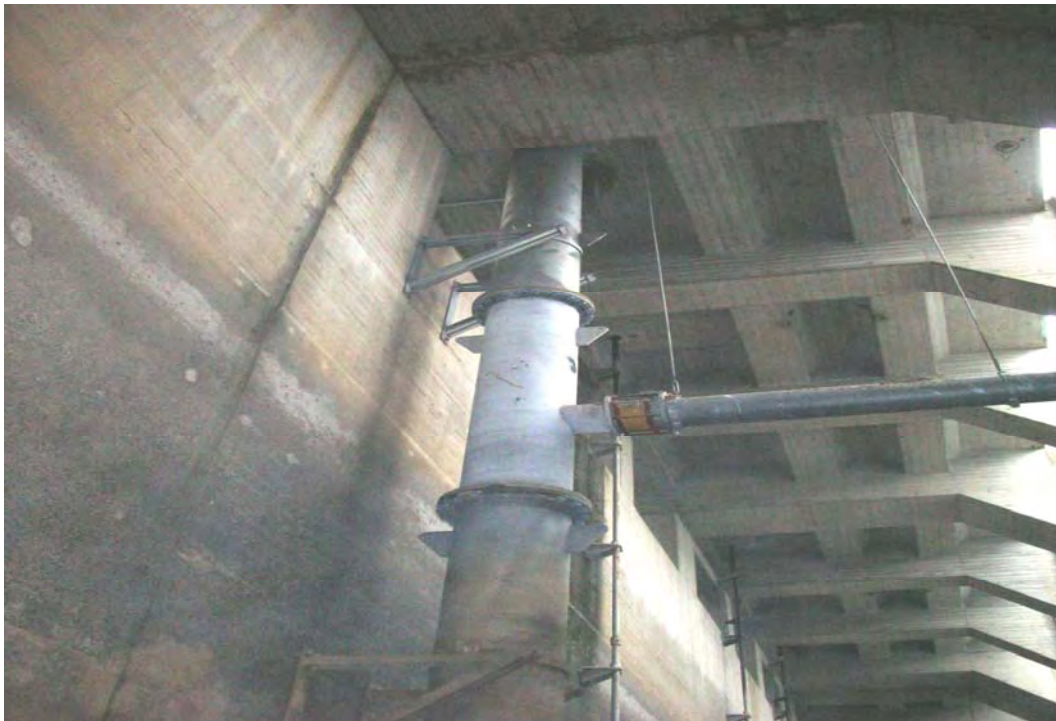
Photo ME-4 Dewatering pump casings along upstream side of collection channel

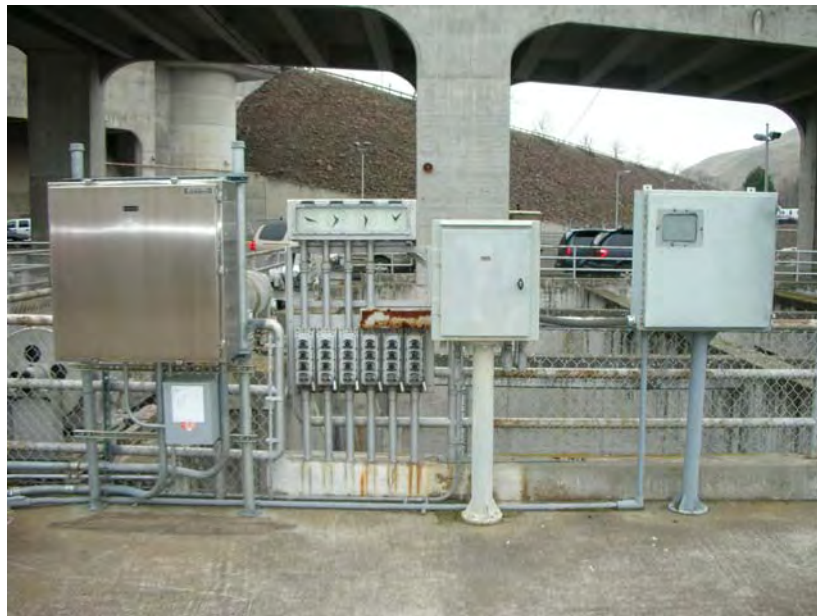
Photo ME-12 Hoist Control Station at Junction Pool

A hoist control station appeared to be somewhat weathered and old, but no reports of malfunction were reported. (Photo ME-12) Hoists and rigging appeared to be in good condition. Evidence of regular changing of hoist gearbox oil was noted on several gearbox housings. (Photo ME-13) District staff pointed out that the gearboxes were located over water.

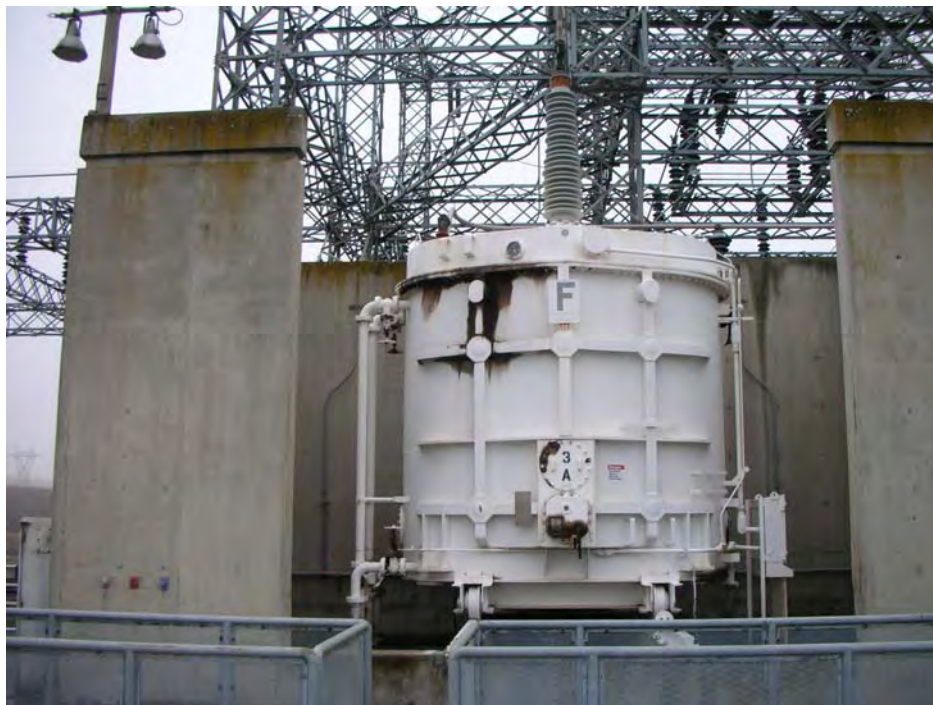
Photo ME-16 Fish Turbine Transformer

The two fish turbine transformers (one per unit) were observed and appeared to be in good condition. (Photo ME-16) The fish turbine units and controls were observed and appeared to be well-maintained. (Photo ME-17, ME-18)

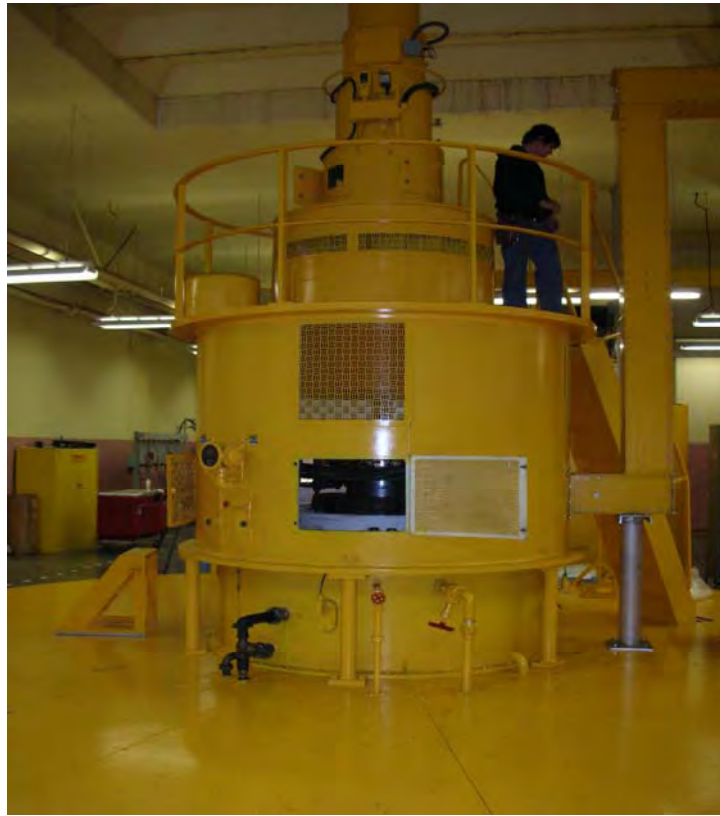
Photo ME-17 Fish Turbine Units

The condition of the fish turbines was discussed. Although they have been very reliable, they are showing signs of age. New windings have been installed. The

original 50-year-old bearings are “sagging.” The carbon packing would be the first item to fail and would take 3 weeks to replace. If replacing the packing only was not sufficient, it would then take 3 months to replace the bearings.

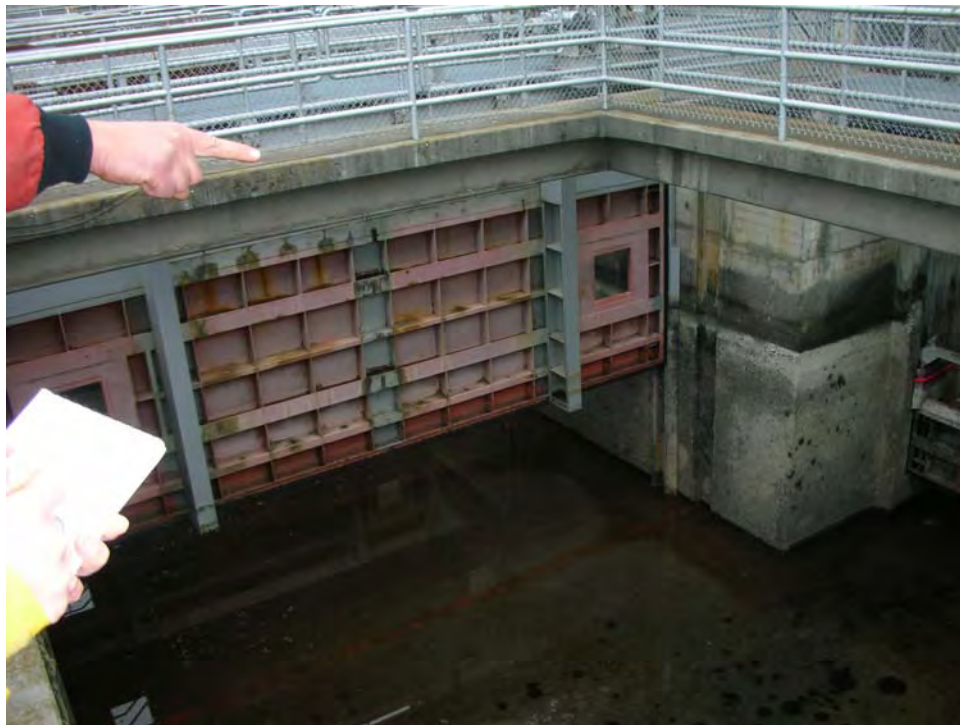
Several adjustable weirs were observed in the ladder exit section. (Photo ME-19) The weirs were in various positions. District staff reported that the number of adjustable weirs added complexity and maintenance to the operation of the ladder, and questioned whether they were needed. The ladder exit consists of two smaller adjustable weirs that appear to have been fabricated from a former single weir. (Photo ME-20) Bulkheads were observed on the upstream side of the weirs. The various adjustable weirs are controlled by a motor control center and PLC located in a room adjacent to the gates. (Photo ME-21) No electrical or control problems were reported.

Photo ME-19 Adjustable weirs in fish ladder exit section

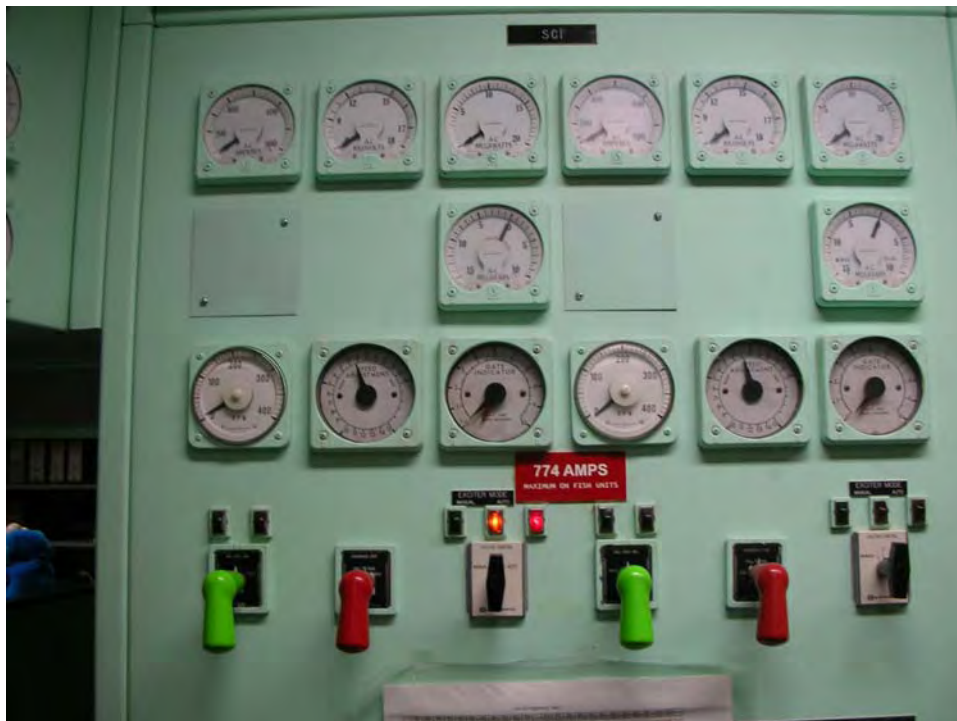
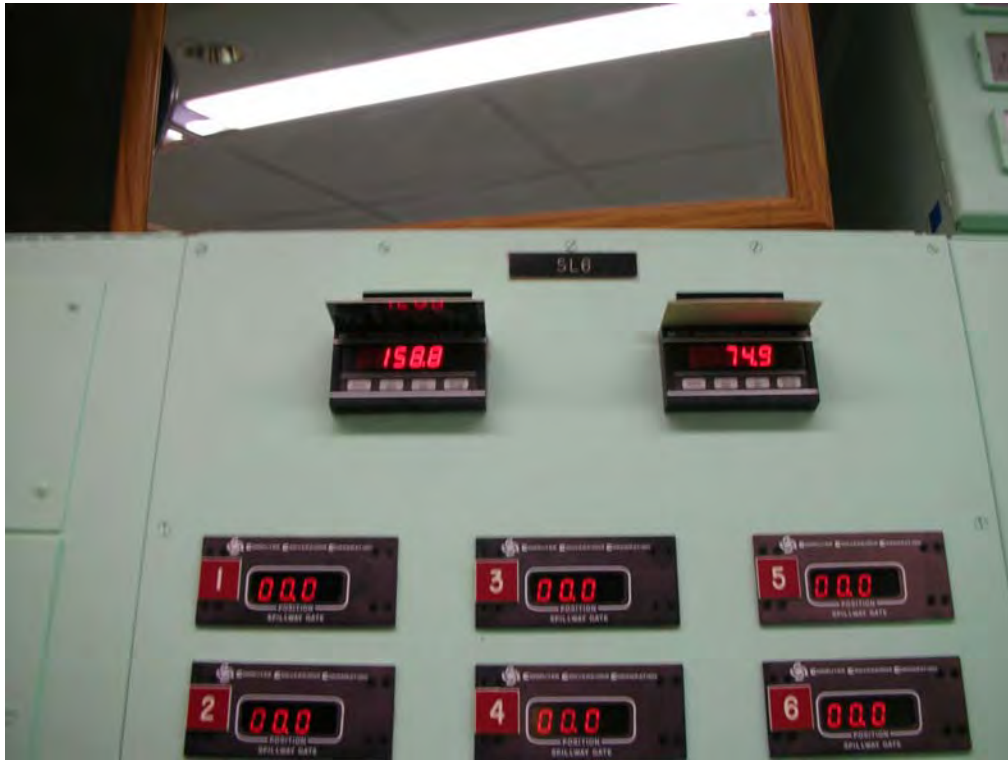
Photo ME-22 Fish Turbine Control Panels

The fish turbine control panels located in the powerhouse control room were observed. Operators reported no problems with their operation. (Photo ME-22, ME-23)

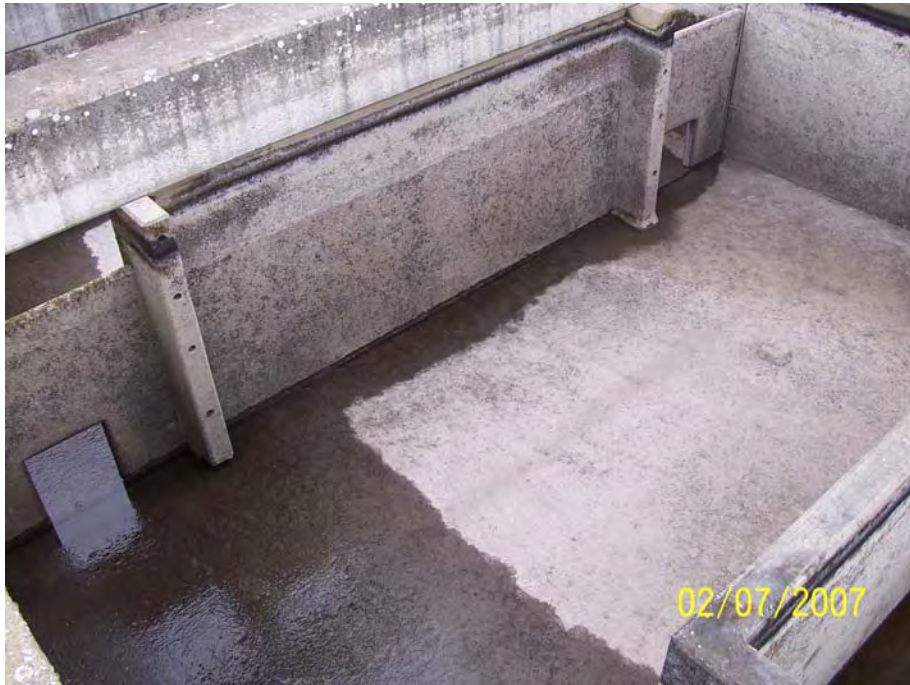
The East Ladder appeared to be in good condition, with the weirs and orifices appearing in satisfactory condition. On the lower approach to the junction pool, several weir pools contained chunks of concrete as shown in Photo H-11. It appears that the concrete may have come from under the upstream weir approach wall. Several of the diffuser sections have new grating.

Photo H-11 Typical East Ladder Weir

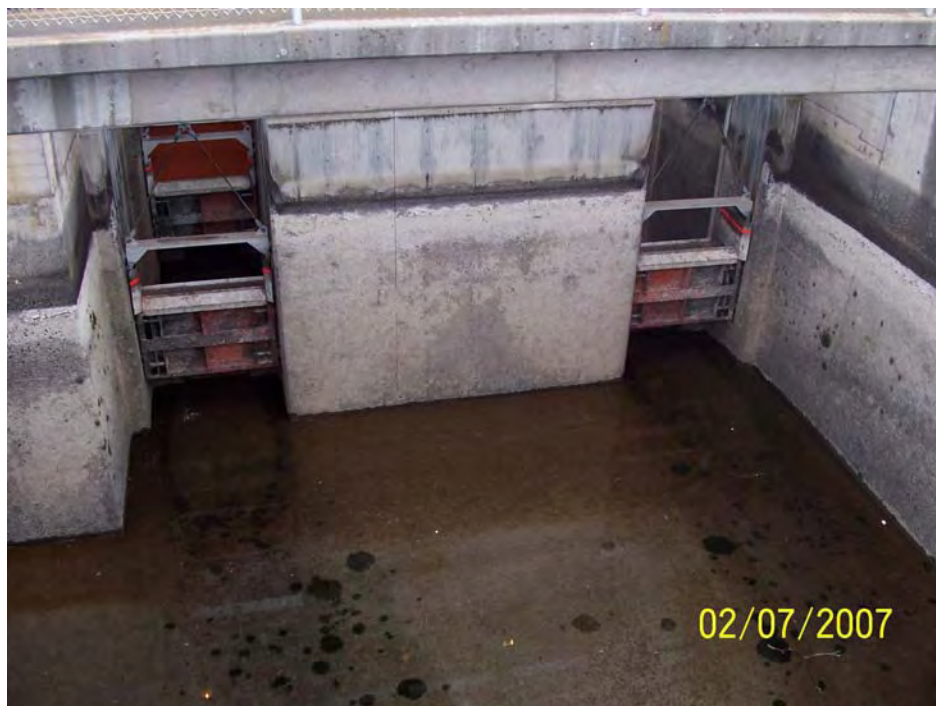
Photo H-14 Exit Weirs

The exit weirs are shown in Photo H-14. The pair of weirs are automatically operated based on forebay elevation. The downstream weir tracks at 1 foot below the upstream (weir 159) weir elevation. The weirs appear to be in satisfactory condition.

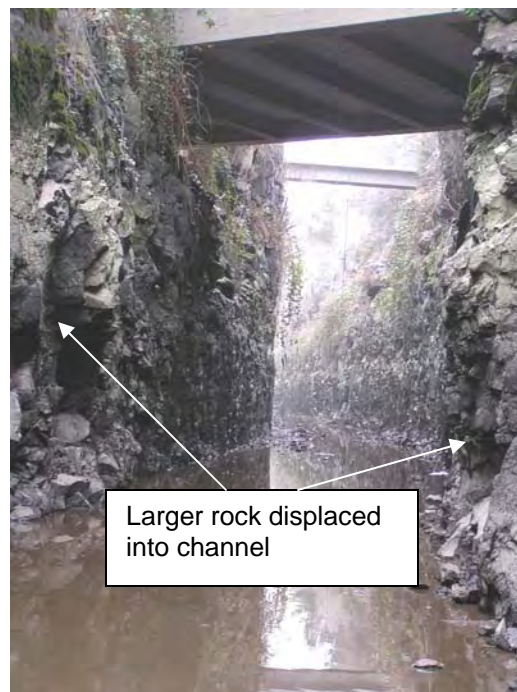
Photo G-2 Vertical slopes in the rock-lined channel. Notice zones where larger rocks have been displaced into channel. Only minor amount of rock debris on floor of the channel.

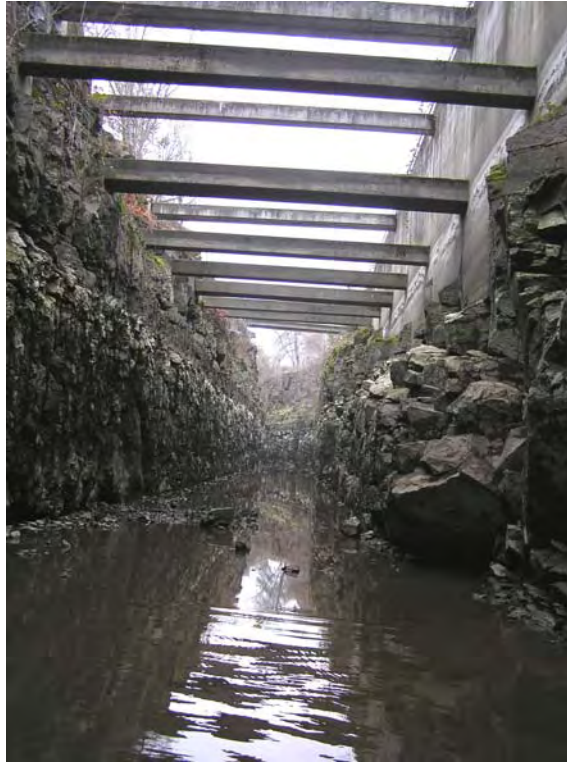
Photo G-3 – Area of rock-lined channel that is stabilized with concrete and cross struts.
