# TYPE A ACCIDENT INVESTIGATION OF THE MARCH 16, 2000 PLUTONIUM-238 MULTIPLE INTAKE EVENT AT THE PLUTONIUM FACILITY LOS ALAMOS NATIONAL LABORATORY NEW MEXICO

July 2000  
Prepared by  
Office of Oversight  
Office of Environment, Safety and Health  
U.S. Department of Energy

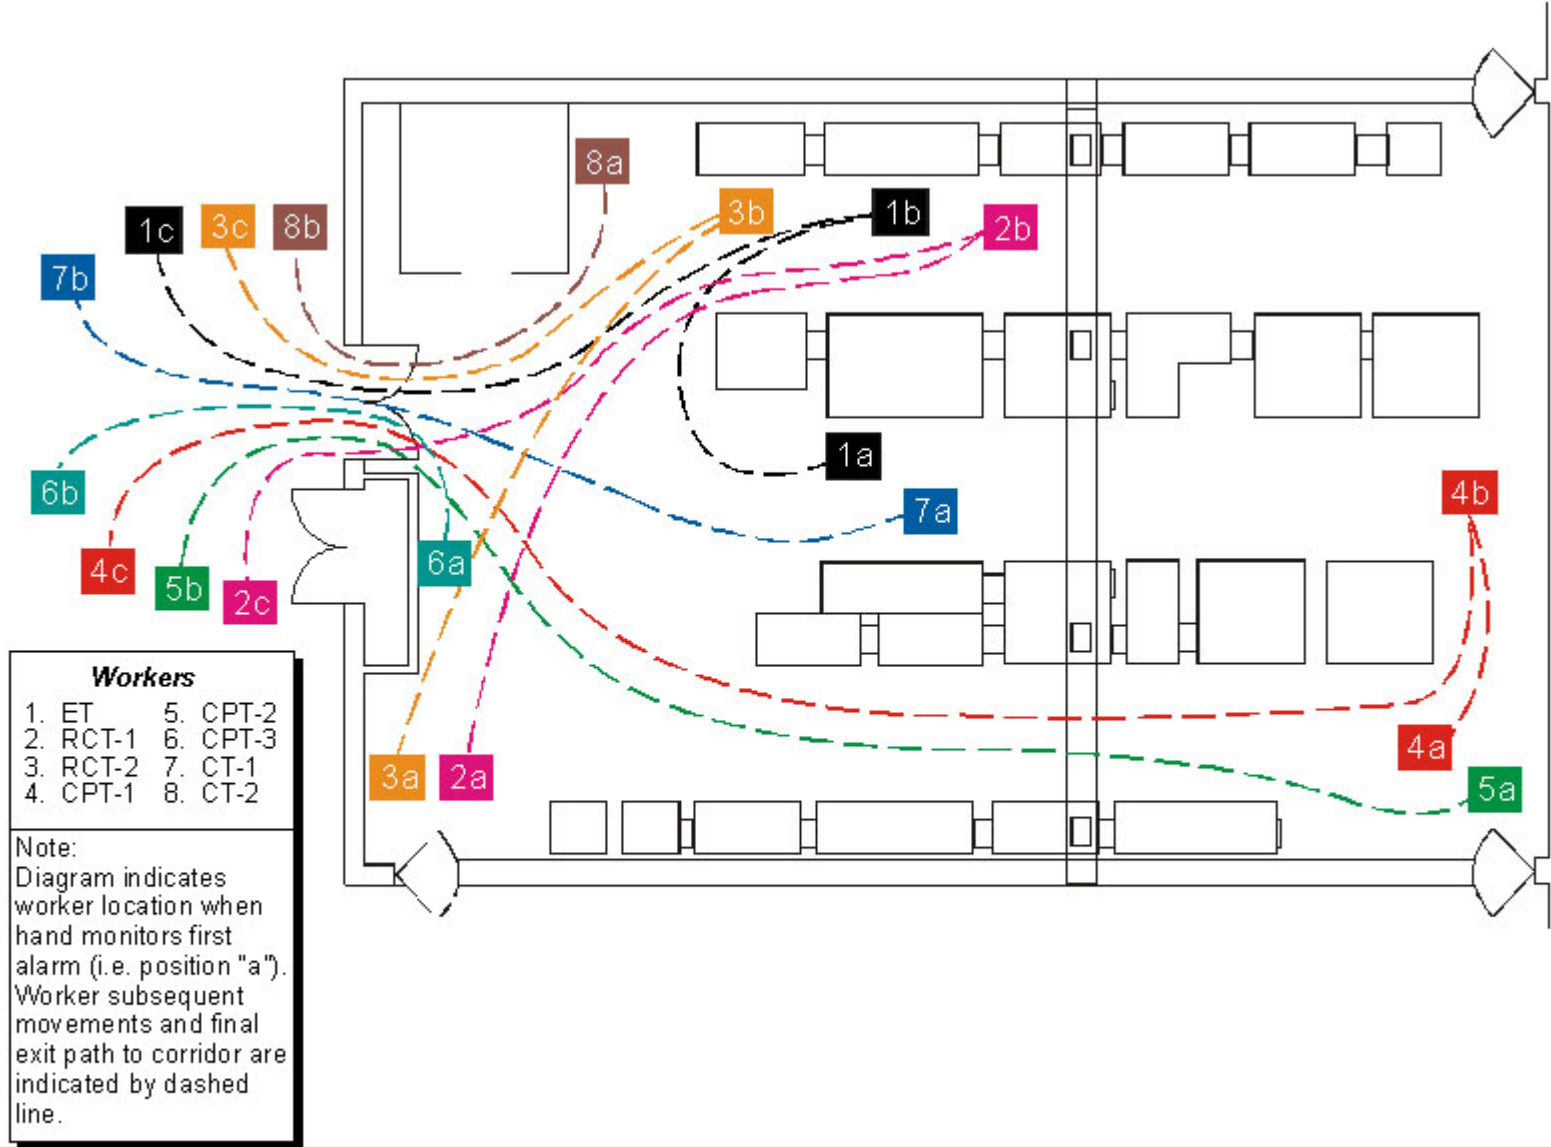
**Figure 2-1. Locations and Exit Paths of Workers**

On March 16, 2000, a release of material containing Pu-238 occurred in one room of Building PF-4 in TA-55. Present in the room at the time were (refer to Figure 2-1):

- Two Chemical Technicians (CT-1 and CT-2) associated with the electrolytic decontamination of the glovebox being examined by ET; CT-1 was on the east side of the glovebox, and CT-2 was at the desk in the southwest corner.

The first indication of a release was when the hand monitor on the northwest side of the glovebox being examined by ET alarmed. At that time, ET was located at the northwest corner of the glovebox. RCT-1 and RCT-2 responded to investigate. A second hand monitor on the southwest side of the associated dropbox alarmed. CPT-1 also reacted to the alarms by walking along the north wall toward the corridor west of the glovebox to determine the cause of

[Figure 2-1](#) illustrates the room orientation with the location and paths taken by the eight workers, from just before the first hand monitor alarm until exiting to the corridor.

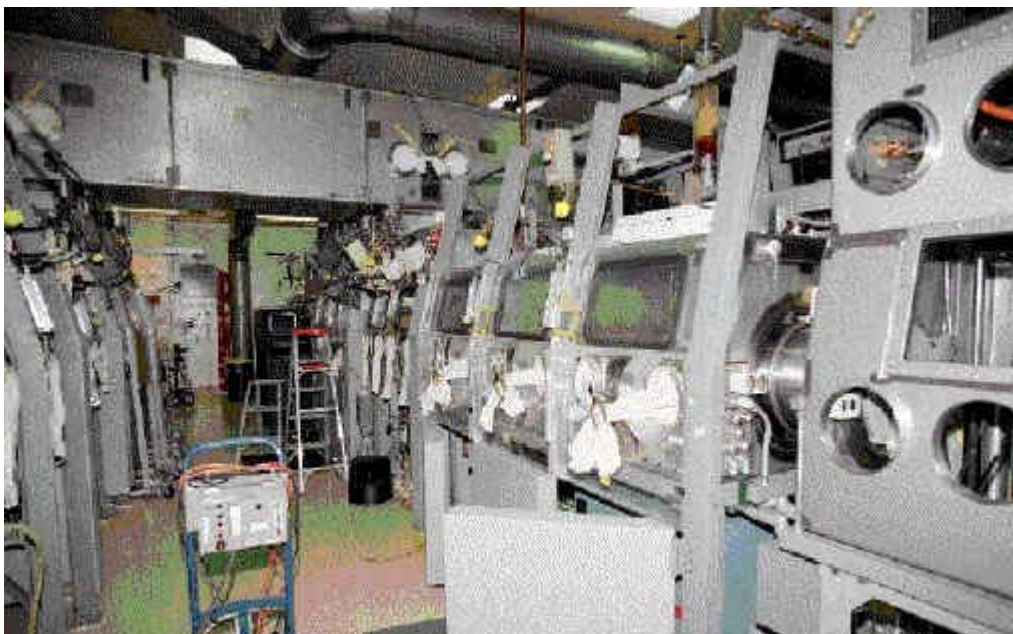
**Exhibit 2-1. Affected Line of Gloveboxes**

The Nuclear Materials Technology Division (NMT) at LANL uses gloveboxes (see [Exhibit 2-1](#)) for various processes involving highly hazardous materials such as Pu-238 and Pu-239. The gloveboxes are uniquely designed for specific applications and processes. They are essentially self-contained processing areas with a controlled atmosphere and containment to ensure the safety of the worker, the facility, and the public.

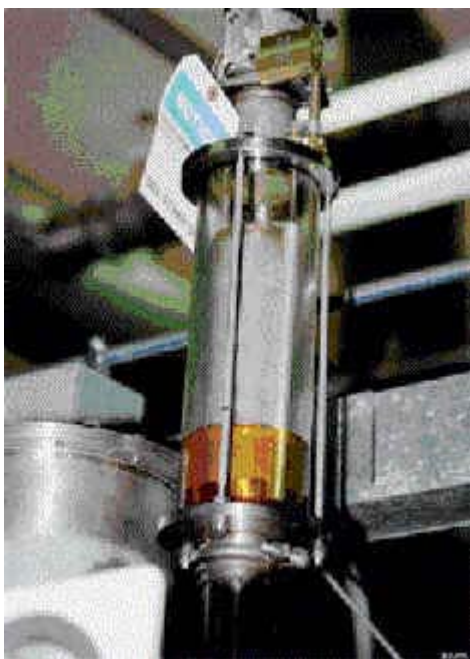
**Exhibit 2-2. Glovebox Bubbler**

On March 16, 2000, a supervisor, performing his morning walkdown of glovebox lines in TA-55, noted that one glovebox had no argon flow through its oil bubbler. This inert glovebox has an argon atmosphere, maintained by a system that provides argon to the glovebox when its pressure falls below a specific setpoint and by an oil bubbler that regulates the negative pressure in the glovebox.
