**Type A Accident
Investigation Report**

June 7, 2004

**Construction contractor
electrical accident at
double-circuit structure 38/1,
Watertown-Granite Falls
230-kV Transmission Line**

**East of Watertown,
South Dakota**

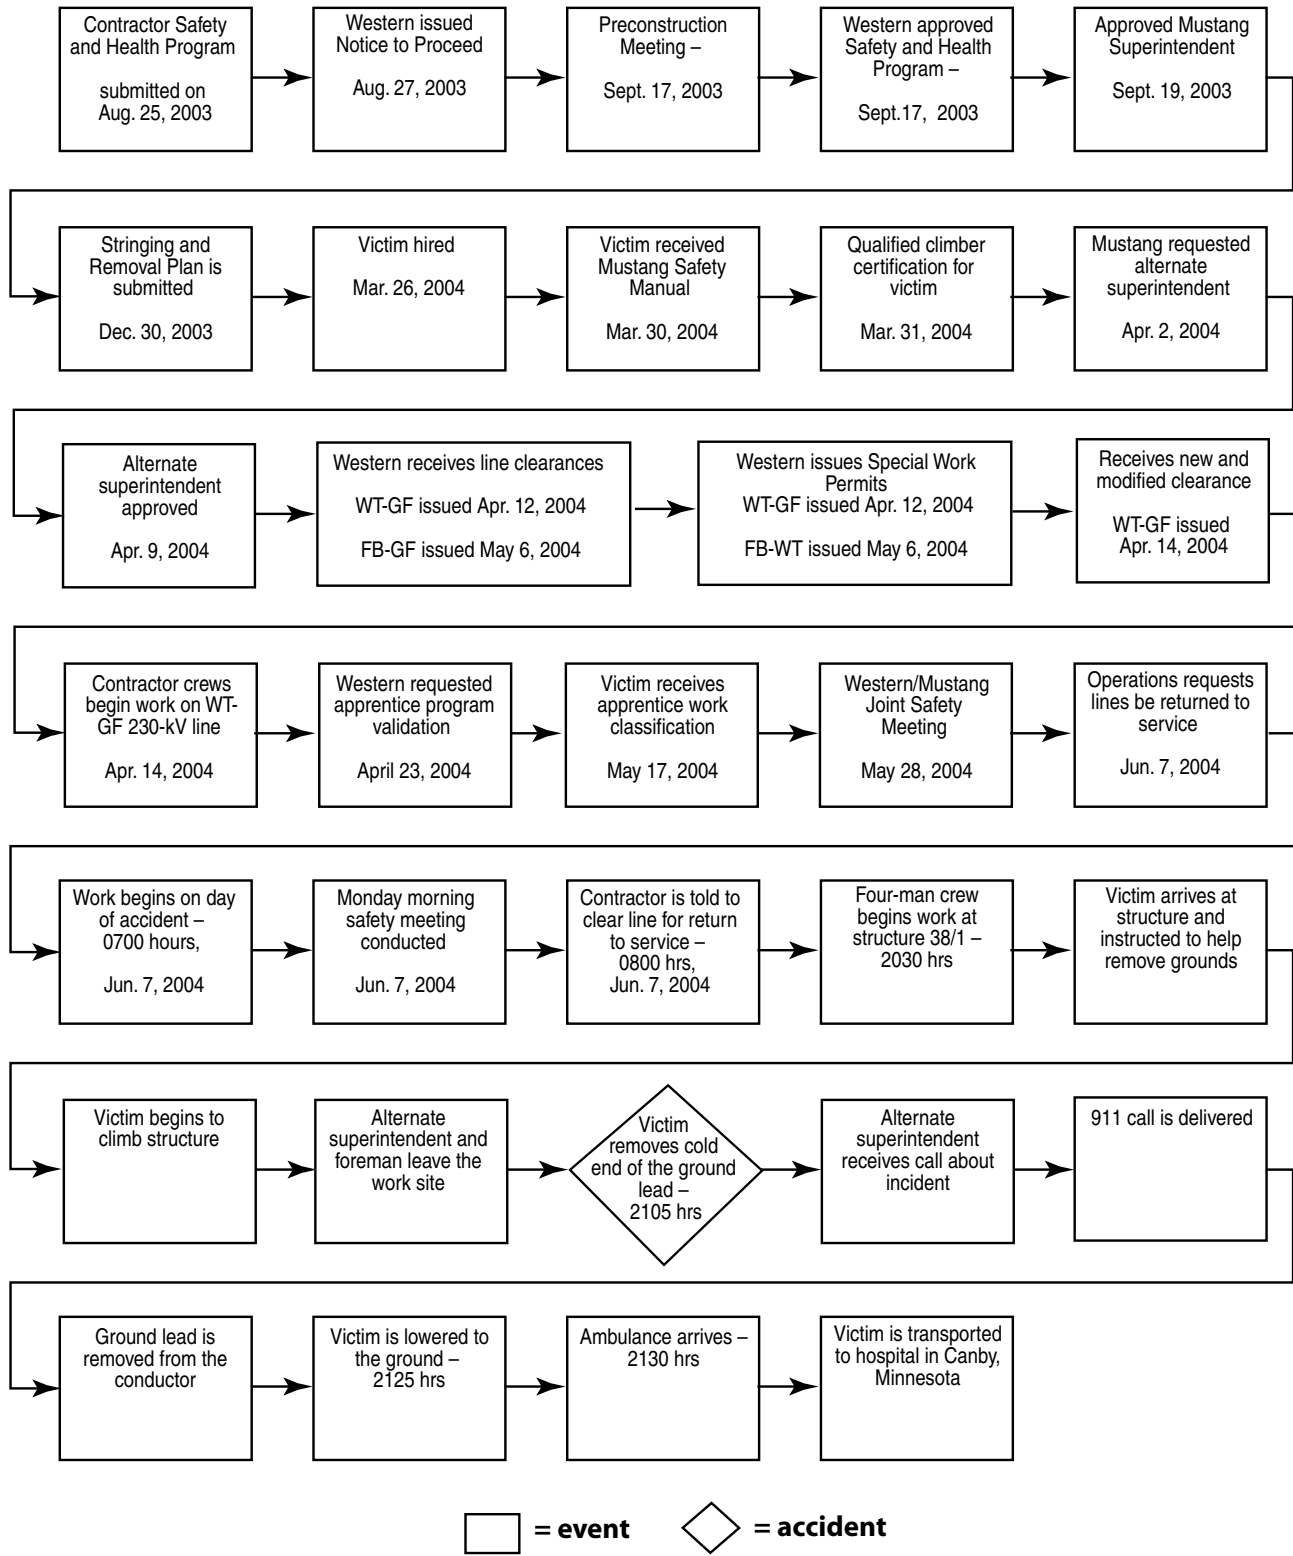
Figure 7: Chronology of events

Figure 7 provides a chronological summary of significant events that relate to this accident.
