Type A Accident
Investigation Board Report
of the
April 25, 1997
Contractor Fatality
on the
Olympia-White River #1
230 kV Line

B O N N E V I L L E
POWER ADMINISTRATION

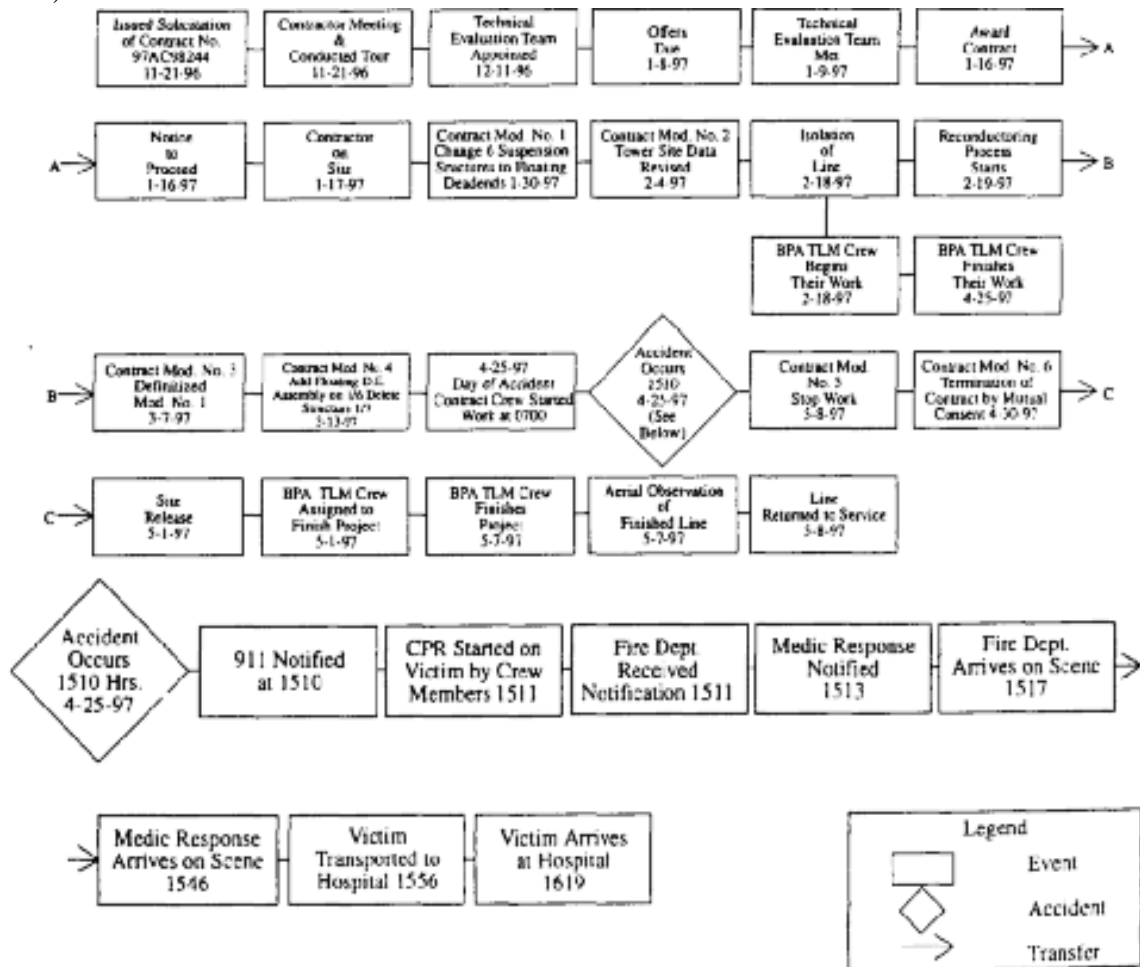
Figure 2, Summary of Events and Accident Chronology

Pictures contained within APPENDIX C summarize the chronology of significant work process events that the lineman would have performed just prior to the accident. The graphic summary of events below (Figure 2) shows the accident in the context of the overall construction contract.
