**Office of Oversight
Environment, Safety and Health**

*Type A Accident Investigation
of the December 8, 1999*

**Multiple Injury Accident
Resulting from the
Sodium-Potassium Explosion
in Building 9201-5
at the Y-12 Plant**

February 2000

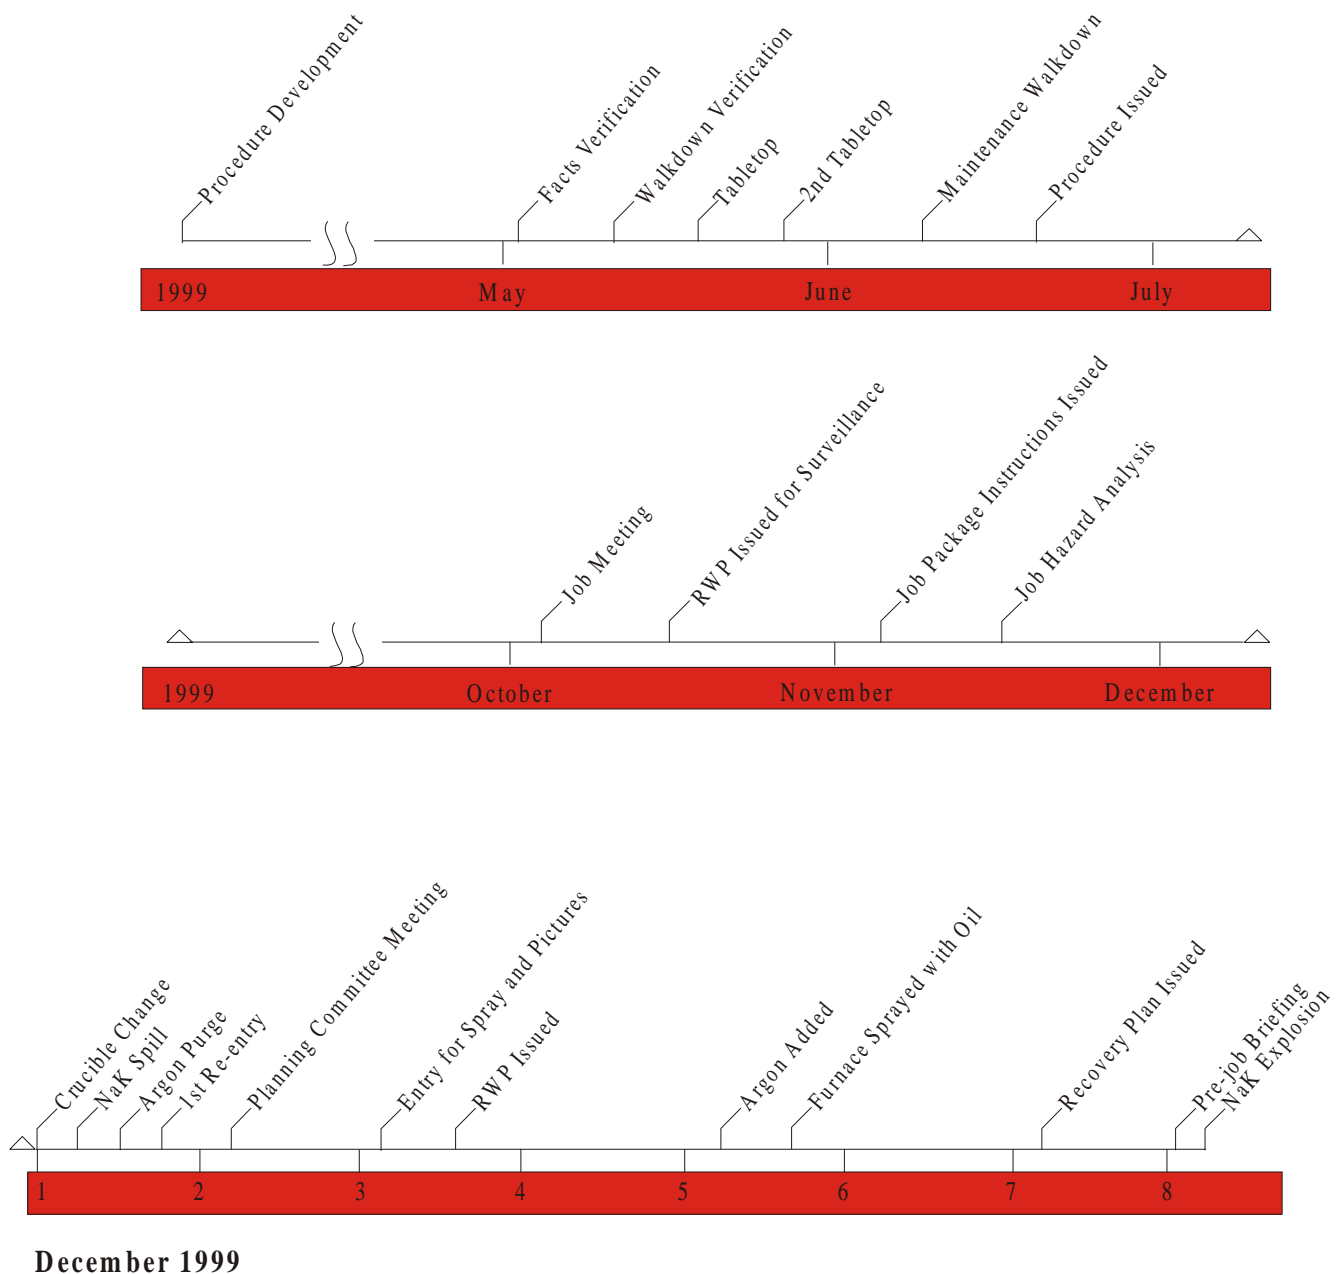
Figure 1. Activities Related to Development of the Crucible Changeout Procedure

Although the explosion and injuries occurred on December 8, the circumstances that led to the accident occurred on December 1, 1999, when NaK was inadvertently released during preparation for crucible changeout. This section describes the chronology of events leading up to the accident, the response to the accident, and the personnel injuries resulting from the accident. The event timeline is shown in Figure 1.

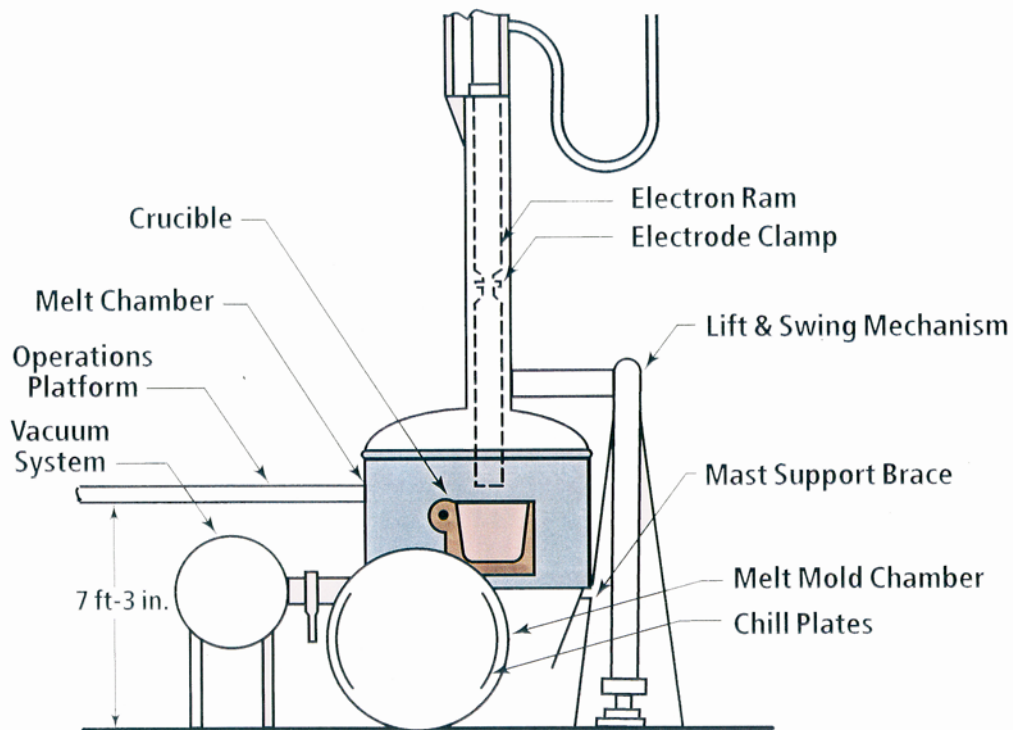
Figure 2. Skull Caster Furnace

In early 1999, Y-12 Plant management began planning to replace the steel crucible of the skull caster furnace (Figure 2). These crucibles experience heat stress during the arc melting process and need to be replaced (typically after about 70 melting cycles) to reduce the likelihood of a crucible failure during operations. The last crucible change occurred in 1993.

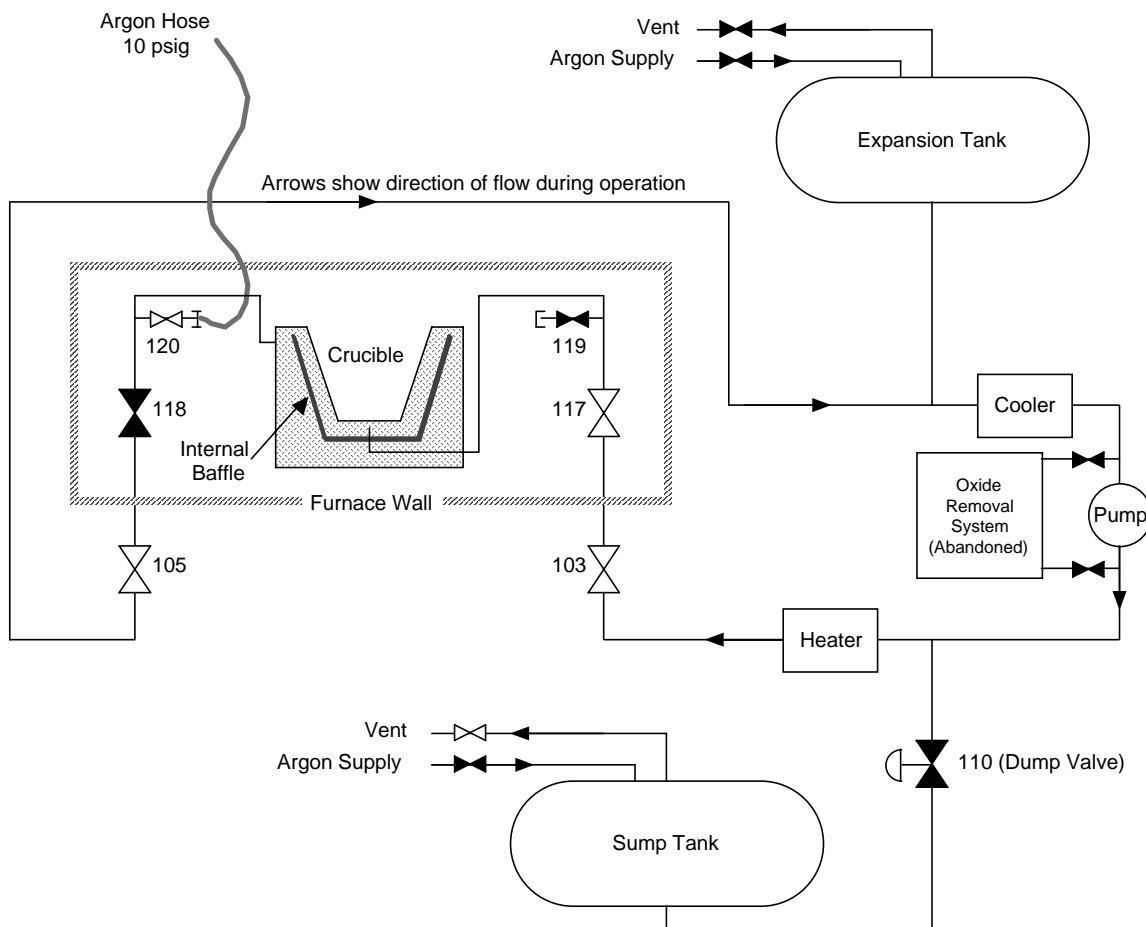
Figure 3. Simplified NaK System Schematic

Figure 3 (see page 10). The first portions of the procedure involved heating the NaK system to about 200 F to improve flow characteristics and then draining the expansion tank through the dump valve.

A combination of procedural errors (as discussed in Section 3.2) resulted in NaK spraying out the vent line. The spray of argon and NaK continued until the operators closed the NaK crucible isolation valves outside the furnace. Operators also closed the furnace lid and added argon to minimize the exposure of NaK to air. Oxides coated the walls and outside surfaces of the piping and furnace internals. Y-12 Plant personnel estimate that about three to ten gallons of NaK were spilled (although the estimates vary considerably).

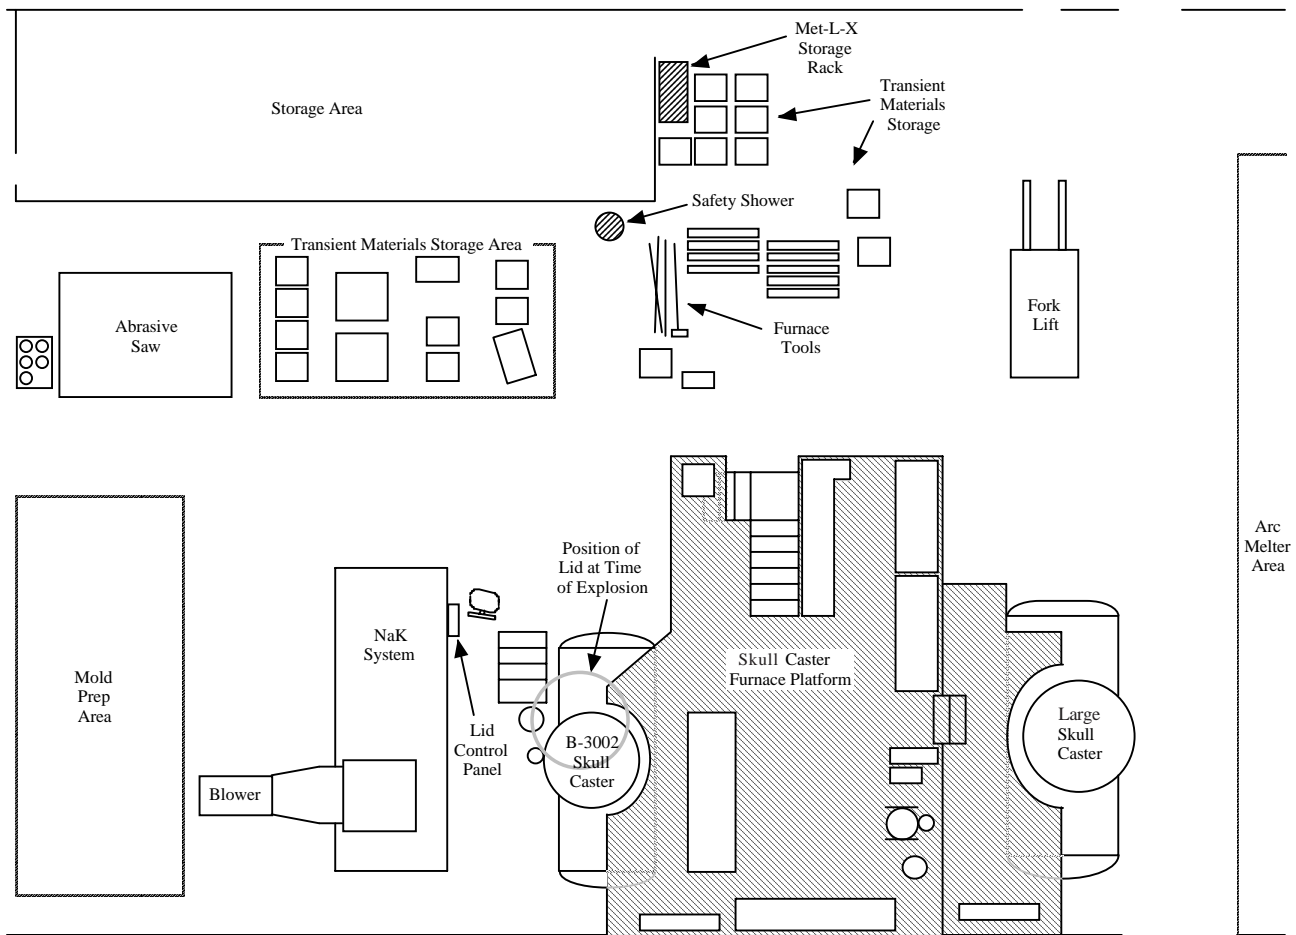
Figure 4. Skull Caster Furnace Area, Showing Position of Safety Showers

The layout of Building 9201-5 is shown in Figure 4. At the time of the explosion, the ten workers were positioned as marked on Figure 5.

Although suffering from burns, three team members (OM-1, CO-3, and CO-4) returned to the furnace area to close the lid and extinguish small spot fires using dry chemical extinguishers. Another worker (FS-2) cleaned up water from the safety showers, which was accumulating on the floor (there are no berms or drains around the safety shower that is nearest the furnace). The water had spread in the direction of furnace and was reacting with NaK that had been dispersed onto the concrete floor by the explosion. Another DUO worker not involved in the recovery plan heard the noise and provided assistance when the accident occurred.

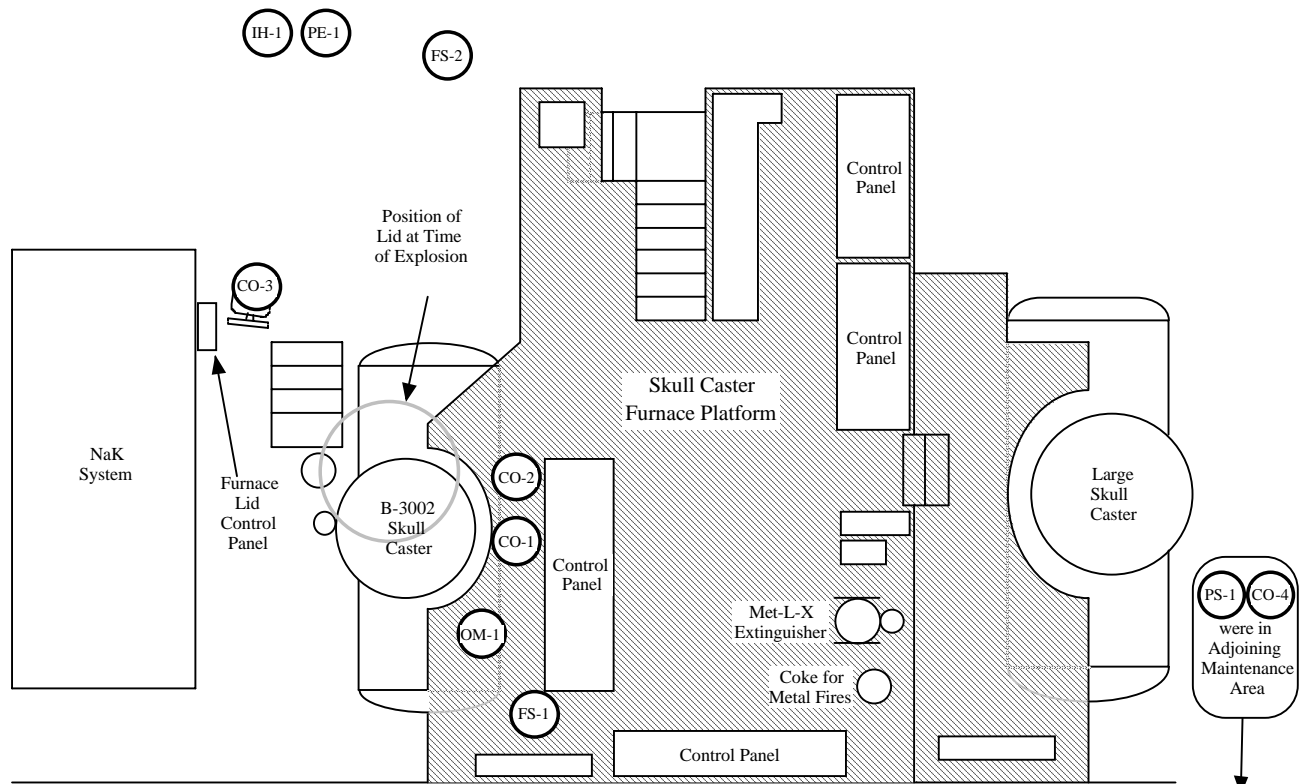
Figure 5. Skull Caster Furnace Area, Showing Positions of Workers at the Time of the Explosion

The workers on the platform left as rapidly as possible. The operations manager (OM-1) helped the most severely injured worker (CO-1) off the platform and held him in an effort to smother his burning coveralls as they proceeded to the safety shower. Other workers discarded burning clothing as they left the area. The workers assisted the injured personnel and extinguished small fires. One worker (IH-1) exited the area and called 911, which connects to the Y-12 fire department dispatcher.

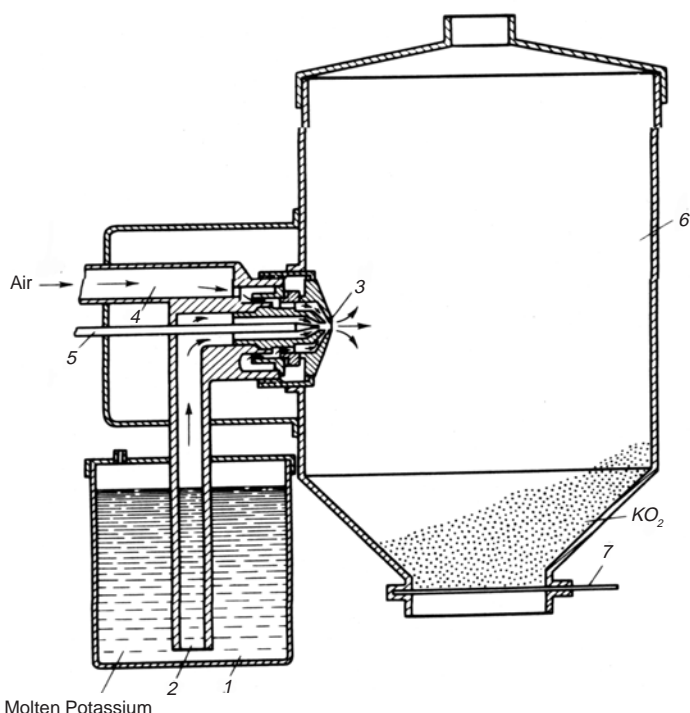
Figure 6. Commercial Production of Potassium Superoxide

The initial spill on December 1, 1999, involved a failure to close a valve, resulting in NaK spraying into the crucible while under pressure and at elevated temperatures. These conditions—forced exposure to air at elevated temperature—were favorable for the formation of potassium superoxide. Spraying NaK into the air in this manner is similar to the process used for commercial production of potassium superoxide, although commercial processes would use a higher temperature and a controlled fine spray (see Figure 6 on page 19).

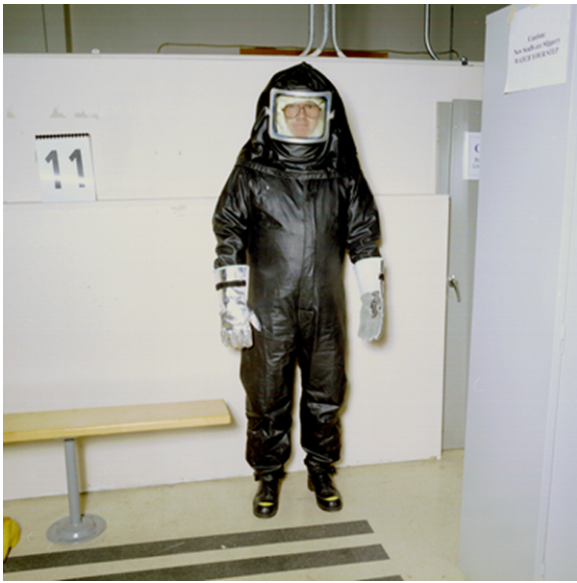
PPE for Workers Contacting NaK

- Impervious NaK suit including respiratory protection and chrome gloves
- Full protection against thermal and chemical burns
- Not worn and not staged

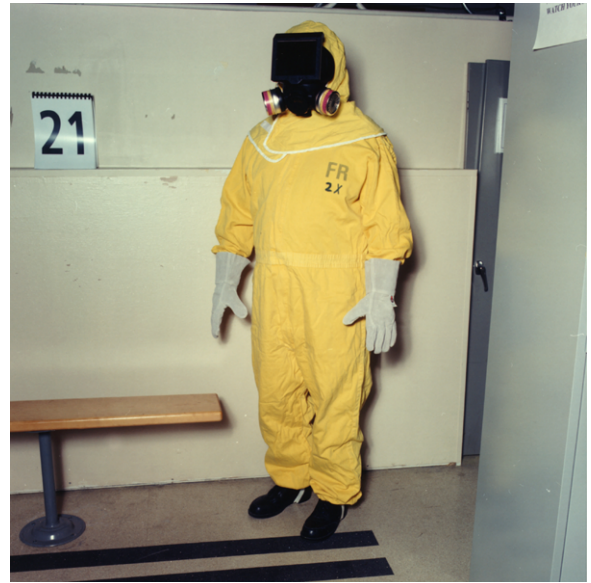
PPE for Support Personnel

- Derived from site requirements
- Includes full face respiratory protection and flame-retardant materials
- Not worn
