Type A Accident Investigation

**Subcontractor Fatality at the
Pond B Dam Upgrade Project
on July 26, 2004
at the
Savannah River Site
Aiken, South Carolina**

September 2004

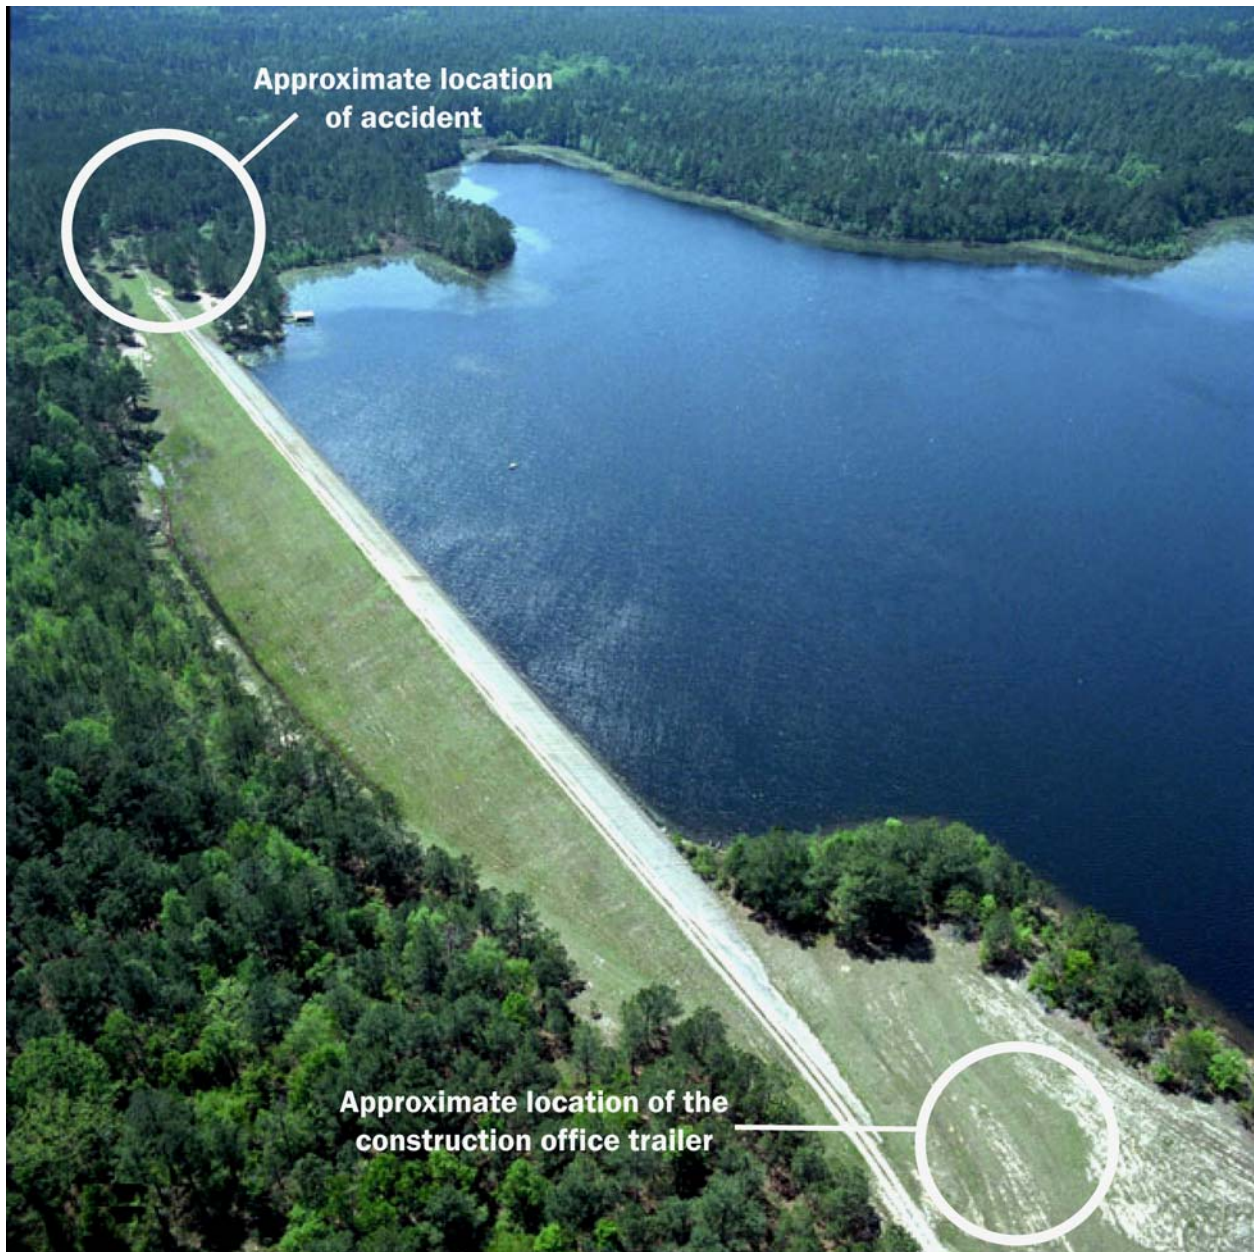
Figure 1-1. South end of Pond B Dam

Figure 1-1 shows an aerial view of Pond B. The Pond B Dam, the scene of this accident, was constructed in 1960 as a simple earthen dam with a sandy-toe drain system that was typical of that period. The dam is operated and maintained using the Federal Energy Regulatory Commission (FERC) guidelines as set forth under Title 18 Code of Federal Regulations (CFR) Part 12, *Safety of Water Power Projects and Project Works*. WSRC and FERC inspections confirmed that the pre-repair state of the Pond B structure did not comply with FERC guidelines and required repair. A fixed-price construction contract was awarded to and executed by GradeSouth, Inc., a sister company to Beam's Contracting. The scope of the Pond B Upgrade Project included the installation of a filter and drainage system consisting of coarse gradation sand, fine gradation sand, and a compacted-earth fill berm; installation of a rock riprap collection ditch; installation and removal of a temporary sediment basin; and installation of four piezometers. At the time of the accident, GradeSouth was completing punchlist activities
