U.S. CHEMICAL SAFETY AND HAZARD INVESTIGATION BOARD

INVESTIGATION REPORT

REFINERY EXPLOSION AND FIRE

TEXAS CITY, TEXAS

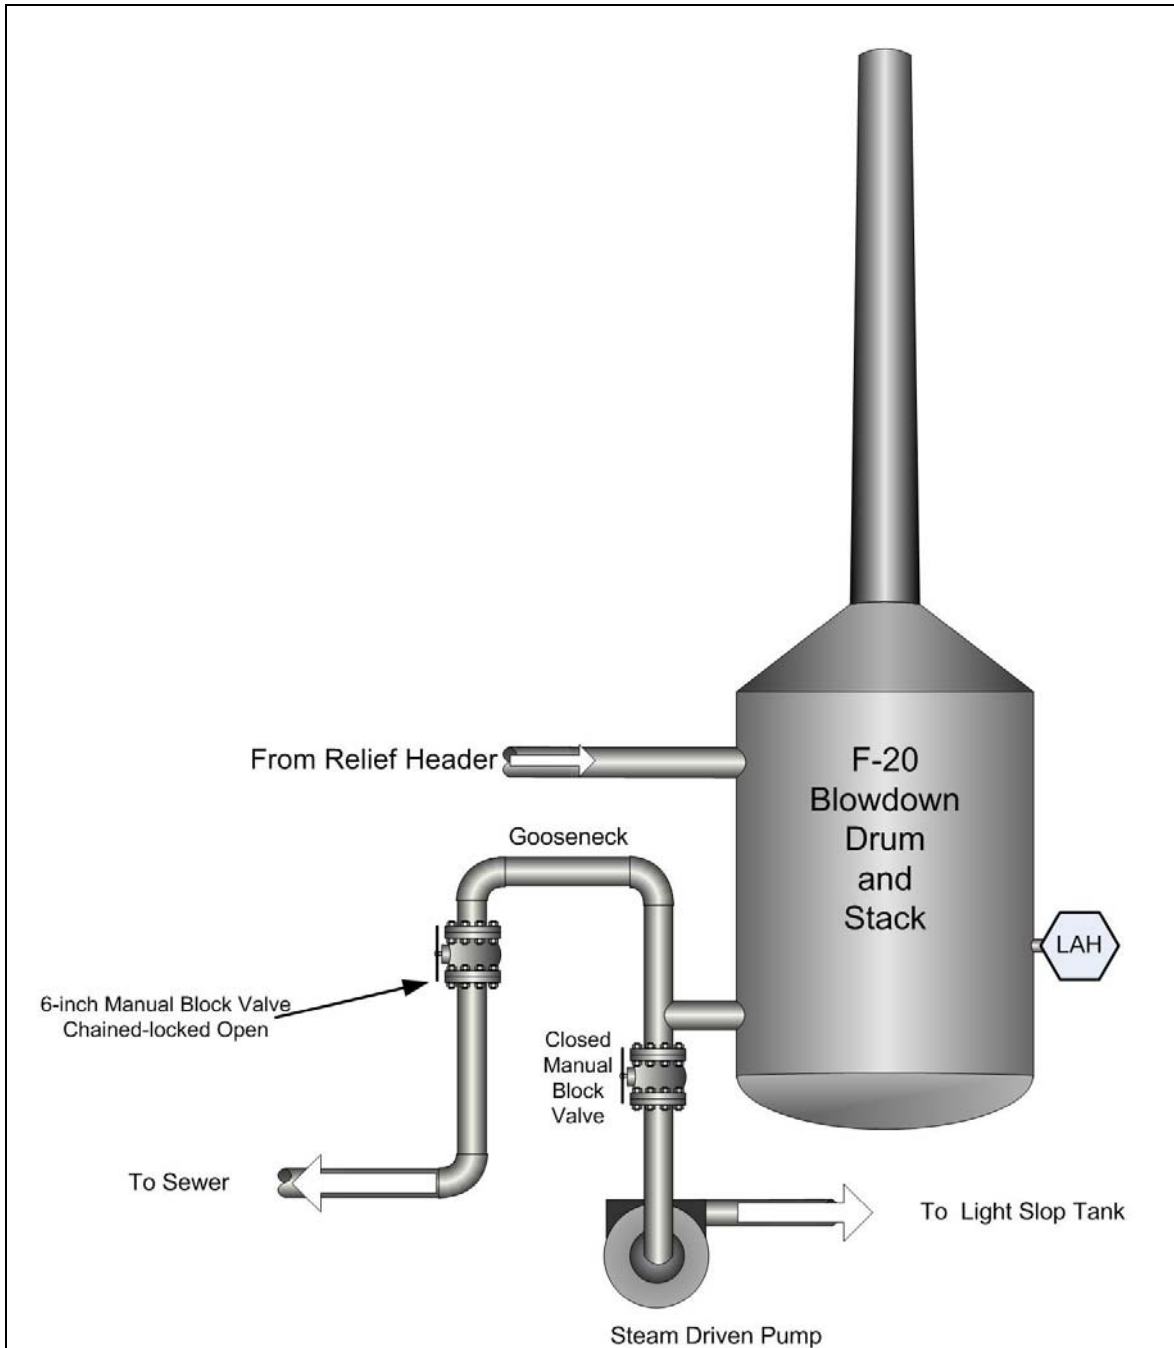
Figure 3. Blowdown drum and gooseneck

As the blowdown drum and stack filled, some of the flammable liquid flowed into the ISOM unit process sewer system through the chained-open 6-inch NPS manual block valve (Figures 3 and 4) and the other safety relief valve discharge pipe headers. As explained in section 2.2.5, this practice of discharging to the sewer was unsafe.

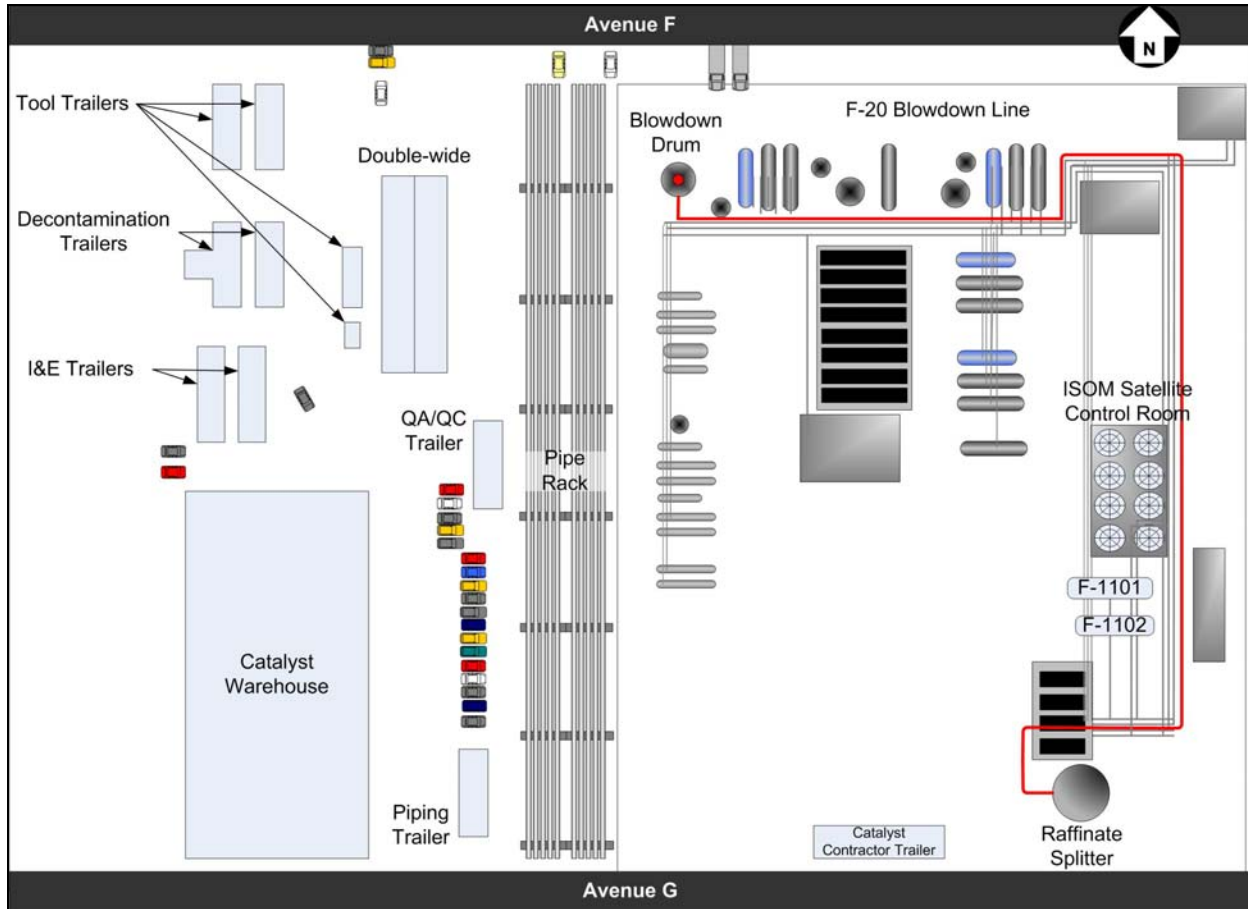
Figure 15. Trailer area and adjacent ISOM unit

BP's placement of occupied trailers close to the ISOM unit was a key factor leading to the fatalities from this disaster. All 15 who died during the March 23, 2005, incident were in or around trailers. The trailers were sited in this area primarily for convenience: the unoccupied area between the ISOM and NDU units was selected because it was across the road from the Ultracracker, (ULC) and would be a convenient staging area for the contractors in their turnaround work (Figure 15). The CCPS noted that this practice is an increasing trend:

While planning for the 2005 ULC unit turnaround, in September 2004 BP sited a double-wide trailer between the NDU and ISOM to house employees for the Motorization Project. Nine others were located in the same area to support the ULC turnaround, but a MOC was not conducted for any of them despite being required by BP policy (Figure 15). (Appendix F provides further information on the location, construction, and use of all the trailers sited in this area.)

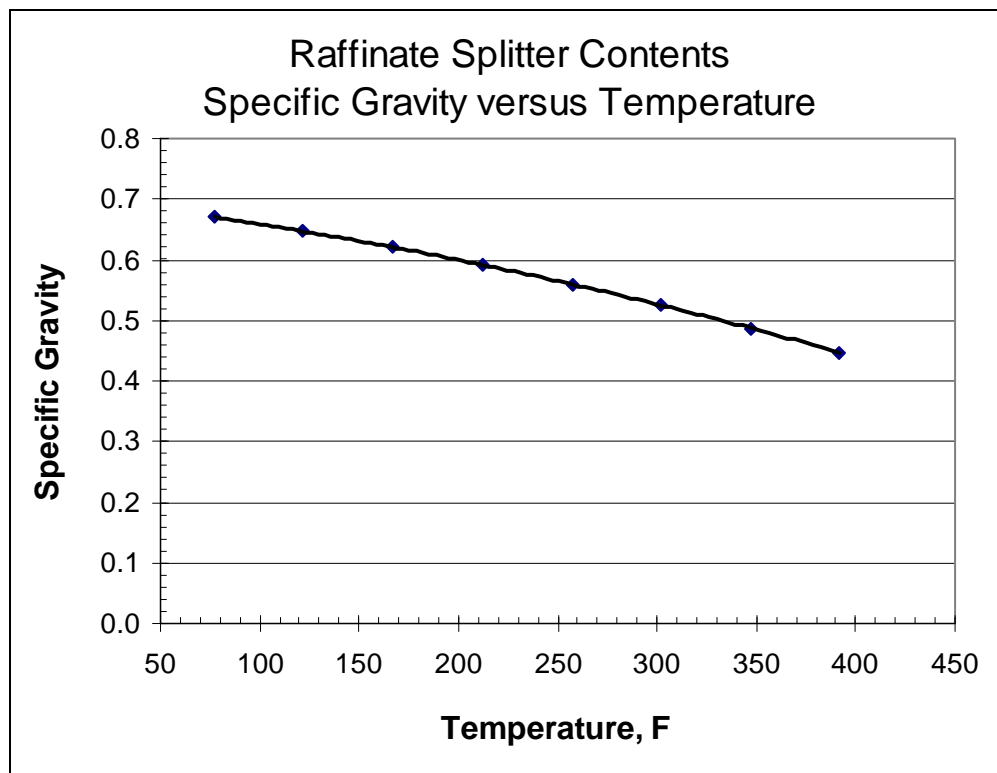
The specific gravity of the hydrocarbon liquid in the raffinate splitter tower is strongly temperature-dependent. At 300°F, the temperature in the base of the raffinate splitter when it overflowed, the specific gravity is about 0.55 (Figure S-2). As Figure S-1 shows, at a specific gravity of 0.55 the transmitter would indicate a level of 78 percent when flooded, which matches the value observed when the raffinate splitter tower over-filled. The CSB concludes that the level transmitter was not calibrated for the specific gravity of fluid at its normal operating temperature.

The CSB investigators learned that the instrument data sheet, which should have been used for calibrating the transmitter, had not been updated since 1975 when the tower was part of a different process with a different feed fluid. The data sheet had never been changed to reflect the operating specific gravity in the ISOM process; furthermore, instrument technicians responsible for maintaining and calibrating the transmitter stated that the data sheets—even if they had been updated—were unavailable to them. The CSB learned that these data sheets were filed in an engineer’s office and were not typically given to technicians with work orders for instrument calibration.

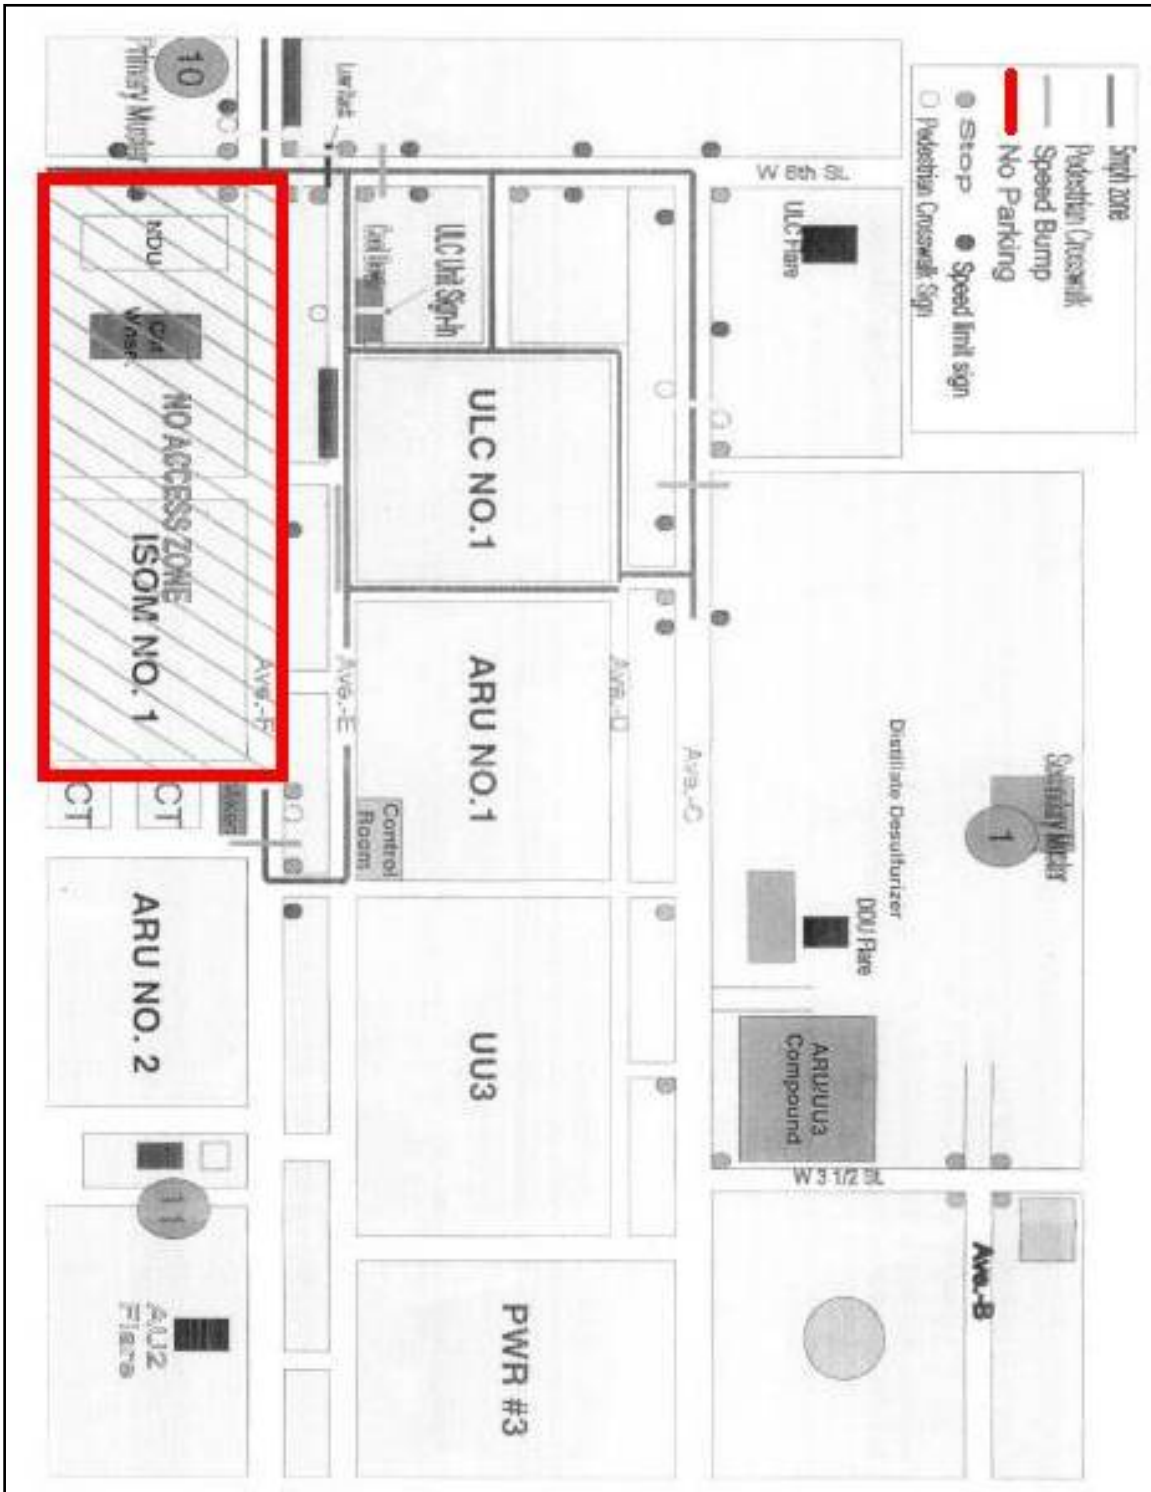
APPENDIX U: BP turnarounds traffic control map*

As Section 6 discussed, mobile trailers were not sited in accordance with MOC policy. Insufficient training for PHA leaders in the use of the MOC policy and its various checklists, a lack of identified responsibilities for the refinery's turnaround organization, trailers being occupied before PHA all action items were resolved, and lack of review of MOCs all prevented the MOC policy from being implemented as was intended.
