PART B5

INCIDENT EVENTS

This part of the report covers the significant events which took place at the time of the accident. The period covered is 55:52:00 g.e.t. to 56:00:05 g.e.t. Prior to this period, spacecraft operation had been essentially according to plan and neither the ground controllers nor the crew had any warning of the events about to occur. The first indication of a problem was a loud bang heard by all three crew members which was followed by a master caution and warning. The immediate indications in the spacecraft were that this warning had been triggered by an electrical transient. Several minutes later two fuel cells failed in the power system, and the crew became fully occupied trying to reconfigure the spacecraft electrical system. Fourteen minutes later they noticed venting and began to understand what had actually happened in the cryogenic oxygen system.

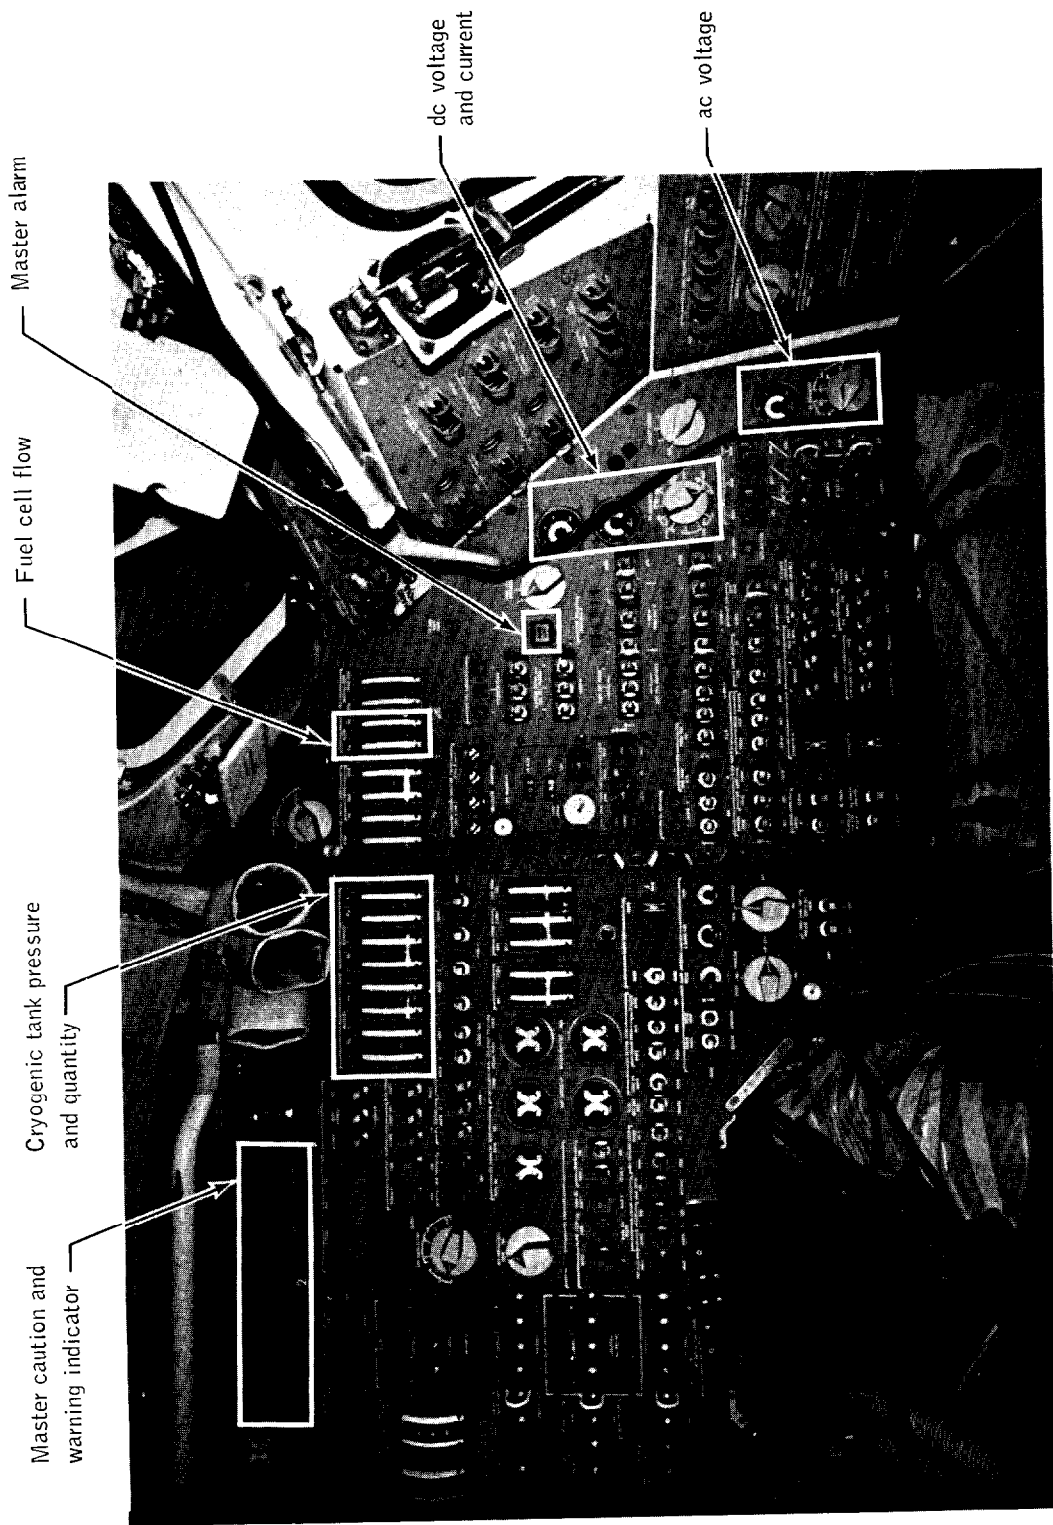
Figure B5-8.- Command module instrument panel.

Approximately at the time of telemetry loss all three crew members heard a single loud bang. One or two seconds later they noted the master caution and warning caused by main bus B undervoltage and at 55:55:00 turned off the alarm. They also verified that fuel cell currents were normal at this time. Figure B5-8 is a photograph of the command module control panel showing the type of displays provided the crew. At 55:55:20 the crew reported, "I believe we've had a problem here," and at 55:55:35, "We've had a main B bus undervolt." Later they reported that a computer restart had occurred at the time of the bang, which had already been noted in Mission Control.
