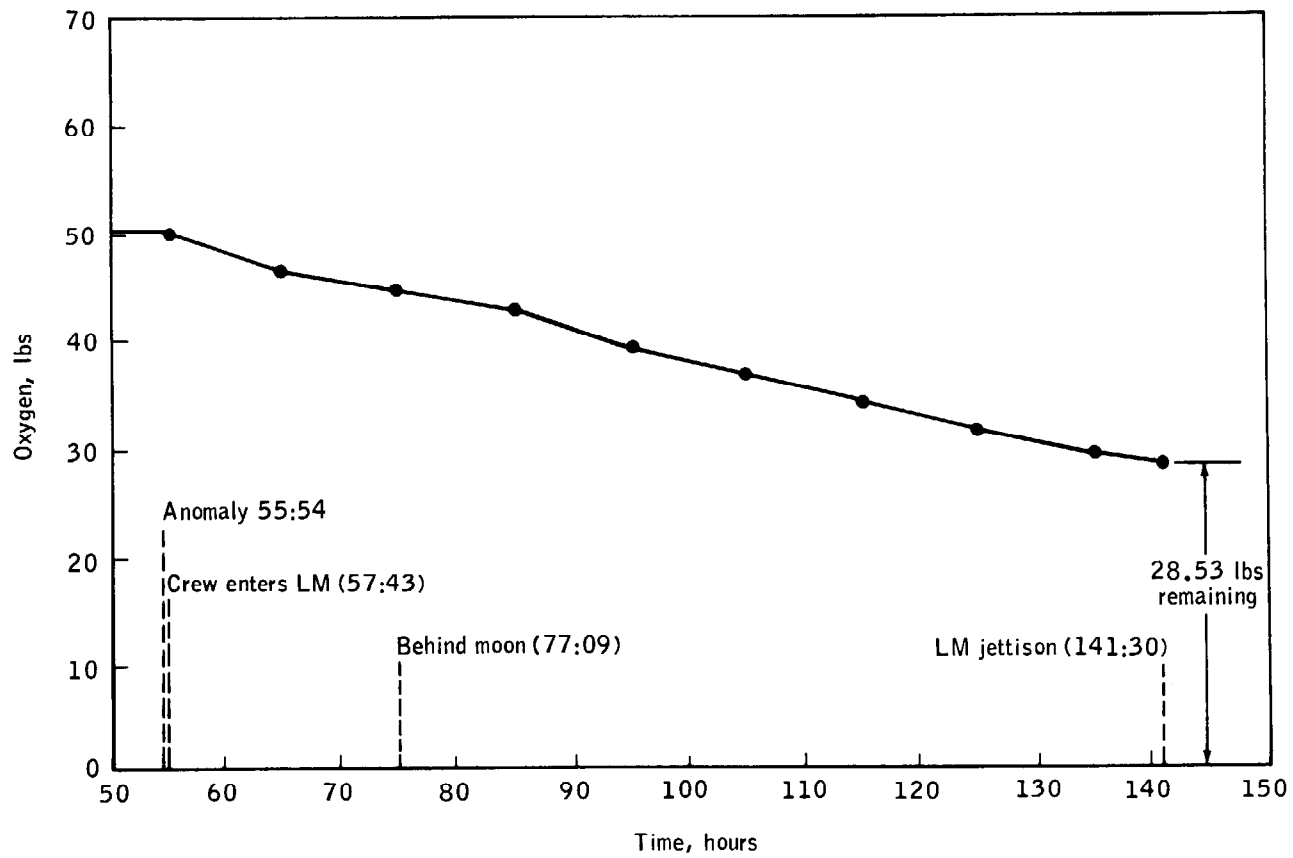
Figure B6-6.- Usable remaining oxygen.

Oxygen supply and carbon dioxide removal: The oxygen supply in the LM was adequate for more than 200 hours g.e.t., and was of no concern (fig. B6-6). This included a supply in the systems normally used for the lunar extravehicular activity (EVA). The initial problem with the ascent oxygen tank 2 had stabilized to the condition that the pressure in the tank was about 100 psi above the normal operating range. Engineering support personnel had advised Mission Control that this was no problem, and no further actions were taken in this area.

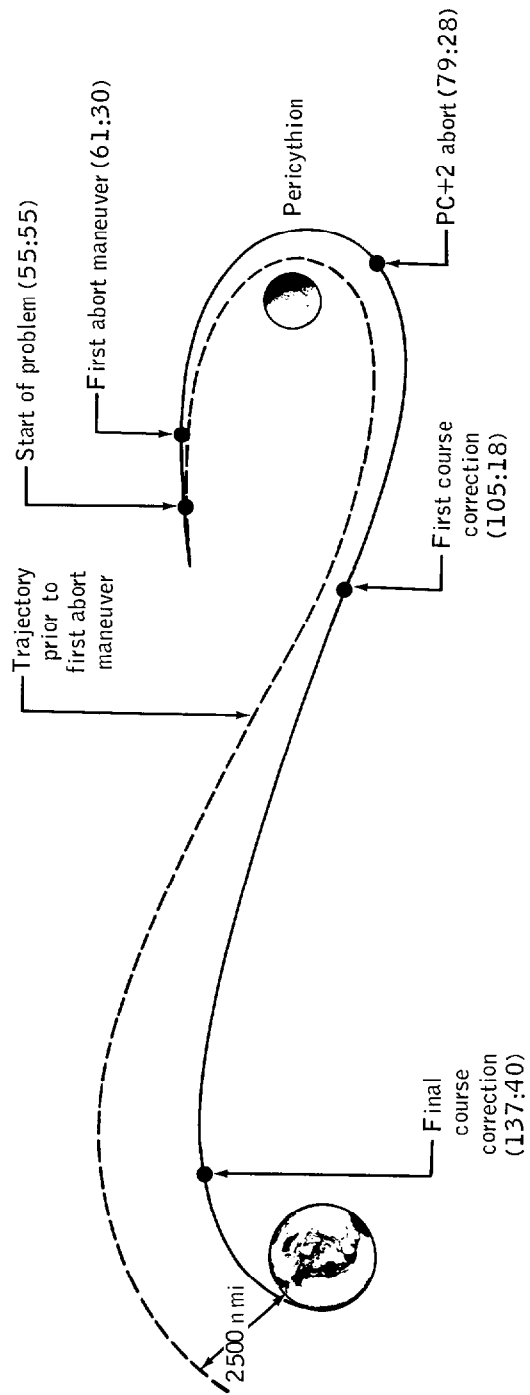
Figure B6-9.- Return-to-Earth trajectory control.

the mid-Pacific recovery area. The last two maneuvers, performed at 105:18 and at 137:40 g.e.t., were course corrections which adjusted the entry conditions to be in the middle of the safe entry corridor. These maneuvers and the decisions related to the choice of specific course changes are described in the following paragraphs.

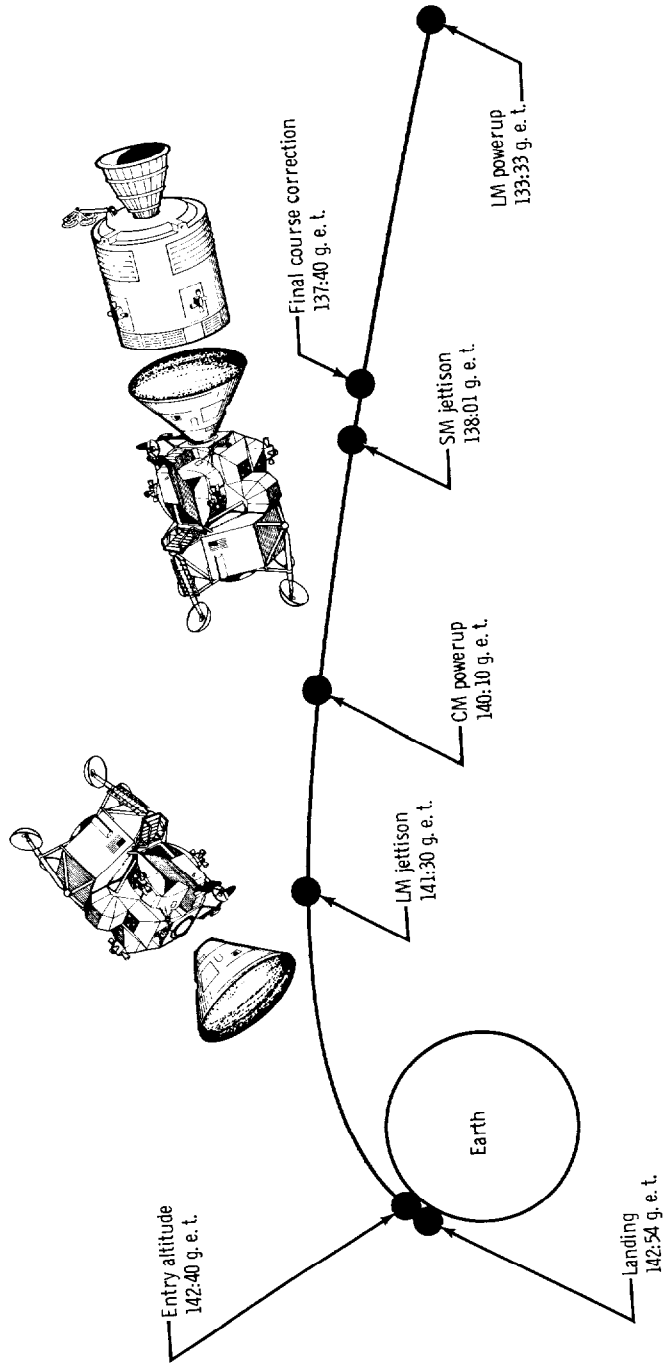
Figure B6-10.- Pre-reentry sequence milestones.

The pre-entry sequence plan (fig. B6-10) called for initiating the powerup at EI -  $6\frac{1}{2}$  hours, with the LM supplying power to main bus B in the CM and entry battery C supplying power to main bus A. A total of 115 amp-hours was required of the CM entry batteries, including a 23 amp-hour allowance for contingency after splashdown. A detailed expected battery current profile was plotted and used during the actual preparation to verify that a safe power margin was maintained throughout the reentry preparations. Battery utilization was planned so that all three entry batteries would be available throughout the entry phase. It

was predicted that battery C would be depleted after deployment of the main chutes, and in fact it was. This left the redundant capability of two batteries available to inflate the uprighting bags after splashdown.

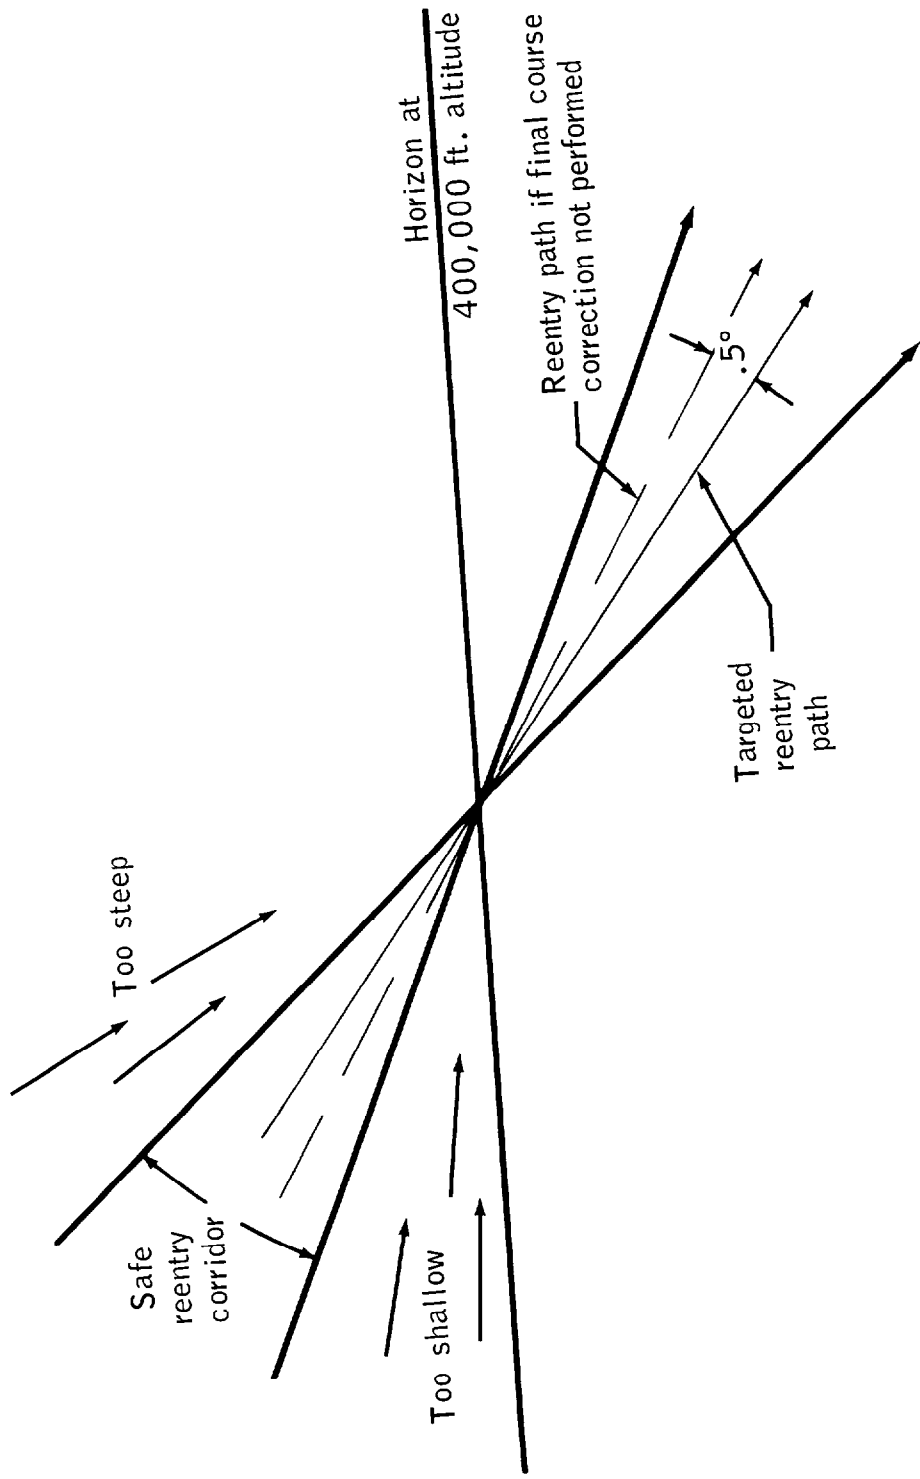
Figure B6-11.-- Flight path angle and the safe reentry corridor.

After activating the LM guidance and control system, the first major milestone in the entry sequence was to execute the final course correction to place the spacecraft on a trajectory that was in the center of the safe entry corridor. Prior to the final course correction, the trajectory had an entry angle error of about +0.5 degree, which is a safe condition, but slightly shallow (fig. B6-11). It is a standard practice to perform a final trim maneuver a few hours prior to entry to try to remove any entry angle error greater than  $\pm 0.1$  degree, and this course correction was incorporated in the timeline before it was known whether or not it could be required.
