INTEGRATION, SYSTEM TESTING, AND PRELAUNCH CHECKOUT OF THE CRYOGENIC OXYGEN STORAGE TANKS

Summary of Significant Aspects of Serial No. 0008 Tank
Prelaunch Integration Test and Checkout History

Investigation and Supporting Work

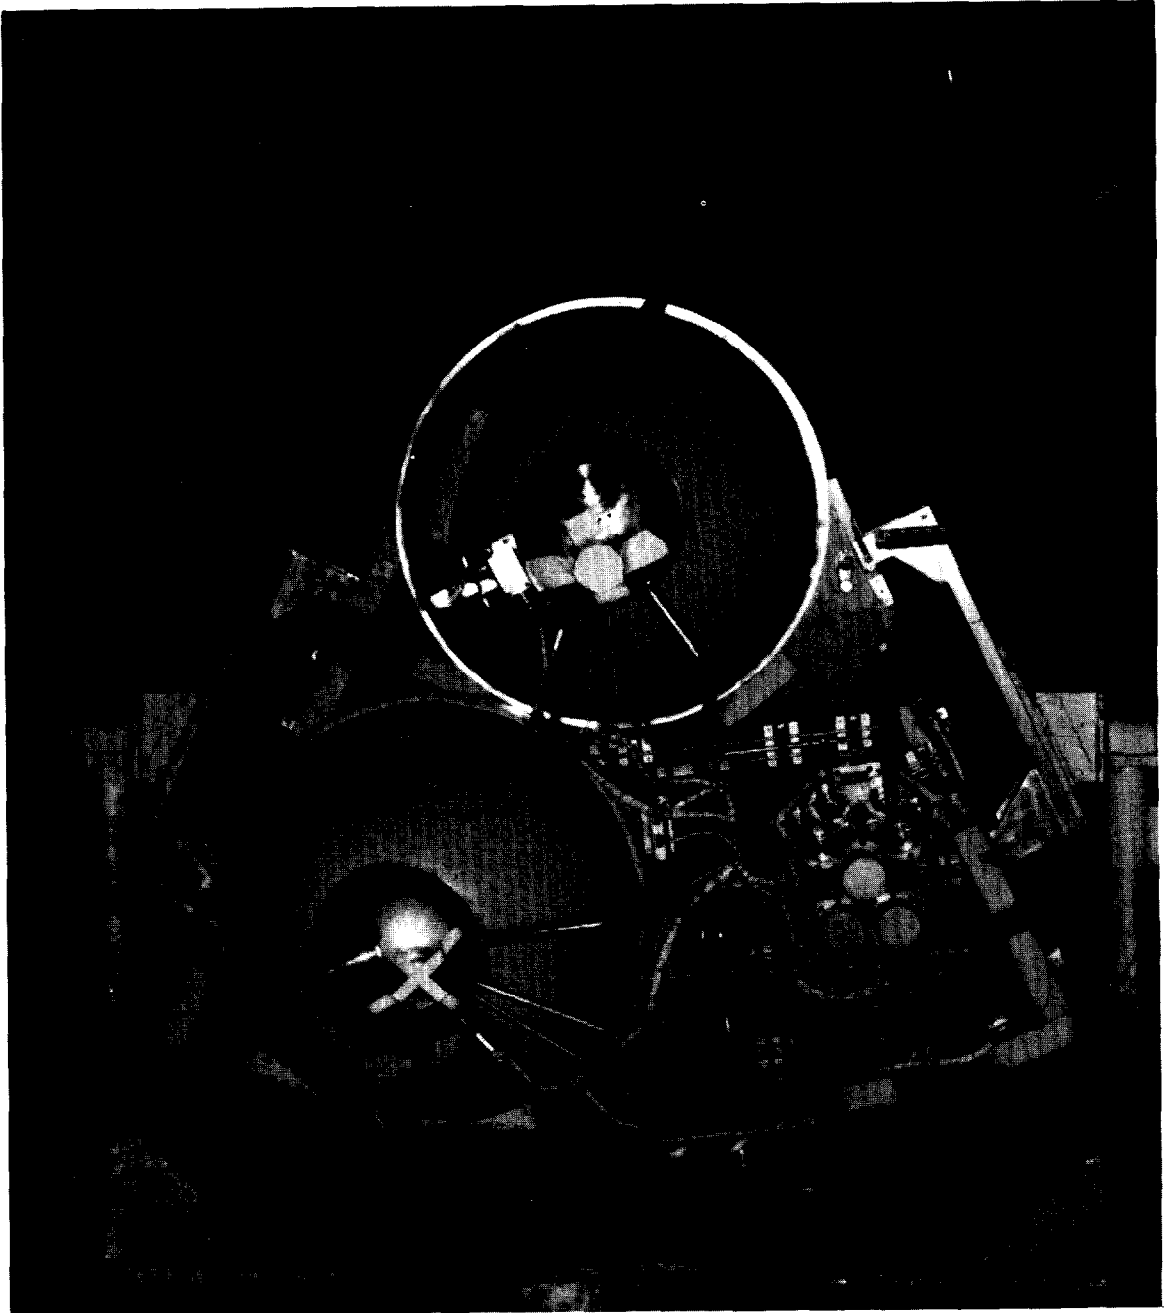
Figure C4-50.- Oxygen shelf with tanks 10024XTA0008
and 10024XTA0009 installed.

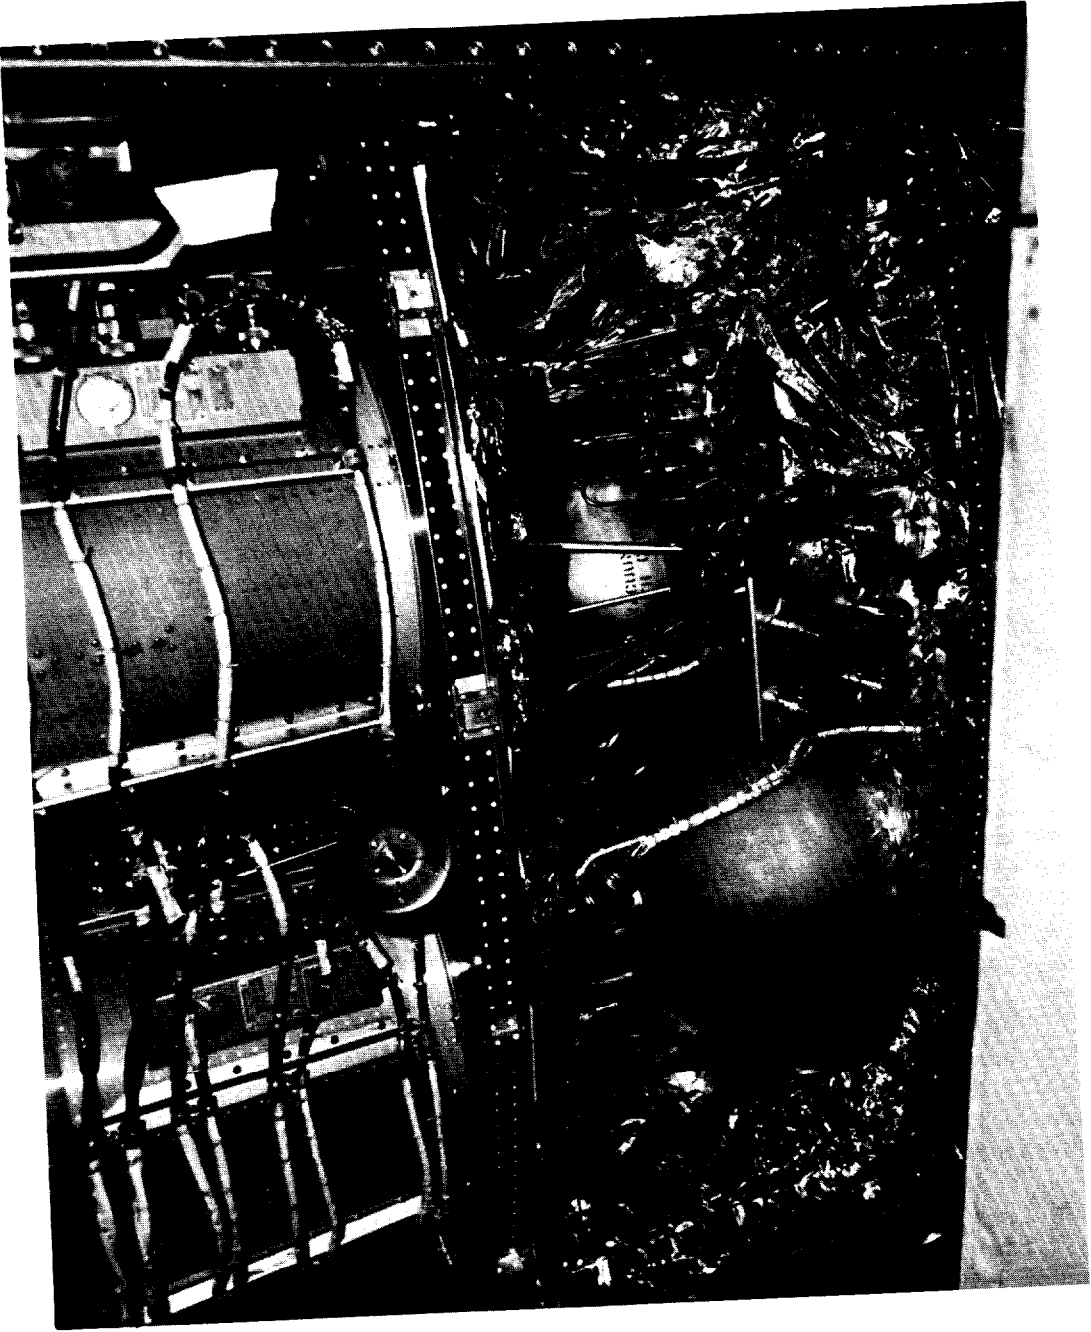
A progress photograph (fig. C4-57) taken at KSC on November 14, 1969, shows the visible condition of the oxygen shelf with tanks, valves, tubing, and cables.

Figure C4-57.- Progress photograph of oxygen shelf taken at KSC
November 14, 1969

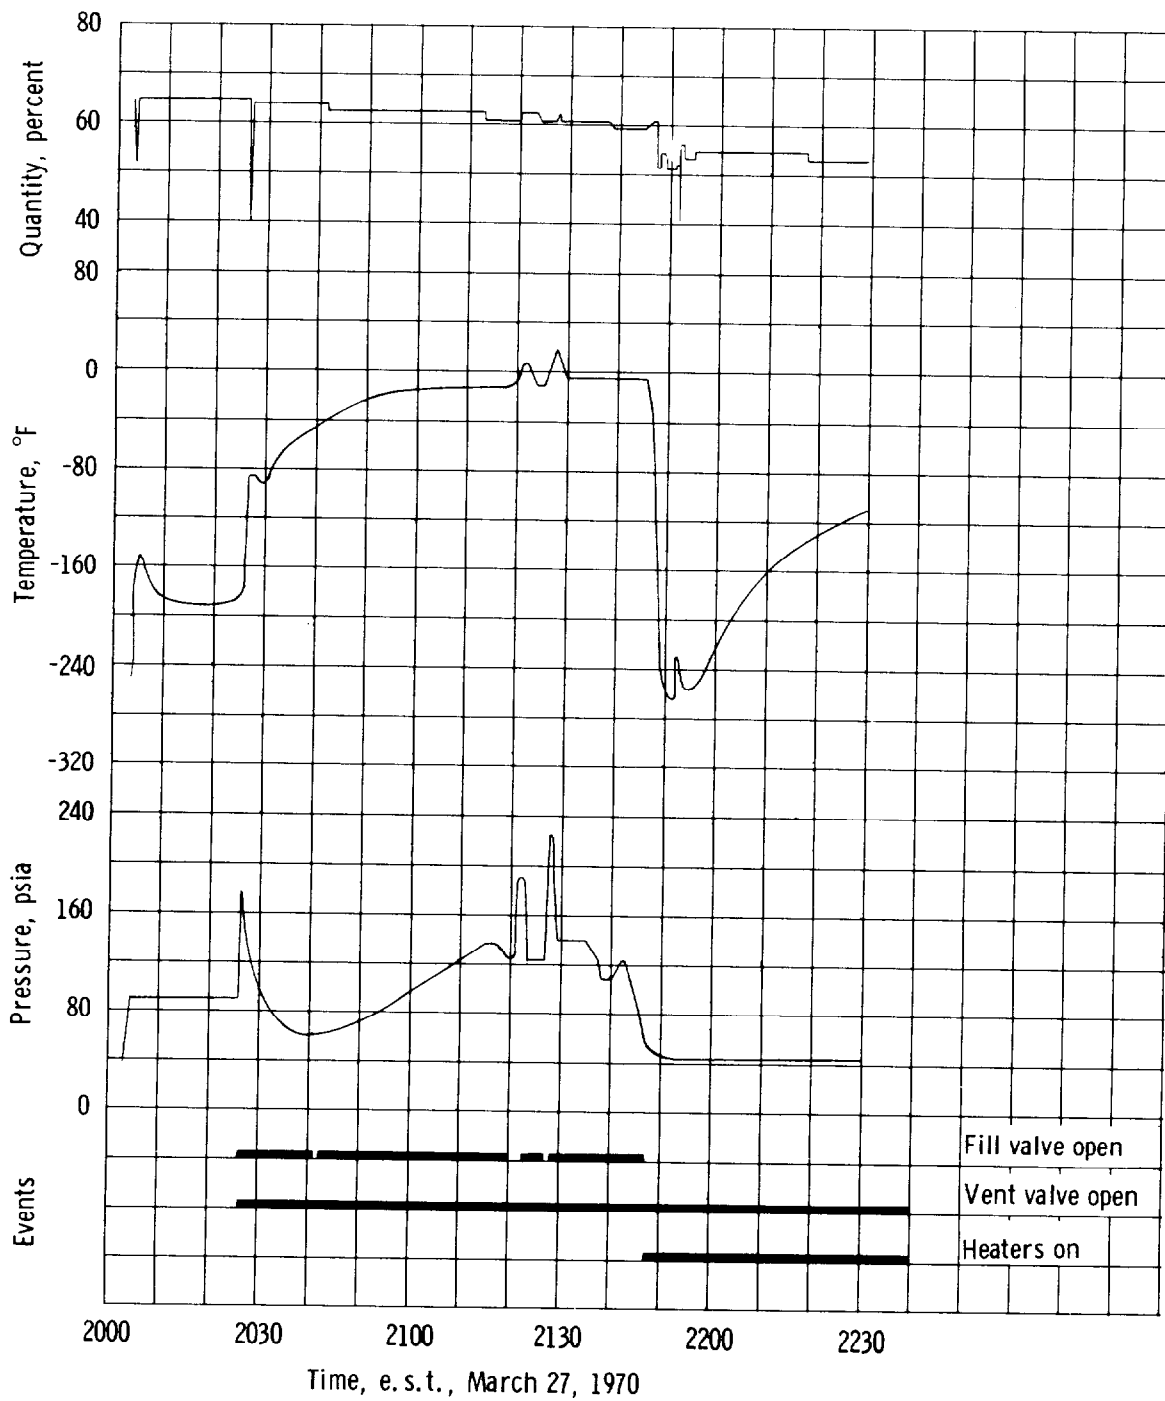
Attempts were made over an 80-minute period to deplete the oxygen content of tank no. 2 by cycling up to various pressures and down, but did not reduce the indicated quantity below 54 percent (fig. C4-59). An attempt was made to expedite oxygen expulsion through the use of the tank heaters operated at maximum voltage and the fans. These were turned on for nearly 6 hours while the vent port remained open (fig. C4-60). Still the indicated quantity remained above 30 percent.

Figure C4-59.- Oxygen detanking attempt using varying purge pressure.

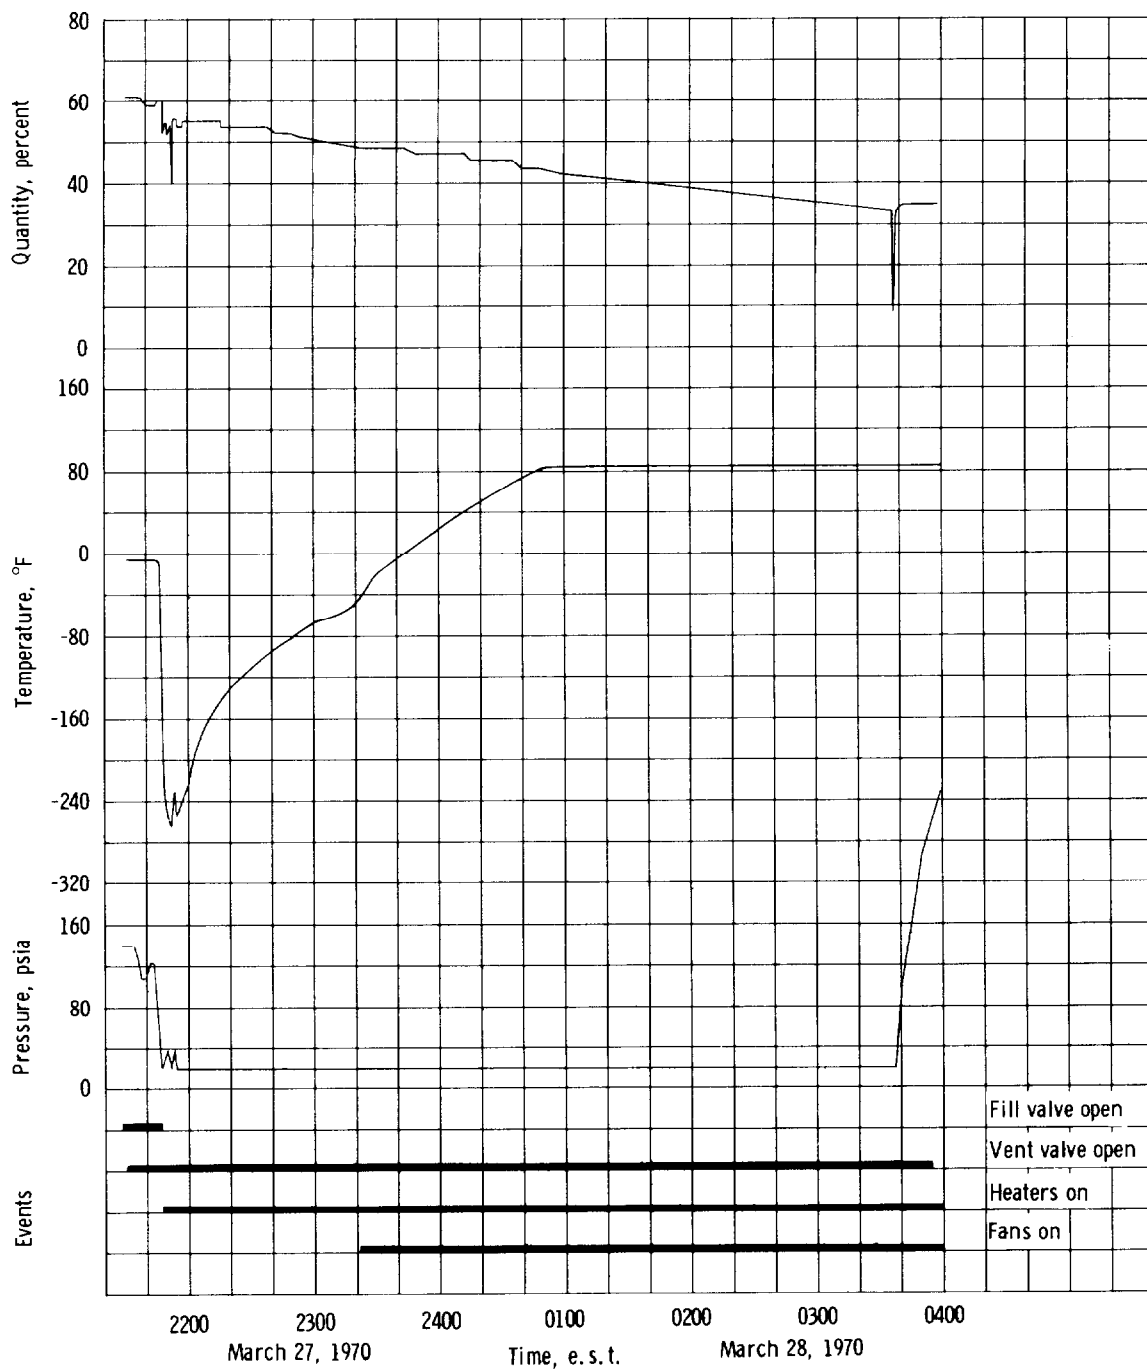
Figure C4-60.- Oxygen detanking attempt using tank heaters.

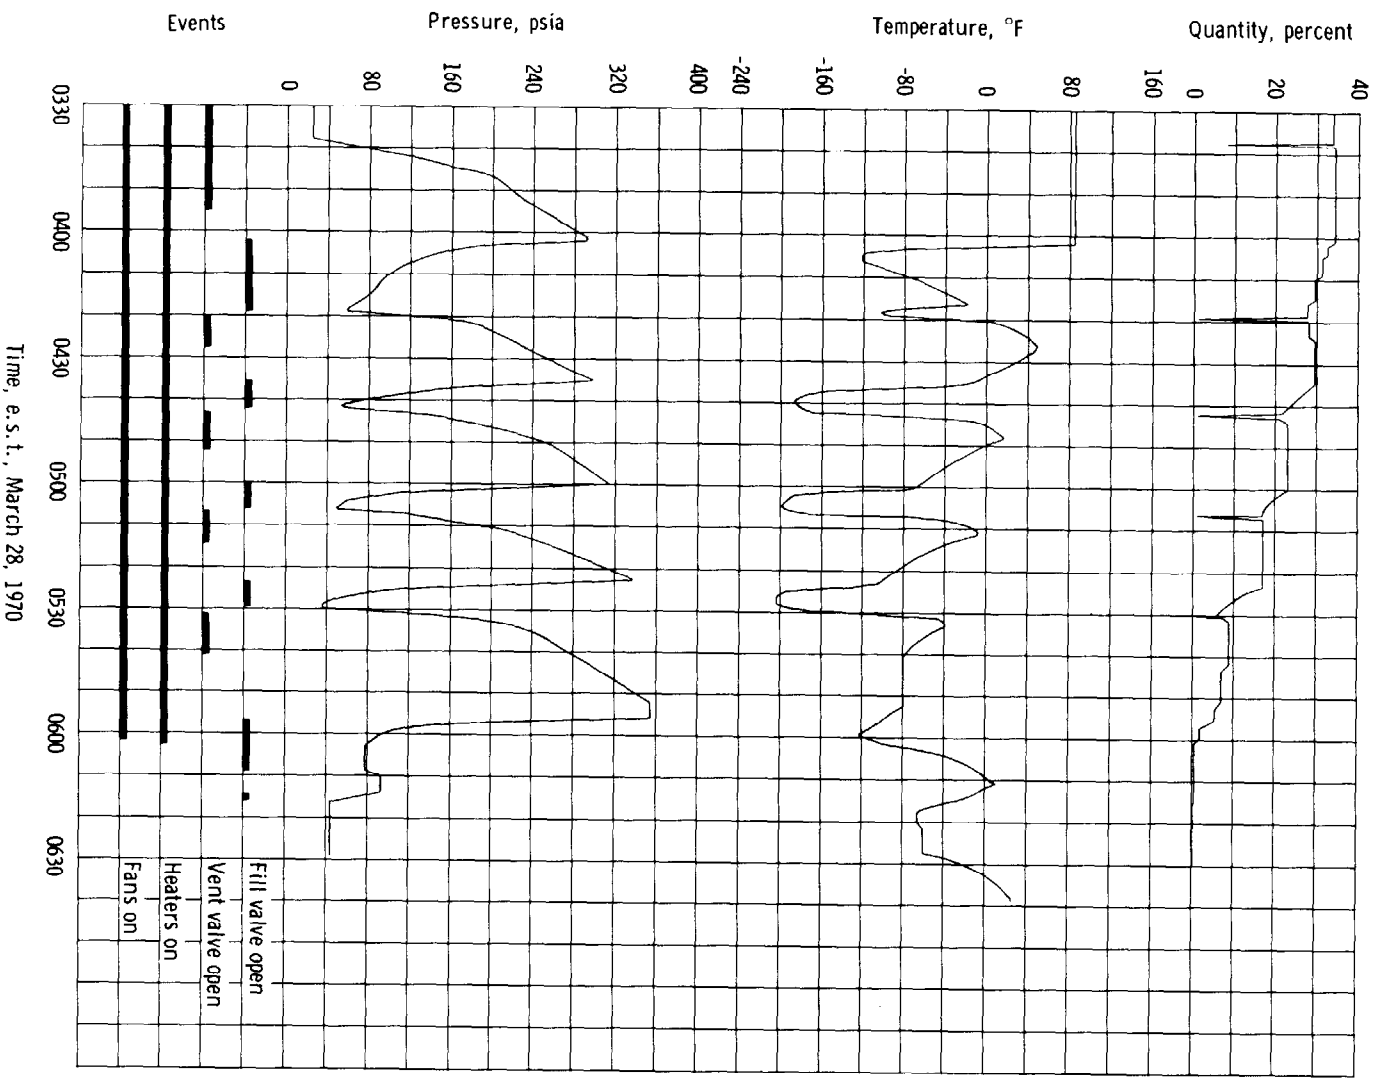
Then a pressure cycling technique was employed over a 2-1/2 hour period with maximum power being applied continuously to both tank heaters and fan circuits (fig. C4-61). This technique involved raising the tank pressure by external gaseous oxygen to approximately 300 psia and then opening the fill line to induce rapid boil-off. After five cycles, the oxygen tank quantity indicated zero.

Fan responses were observed to be normal throughout these operations. The temperature sensor on the quantity probe reached its indicating limit (+84 F) halfway through the 6-hour heating period. No observations of whether the heaters cycled on and off were made and subsequent review of the power supply voltage recording showed no indication of heater cycling.

Figure C4-61.- Oxygen detanking using pressure cycles and tank heaters.

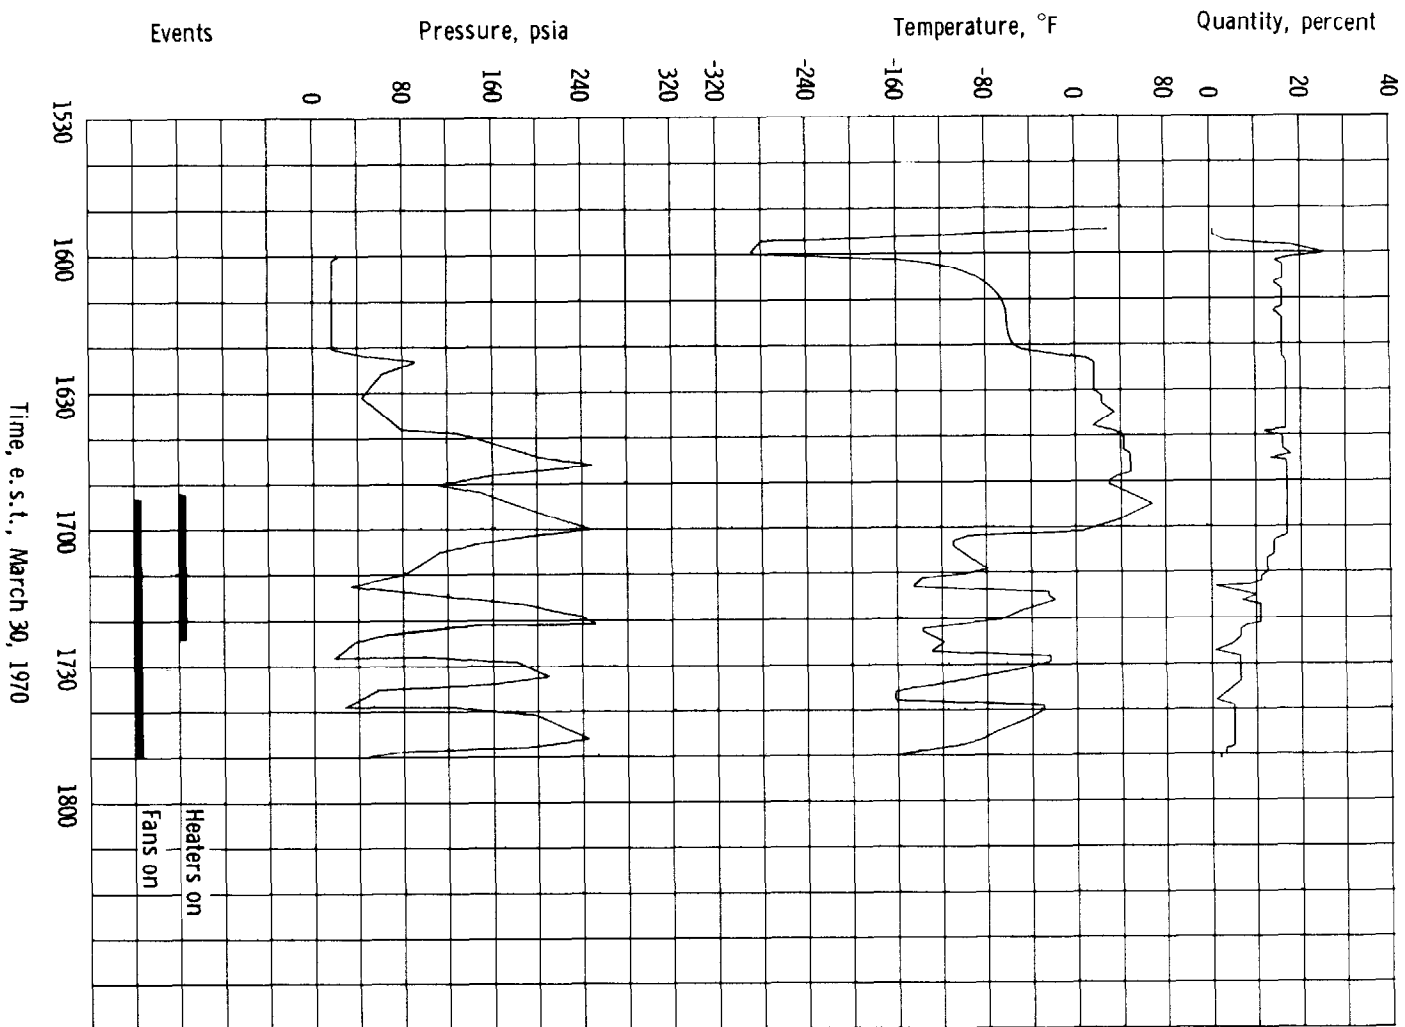
To verify this judgment and to assure countdown operability, both tanks were filled on March 30 to about 20 percent in approximately 2.5 minutes. Tank no. 1 detanked normally; tank no. 2 did not. Again the procedure of applying heat at maximum voltage and the cyclic application of gas pressure of approximately 250 psia and then venting was used. Five cycles were applied in a 1-1/4 hour period and tank no. 2 was emptied (fig. C4-63). The fan responses were observed to be normal and no indications of heater cycling were observed.

Figure Cl-63.- Oxygen detanking using pressure cycles and tank heaters.

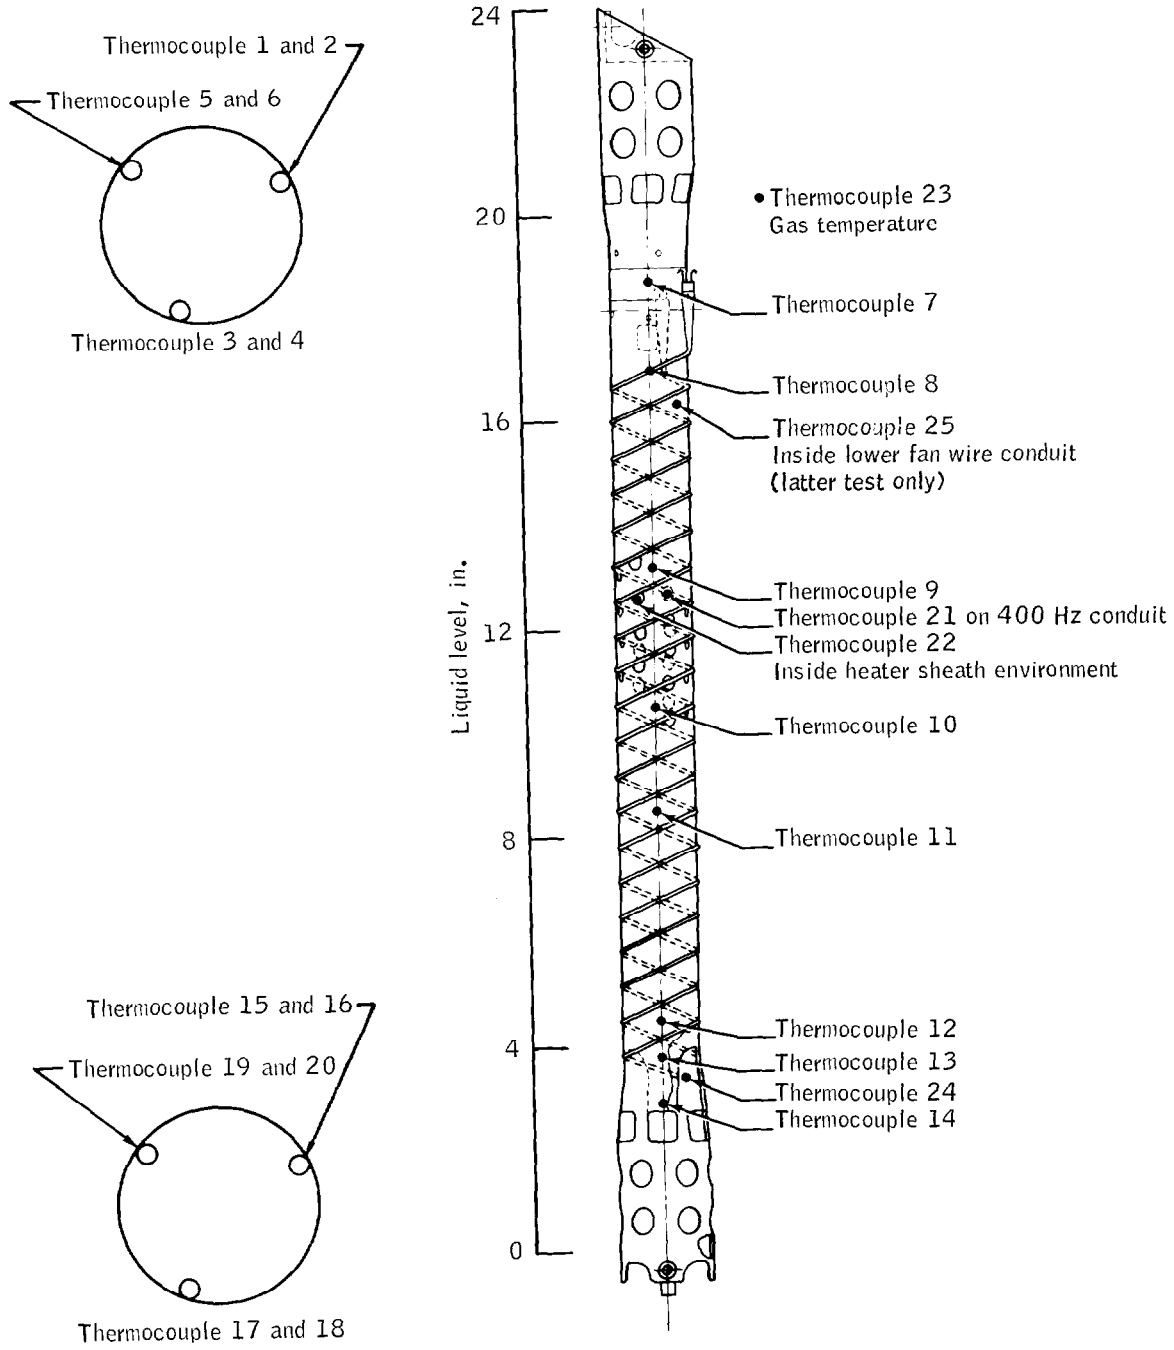
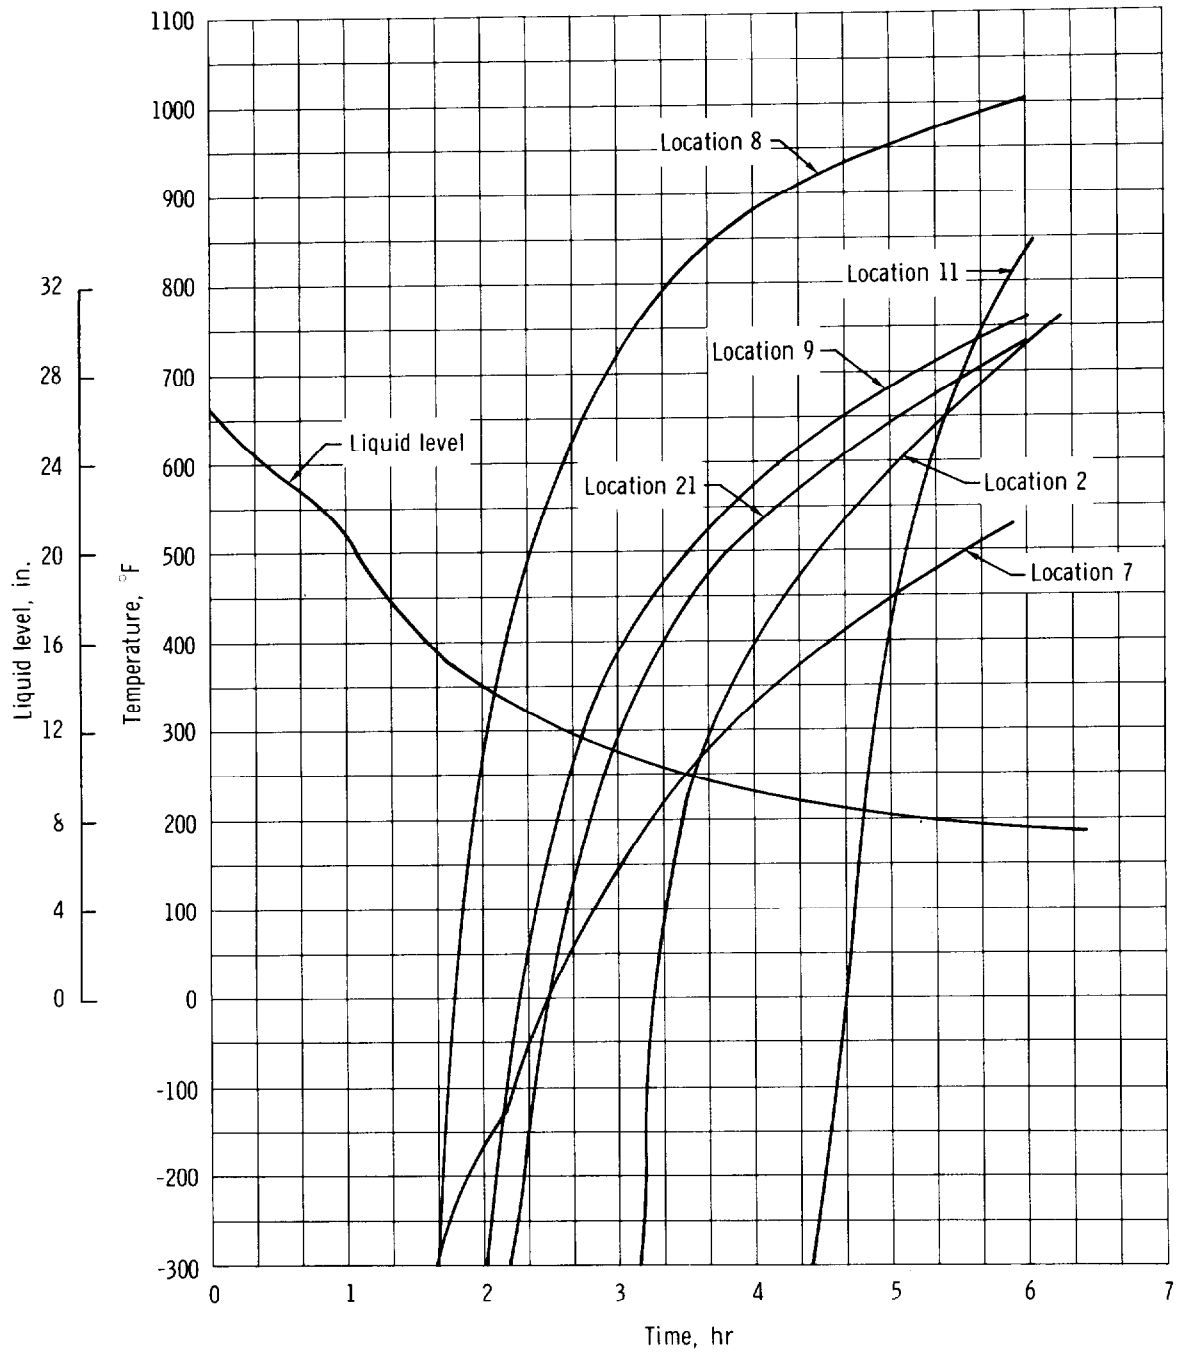
Figure C4-66.- Heater tube assembly temperature test.

(b) Typical test results.
Figure C4-66.- Concluded.

The test was started and after a few cycles in this mode the previously nonfunctioning (open) thermostat started indicating normal function. At this time it was decided to revert to the originally intended test configuration, i.e., the thermostats directly controlling the heaters. Data from that point on indicated that the thermostats were not cycling the heaters. The heater tube temperature data looked just like the nonthermostat test run. The test terminated at this point and the thermostats were removed and X-rayed. The X-rays indicated that the contact gap was bridged. One thermostat had its case carefully removed to examine the conditions of the contacts (fig. C4-67).
