CHAPTER 4
REVIEW AND ANALYSIS OF APOLLO 13 ACCIDENT

PART 1. INTRODUCTION

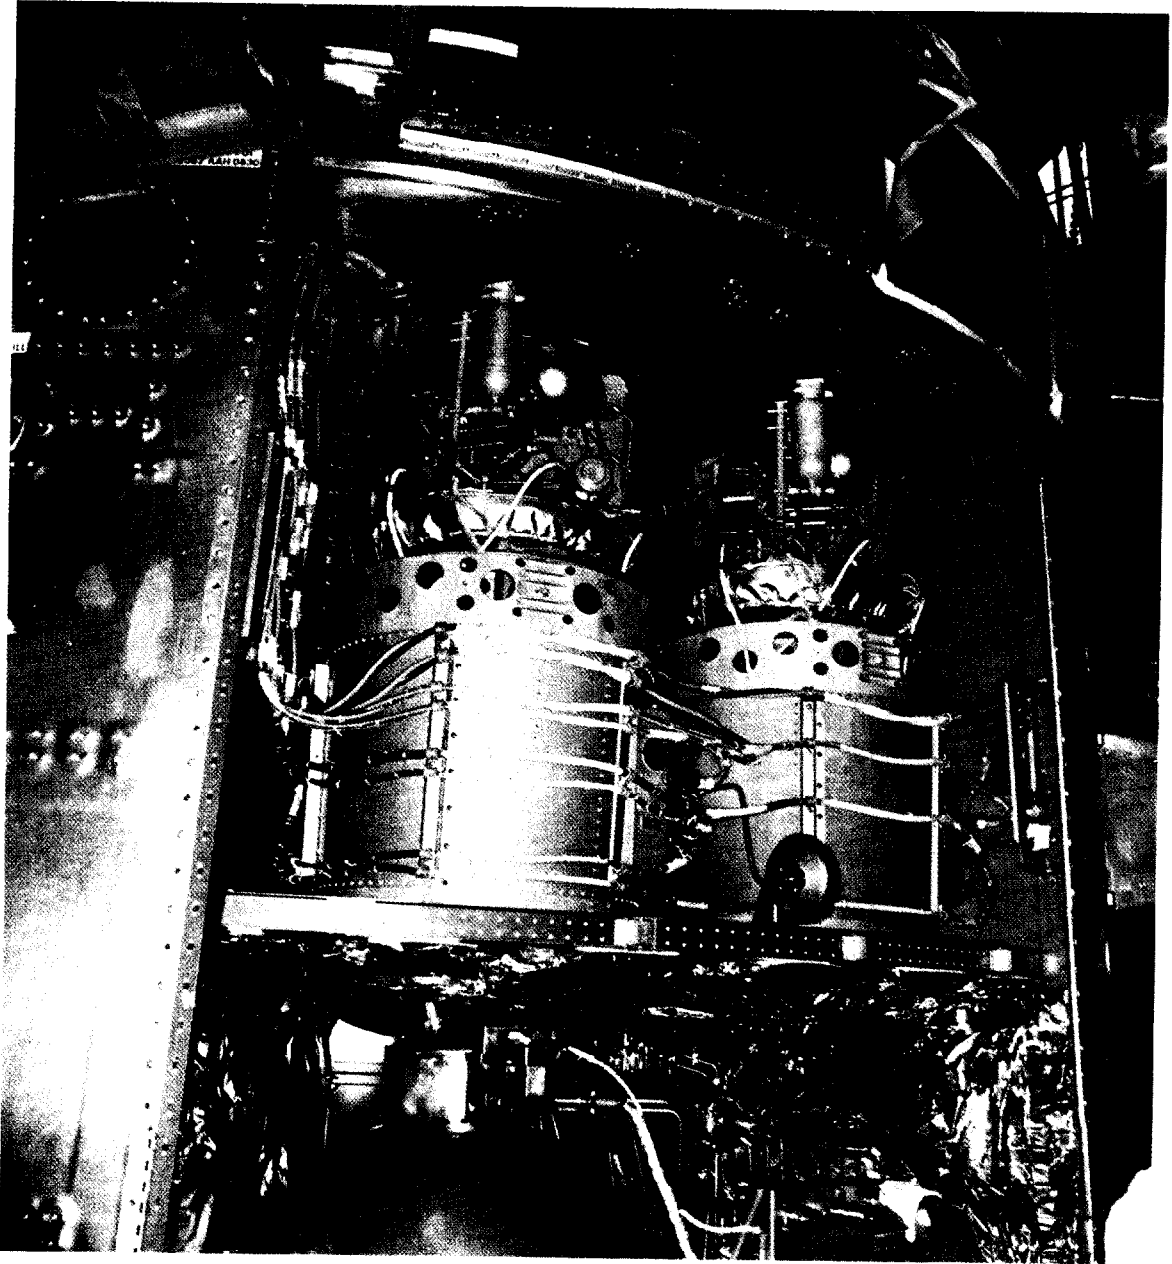
Figure 4-5.- Fuel cells shelf.

of the Apollo 13 service module (SM 109) at the North American Rockwell plant prior to shipment to KSC. Figure 4-5 shows the fuel cell shelf, with fuel cell 1 on the right, fuel cell 3 on the left, and fuel cell 2 behind cells 1 and 3. The top of oxygen tank no. 2 can be seen at the lower left. Figure 4-6 shows the oxygen tank shelf, with oxygen tank no. 2 at left center. Figure 4-7 shows the hydrogen tank shelf with hydrogen tank no. 1 on top and hydrogen tank no. 2 below. The bottom of the oxygen shelf shows some of the oxygen system instrumentation and wiring, largely covered by insulation. Figure 4-8 is a photograph of the bay 4 panel, which was missing from the service module after the accident.
