# **Investigation of Beryllium Exposure Cases Discovered at the North Las Vegas Facility of the National Nuclear Security Administration**

**August 2003**

**National Nuclear Security Administration  
United States Department of Energy  
Washington, DC 20585**

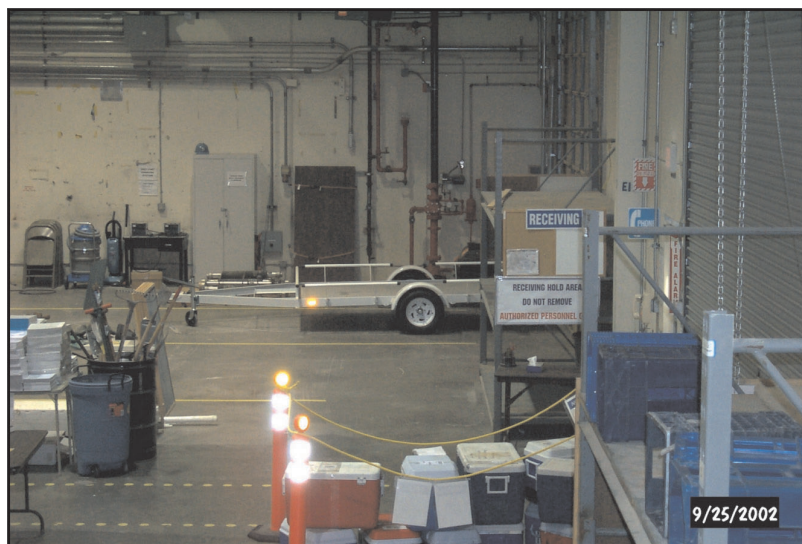
Figure 2.2.2-3: IT/SHAW shipping/receiving area in the B1 high bay.

In the high bay area there are a large number of exposed conduits and pipes that contain a heavy level of dust loading. Some bulk samples were collected on these surfaces for analysis. The only samples found to be elevated were in the south end of the high bay near the IT/SHAW shipping area. The highest result was 2.6  $\mu\text{g}/\text{g}$ , roughly 8 times the soil background value.

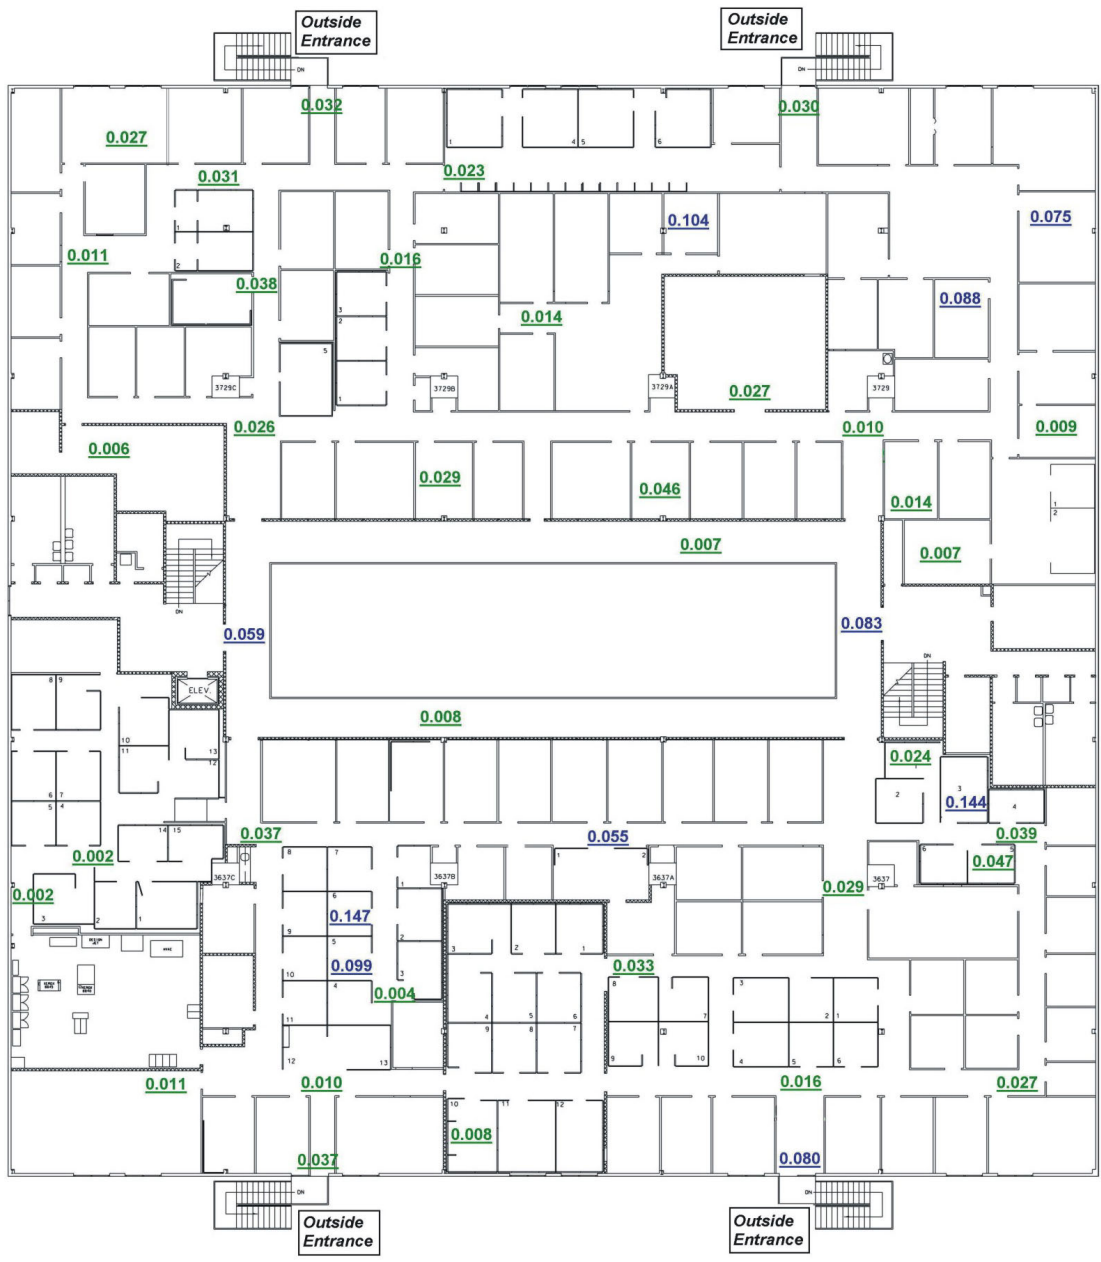
**BUILDING 24-B3  
SECOND FLOOR**

**Carpet Contamination Levels  
(micrograms per 100 cm<sup>2</sup>)**
