Office of Environment, Safety, and Health Oversight
Environment, Safety and Health

Focused Review of the

River Protection Project

July 2001

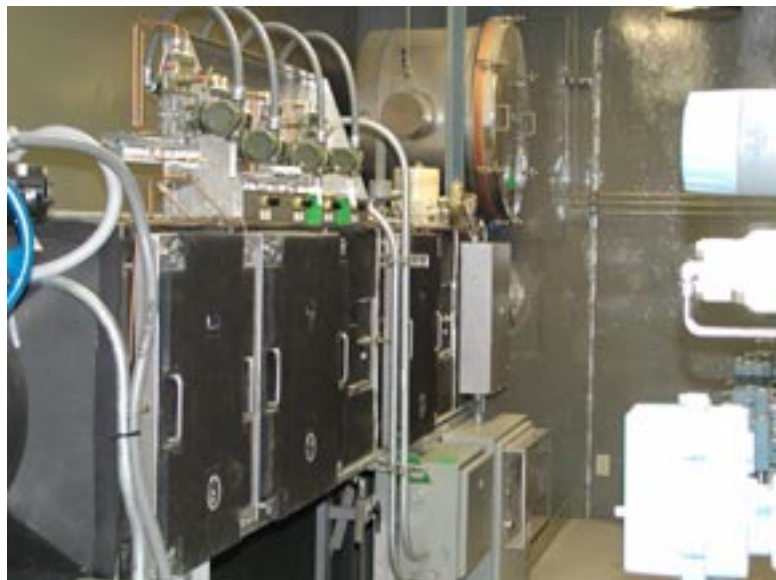
Primary Ventilation System HEPA Filter Train

In normal operation, outside air is drawn into the tanks by the ventilation exhaust fans, and the flow through the tanks is controlled by the recirculation module outlet flow control valves. Recirculation modules for each tank provide additional cooling by recirculating air from the tank through a condenser and back to the tank. Air from the recirculation modules is directed via underground lines to the ventilation building, where it passes through a condenser, a high efficiency mist eliminator, a HEPA/charcoal filter/HEPA assembly, a ventilation fan, and radiation monitors, and then to the atmosphere through a monitored stack. Monitoring is accomplished through a continuous air monitor and a fixed airhead sampler. For redundancy, there is a second parallel filter train that can be started if the operating filter train fails. Proper system operation prevents an unfiltered, unmonitored radioactive release to the environment.

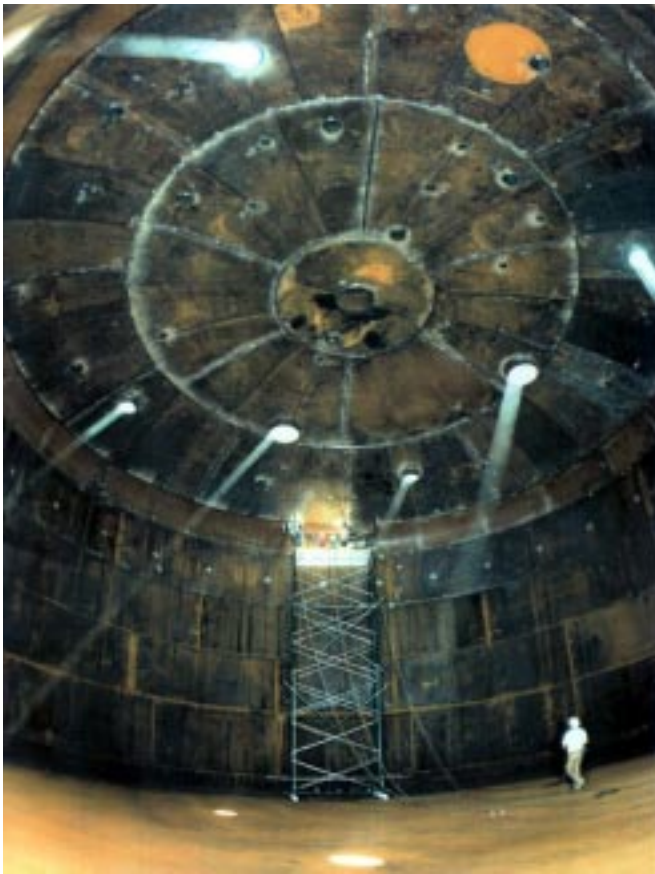
Inside a Waste Tank

Tank Inlet HEPA Filters. The Aging Waste Facility tank inlet HEPA filters do not protect against radiation release for some tank pressurization events as intended by design. The Aging Waste Facility primary tank ventilation system normally operates with the exhaust fans providing flow through the tanks. The tank inlet valve operates automatically and throttles to maintain the tank at a slight vacuum of about minus 1.0 to minus 3.0 inches water gage to ensure that any air leakage is into, rather than out of, the tank in order to minimize releases of unfiltered radioactive materials.

Each inlet air station also contains a HEPA filter intended to prevent radioactive releases through this pathway for most tank pressurization events. There are two conditions that would prevent the HEPA filters from performing their intended function. First, during normal operation, the tank air inlet valves are throttled nearly closed on some tanks. Operators and engineering staff indicated that much of the required flow to the tanks was from leakage paths that bypassed the air inlet station (e.g., inter-tank sleeves and drains). For tank pressurization events, these bypass in-leakage paths would likely become out-leakage paths, bypassing the inlet air HEPA filter. With the inlet valves nearly or fully shut, the condition would be worse. Second, because of the design, tank pressurization events would cause the controls to sense high tank pressure and close the inlet valve, attempting to maintain negative tank pressure. This would further worsen the event by causing all of the out-leakage to bypass the inlet HEPA filter. Although a combination of operator action,

administrative controls, indications, and alarms normally help in maintaining the tanks within allowable limits, the design intent of the HEPA inlet filters may not be met for some overpressurization scenarios. Quantitative analysis of this condition, and the potential consequences of unfiltered releases, should be part of the documented technical basis. Based on the potential deficiency, CHG initiated an unreviewed safety question.

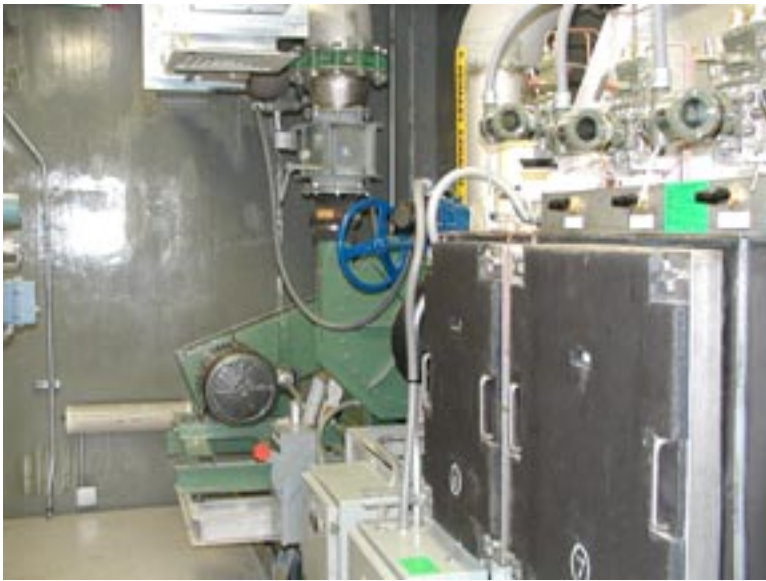
Primary Ventilation Fan in Background; HEPA Filter Train in Foreground

The review of calculations for the HEPA filter train identified two non-conservative errors that could allow exposures above those analyzed.

The review of calculations for the HEPA filter train identified two non-conservative errors that could allow exposures slightly above those analyzed. First, the analyses incorrectly assumed that the filter cartridge frames were made of aluminum; they are made of stainless steel. Second, the analyses did not account for the attenuation that would be caused by the stainless steel filter outer housing. Both factors could cause the actual radioactive burden of the filter to be greater, at the limiting dose rate, than what was calculated. After

discussions with the review team, the CHG engineering organization initiated revisions to the affected calculations. The normal loading of the HEPA filter under current operating practice is low (less than 10 mrem/hour) because filters are changed often, so the calculation deficiency did not result in an immediate safety concern. Re-analysis is necessary to adequately support the safety analysis technical basis. The technical basis for filter changeout needs to be established and documented.
