# Penetration #1 Weld Profile

# **CAUSE ANALYSIS and STATUS**

# What Was Found

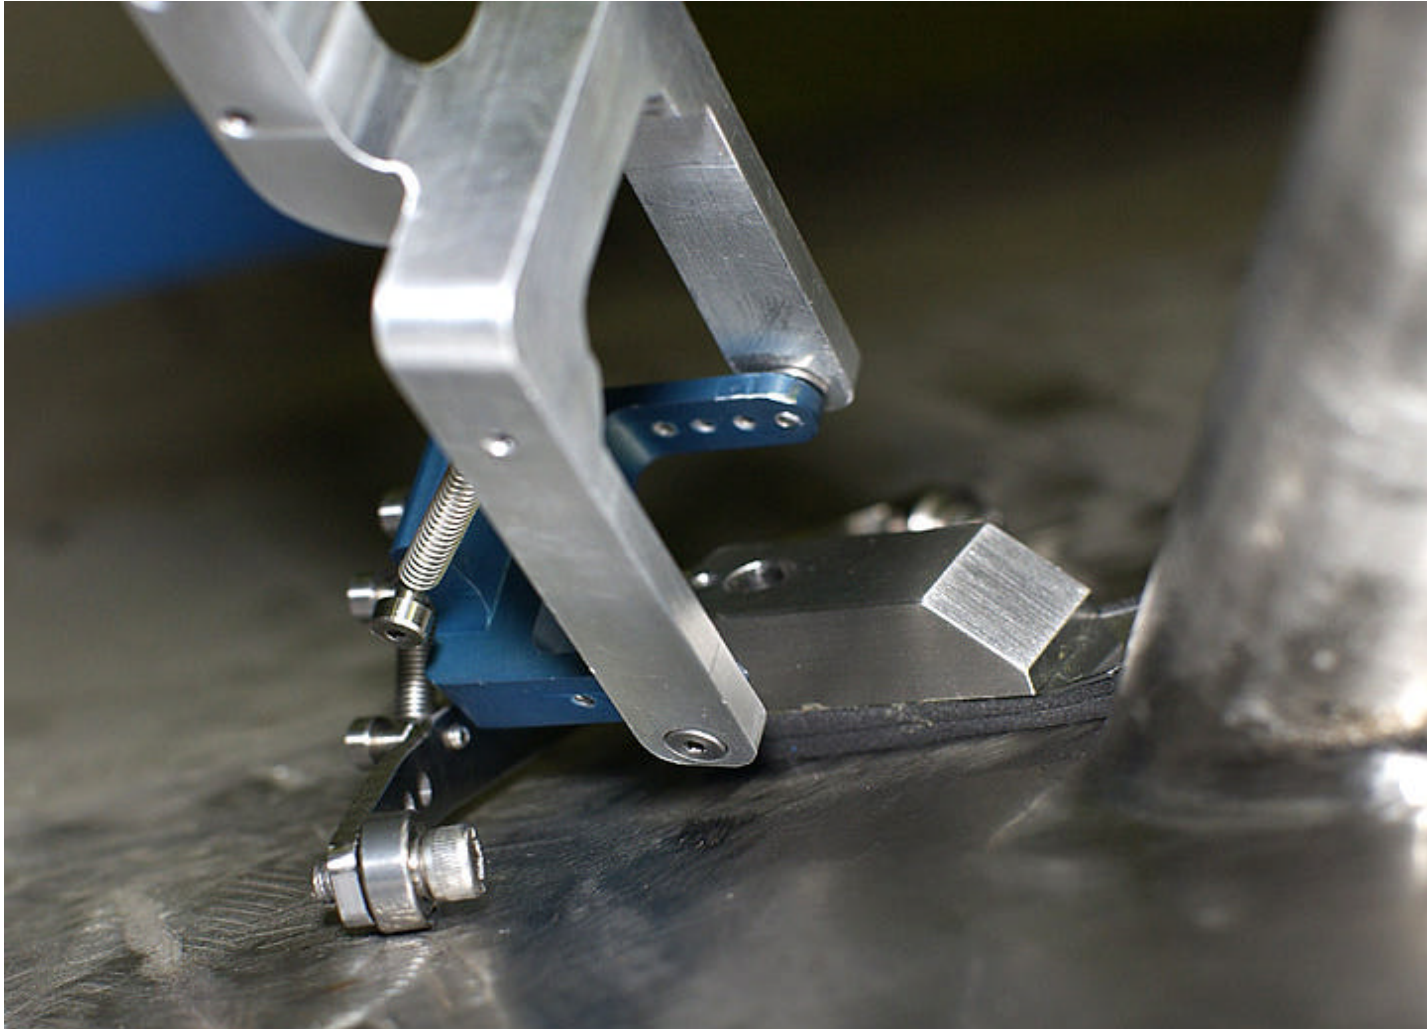
# Eddy Current J-Groove Probe

- Bobbin coil eddy current on penetration ID
  - Penetration #1 displayed a tube ID surface-breaking flaw
  - Penetration #46 displayed a tube ID sub-surface flaw
  - Two other reference penetrations displayed no flaws
- Array coil eddy current on J-Groove weld
  - Penetration 1, 46, 33 & 5 others scanned
  - No flaws identified
