Bottom Mounted Instrument Guide Tube Condition

April 12 - residue found on two of the 58 Bottom Mounted Instrumentation (BMI) penetrations.

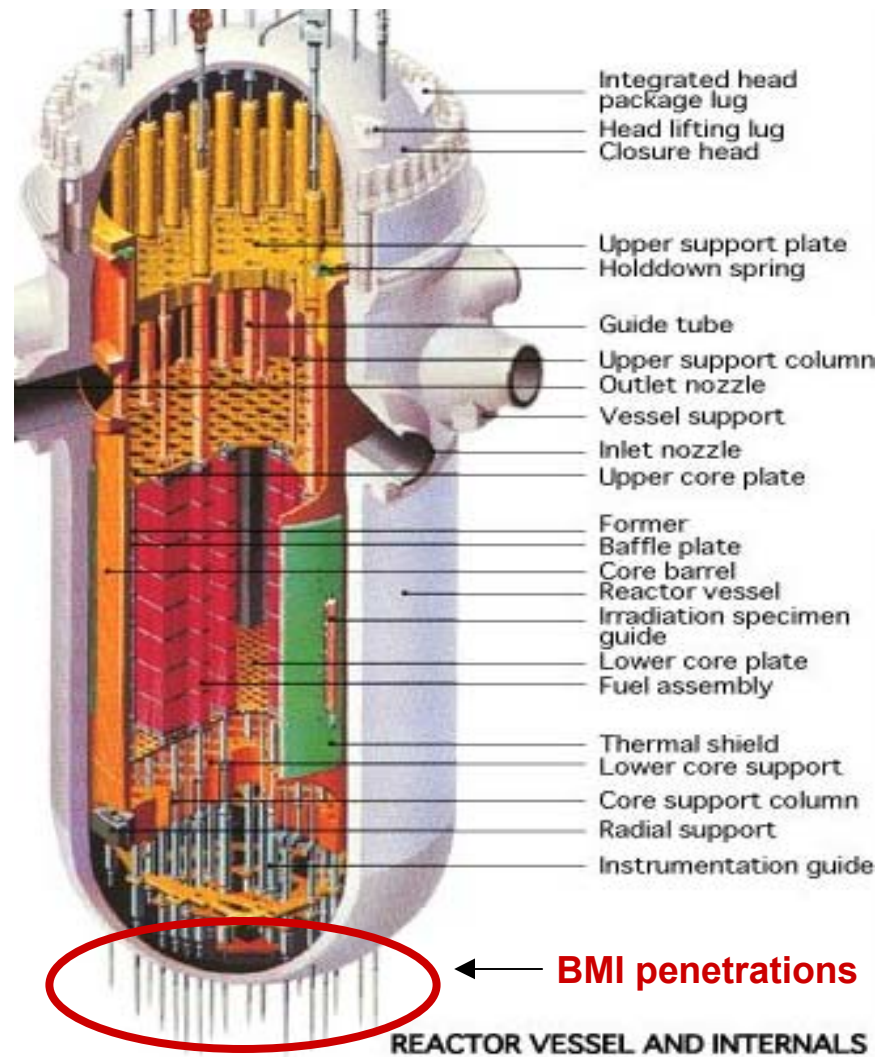
A small amount of residue had accumulated approximately 90 degrees around the guide tubes at vessel Penetrations #1 and #46.

The quantity of residue found on Penetration #1 is equivalent to about half of an aspirin (approximately 150 mg).

Penetration #46 had about 3 milligrams of residue.

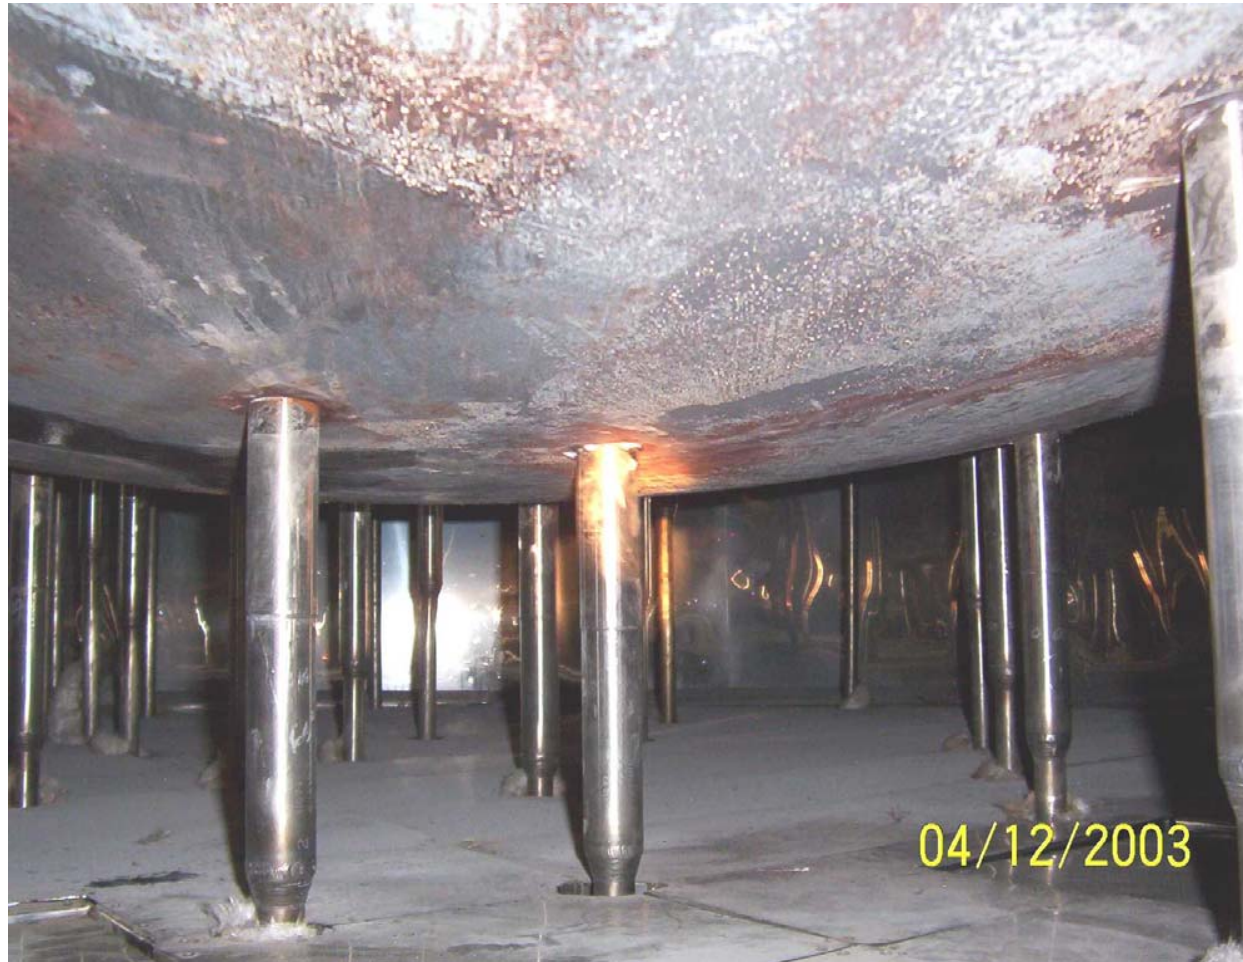
~ 12" Between Insulation and Head

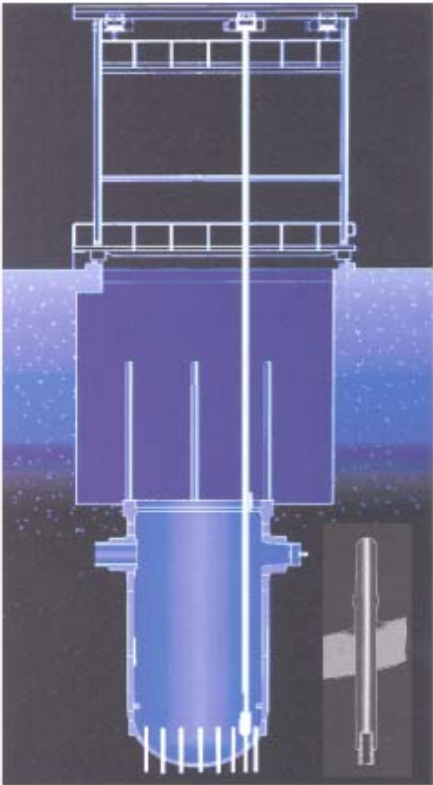
The scanning manipulator is positioned on the nozzle with a rigid pole system.
