NATIONAL TRANSPORTATION SAFETY BOARD

RAILROAD ACCIDENT REPORT

**COLLISION INVOLVING TWO NEW YORK CITY
SUBWAY TRAINS ON THE WILLIAMSBURG BRIDGE
IN BROOKLYN, NEW YORK
JUNE 5, 1995**

Abstract: This report explains the collisions of two New York City Transit subway trains on the Williamsburg Bridge in Brooklyn, New York on June 5, 1995. One person was killed and 69 people were treated at area hospitals for minor injuries sustained in this accident. The total estimated damage exceeded \$2.3 million.

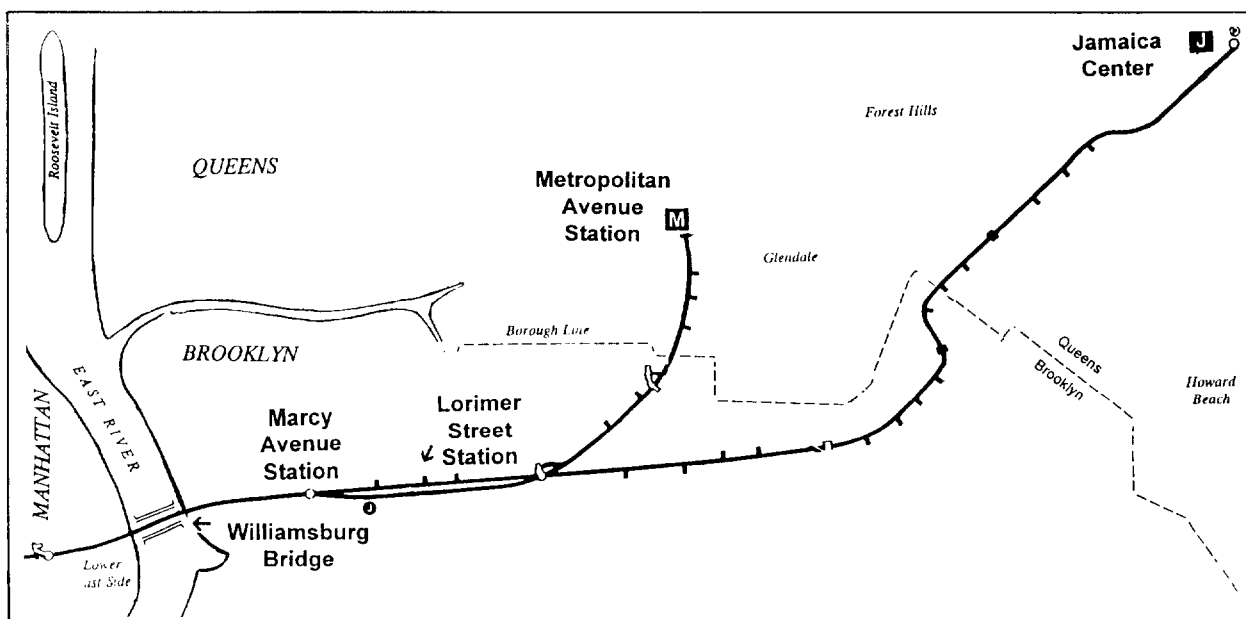
Figure 1 — Routes of the J train and the M train.

The operator and the conductor of the New York City Transit (NYCT) southbound 531 J subway train¹ went on duty at 11:38 p.m.² on June 4, 1995. They were scheduled to make three round trips from the Jamaica Center station to Broad Street station in Manhattan (see figure 1). The J train conductor testified that the first two trips were made in the "proper manner," and that "nothing [was] out of the ordinary." He stated that they departed Jamaica Center station for the third trip on time at 5:31 a.m., that the train operator seemed to be operating the train in the usual manner and at the proper speeds, and that all the station stops were routine. He said that as they pulled out of Kosciusko Street station, they had to stop and wait at the junction point to allow an M train to pass in front of them.
