# Uncontrolled Movement, Collision, and Passenger Fatality on the Angels Flight Railway in Los Angeles, California February 1, 2001

## Railroad Accident Report NTSB/RAR-03/03

**NTSB/RAR-03/03  
PB2003-916303  
Notation 7575  
Adopted August 5, 2003**

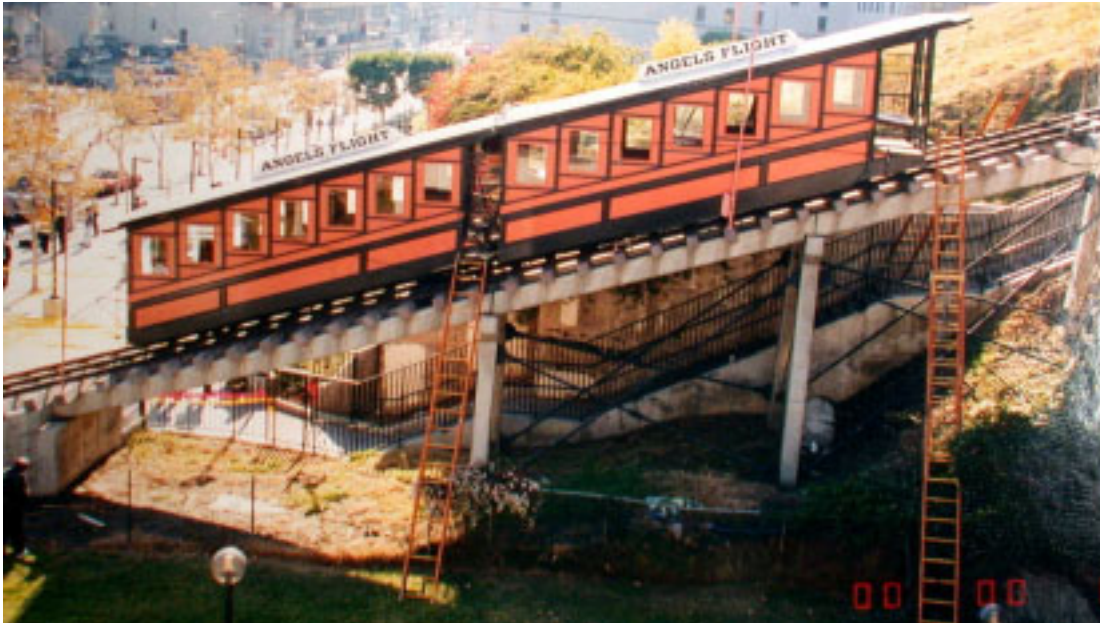
**Figure 4.** Ladders placed for the emergency evacuation. Walkway on the other side of the tracks can be seen below track level.

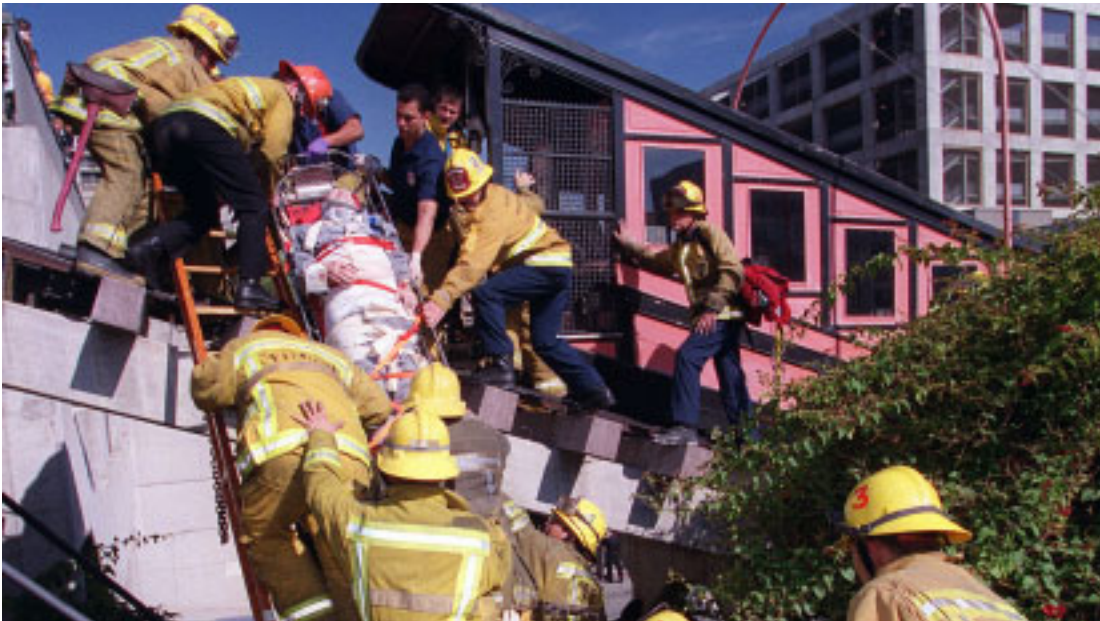
**Figure 5.** Passenger evacuation after collision.

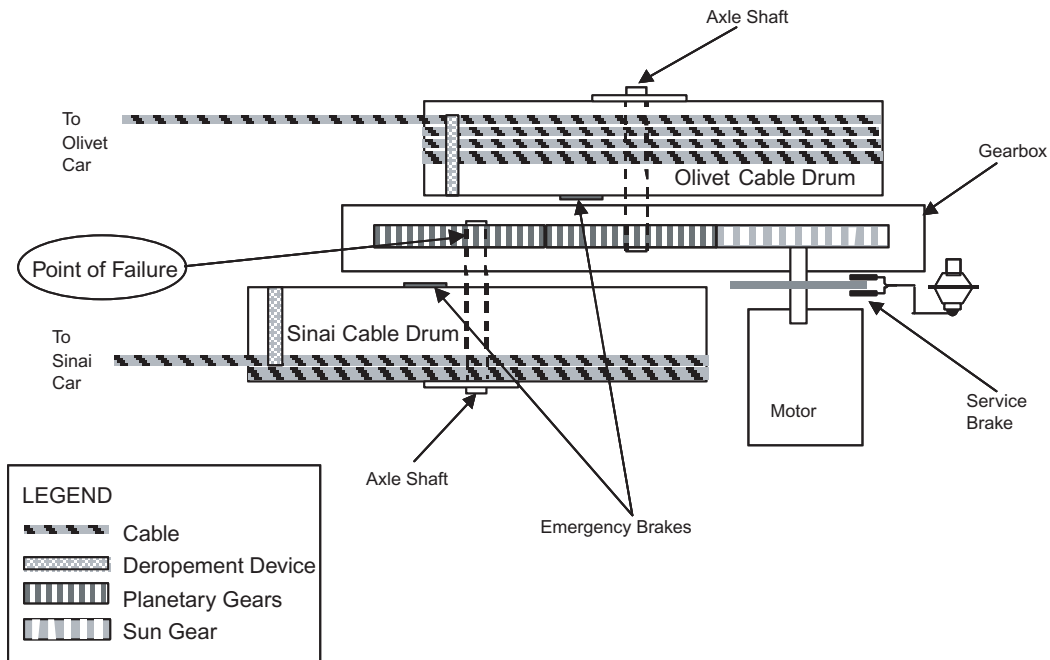
The system's operating machinery was in the machinery room underneath the operator's station house. The Angels Flight haul system consisted of a separate cable, drum, axle, and planetary gear for each car, with a sun gear driven by a single 100-horsepower electric motor. (See figure 8.) The driven sun gear meshed with the planetary gear for the *Olivet* car (the struck car in this accident), which in turn meshed with the planetary gear for the *Sinai* car (the striking car). Axle shafts (about 3 inches in diameter) connected the planetary gears with their respective cable drums. This gear arrangement meant that the two planetary gears, and thus the two cable drums, were counter-rotational, resulting in counterbalancing loads as one car descended while the other ascended.

**Figure 8.** Schematic of Angels Flight haul system.
