## AIRCRAFT ACCIDENT REPORT

UNCONTAINED ENGINE FAILURE/FIRE  
VALUJET AIRLINES FLIGHT 597  
DOUGLAS DC-9-32, N908VJ  
ATLANTA, GEORGIA  
JUNE 8, 1995

**Adopted: July 30, 1996**

**Notation 6579A**

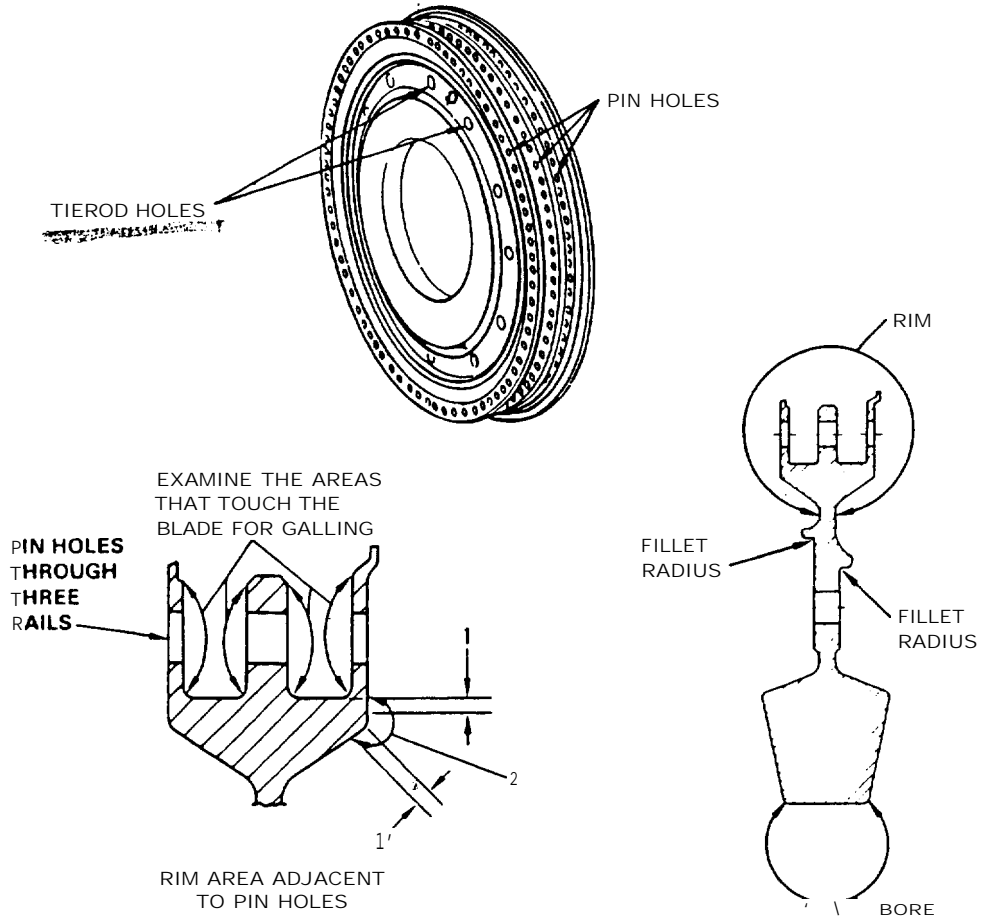
**Pratt & Whitney**  
**JT8D ENGINE (PN 481672 - RESTRUCTURED)**  
**COMPRESSOR DISK, STAGE 7 - INSPECTION-01**

The P&W engine manual specifies that for area 7 of the P&W figure 802 (see appendix D), which is depicted as a tierod hole, no unrepaired damage can be allowed in any hole, or within 0.125 inch of the edge of the hole on adjacent surfaces, and that damage can be repaired to a depth of 0.005 inch by blending. The instructions further indicate that damage up to 0.003 inch is acceptable in the web area of the disk without blending. The cross-section of the 7<sup>th</sup> stage disk in P&W figure 802 depicts the tierod holes, but does not have the hidden lines,<sup>29</sup> which would depict the smaller diameter SR holes behind the tierod holes, or a separate cross-section of the disk, just through the SR holes.
