**Capsizing of New York State-Certificated Vessel
Ethan Allen, Lake George, New York
October 2, 2005**

Marine Accident Report

NTSB/MAR-06/03

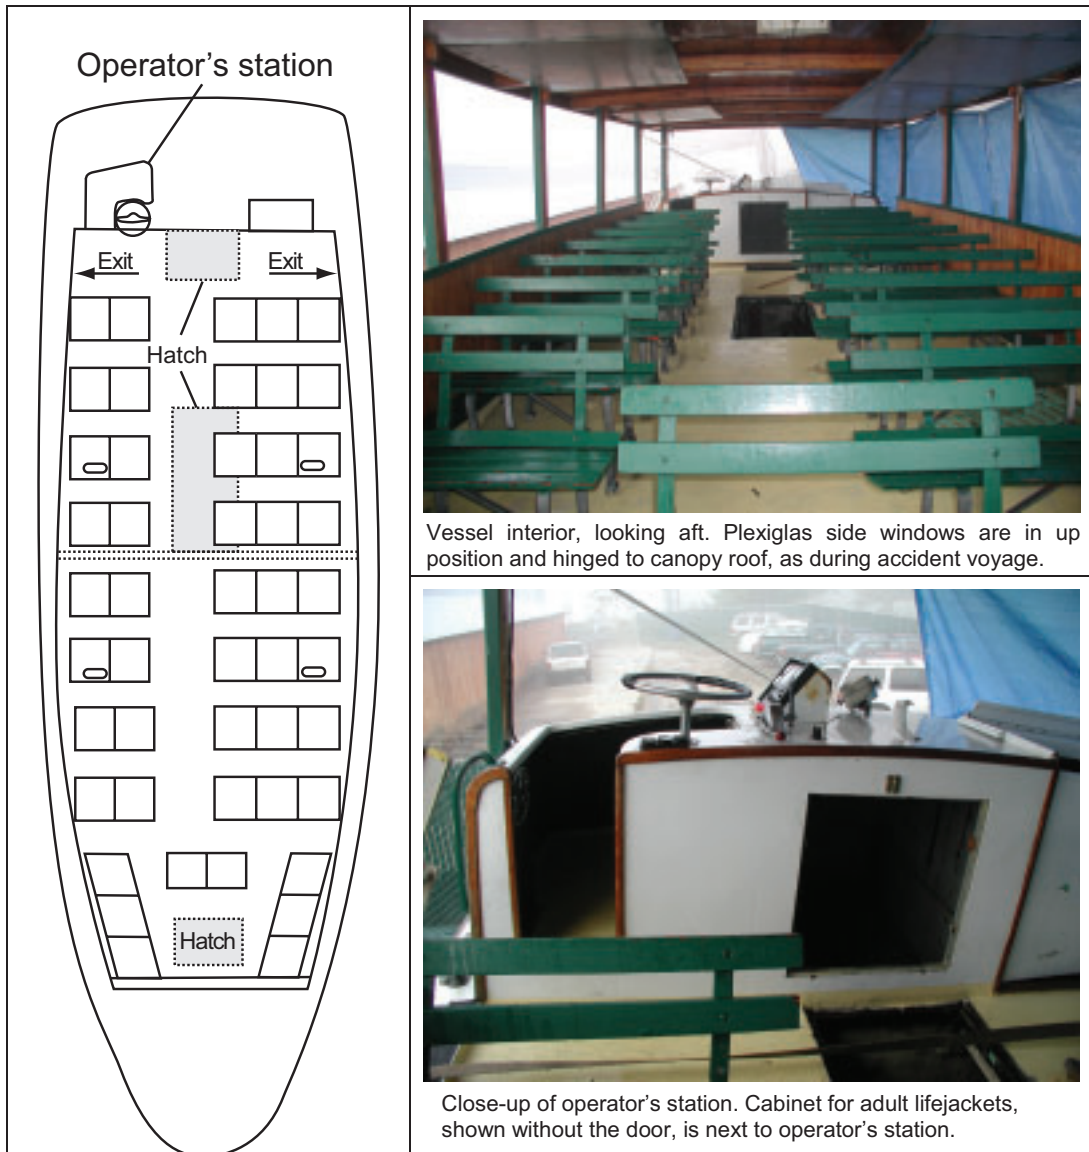
For the voyage, the vessel’s windows, which opened inward, were in the up position and hooked to the underside of the wooden canopy (figure 2). The passengers described the conditions for the lake tour as “beautiful” and “perfect.” The lake waters were “calm.” The operator indicated that vessel traffic was normal for a Sunday afternoon. Several members of the tour group had either recreational or commercial boating experience, and most of them indicated that the master operated the boat “properly.” They said that whenever a passing vessel caused a wake,⁵ the operator of the *Ethan Allen* would turn their boat so that the bow headed into the waves.

Figure 2. Three views of *Ethan Allen* interior. The vessel had 19 slatted-wood, park-style benches whose metal legs were bolted to the deck. Eight benches designed to accommodate three people faced forward along the port side of the vessel and eight benches that accommodated two people faced forward along the starboard side. Three three-person benches were in the forward portion of the vessel. One bench was positioned so that its back was against the port bulkhead and one bench was against the starboard bulkhead. The nineteenth bench, positioned center forward, had a box beneath it that stored 10 child-size lifejackets.

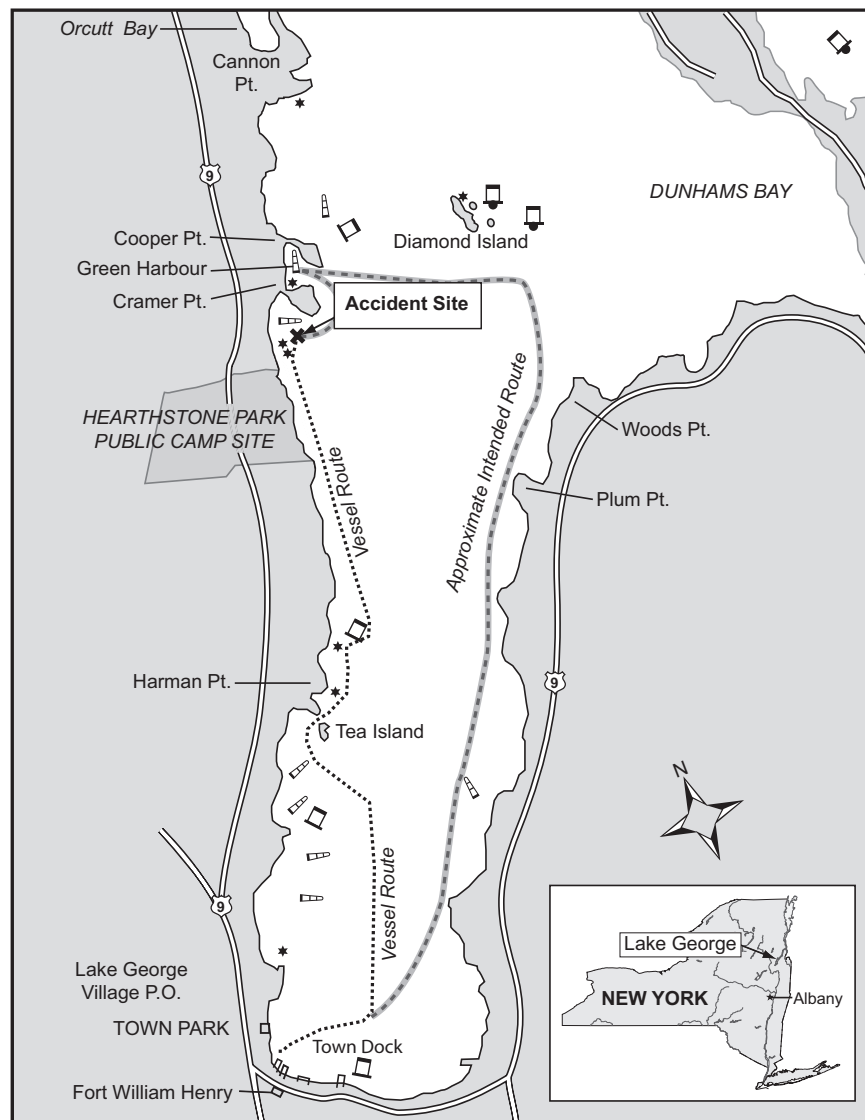
According to witnesses, the *Ethan Allen* operated without incident until it reached a cove near Cramer Point (figure 3). As the vessel neared Cramer Point, some passengers observed a vessel traversing the lake to the right of the *Ethan Allen*, creating a wave or waves that moved toward it. Witnesses varied in their identification of the particular vessel

Figure 3. The 1-hour tour of the *Ethan Allen* on Lake George began at Lake George Village and went north to Green Harbour, a distance of about 3 miles. The tour was to continue north along the west shore and enter Green Harbour before crossing the lake and heading back along the east shore. The accident occurred off Cramer Point, a point of land directly below Green Harbour.
