**Pipeline Rupture and Subsequent Fire  
in Bellingham, Washington  
June 10, 1999**

# **Pipeline Accident Report**

**NTSB/PAR-02/02  
PB2002-916502  
Notation 7264A  
Adopted October 8, 2002**

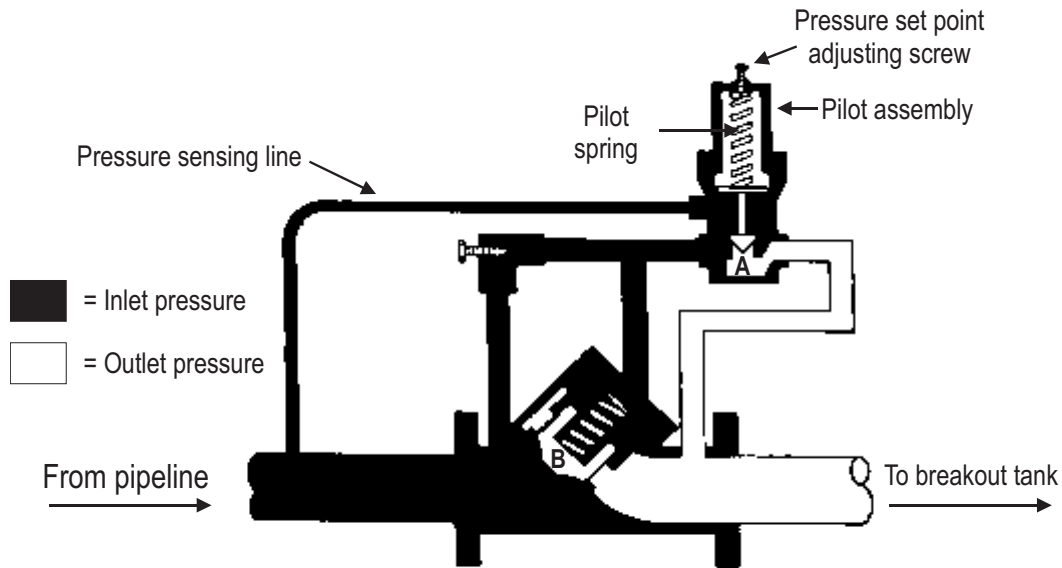
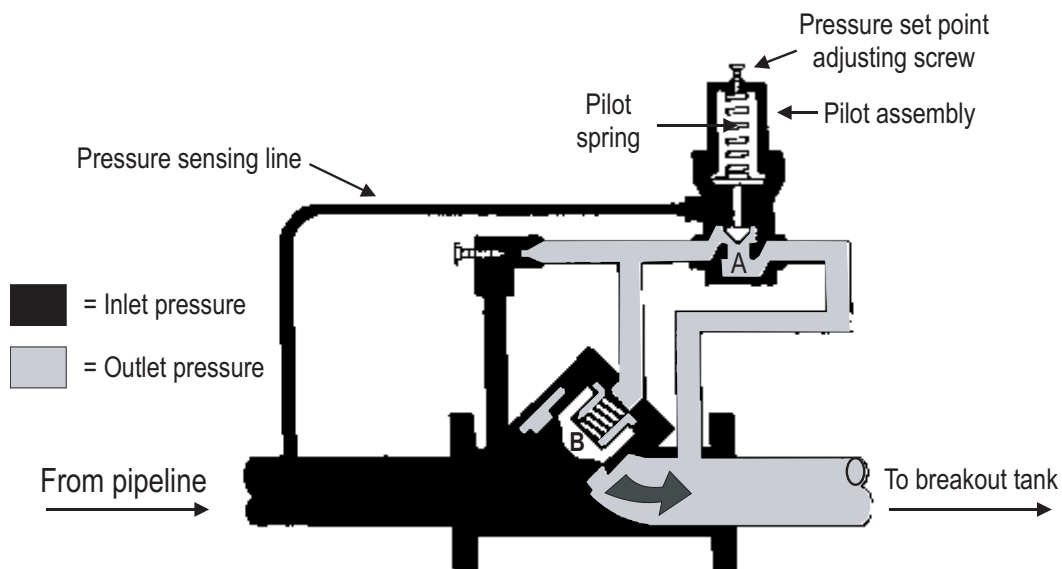
Figure 8. Relief valve schematic.

(Above) Relief valve is fully closed. Because inlet pressure is below the pressure set point, pilot piston (A) is seated, and pressure on both sides of relief valve piston (B) is balanced. The main valve spring keeps the relief valve closed.

(Below) Relief valve is fully open. Inlet pressure is greater than pressure set point, compressing pilot spring and lifting pilot piston (A) from seat. Liquid flow through pilot reduces pressure on back side of relief valve piston (B). Inlet pressure compresses relief valve spring and lifts piston from seat, allowing flow to breakout tank. When pressure drops below the pressure set point, pilot piston will reseal. Inlet pressure and spring force will close relief valve and cut off flow.
