# Rupture of Enbridge Pipeline and Release of Crude Oil near Cohasset, Minnesota July 4, 2002

## Pipeline Accident Report NTSB/PAR-04/01

## **Rupture of Enbridge Pipeline and Release of Crude Oil near Cohasset, Minnesota July 4, 2002**

**NTSB/PAR-04/01  
PB2004-916501  
Notation 7514A  
Adopted June 23, 2004**

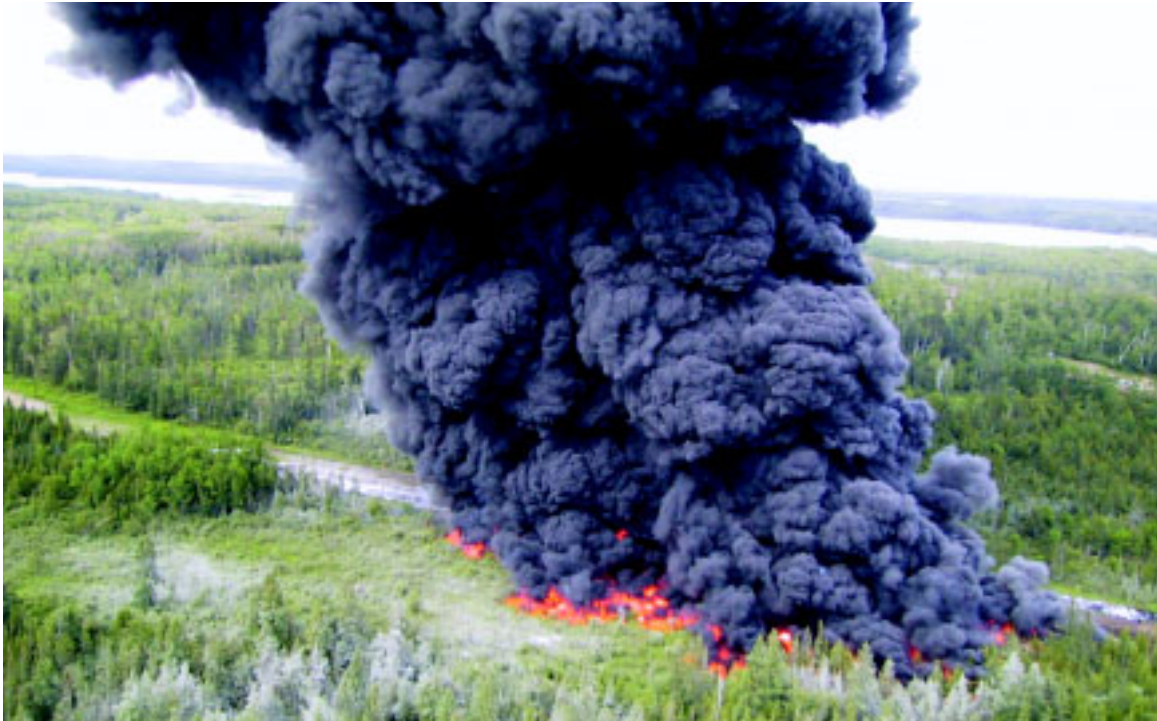
The controlled burn was ignited about 4:45 p.m. (See figure 3.) The burn created a smoke plume about 1 mile high and 5 miles long. (See figure 4.) The controlled burn lasted until about 5:00 p.m. the next day, July 5. While they monitored the fire, Enbridge personnel, firefighters, and environment authorities also monitored the spill perimeter to ensure that no crude was getting into area waterways. Reportedly, no free-flowing product reached any of the boomed areas.

**Figure 3.** Controlled burn surrounded by white fire retardant.

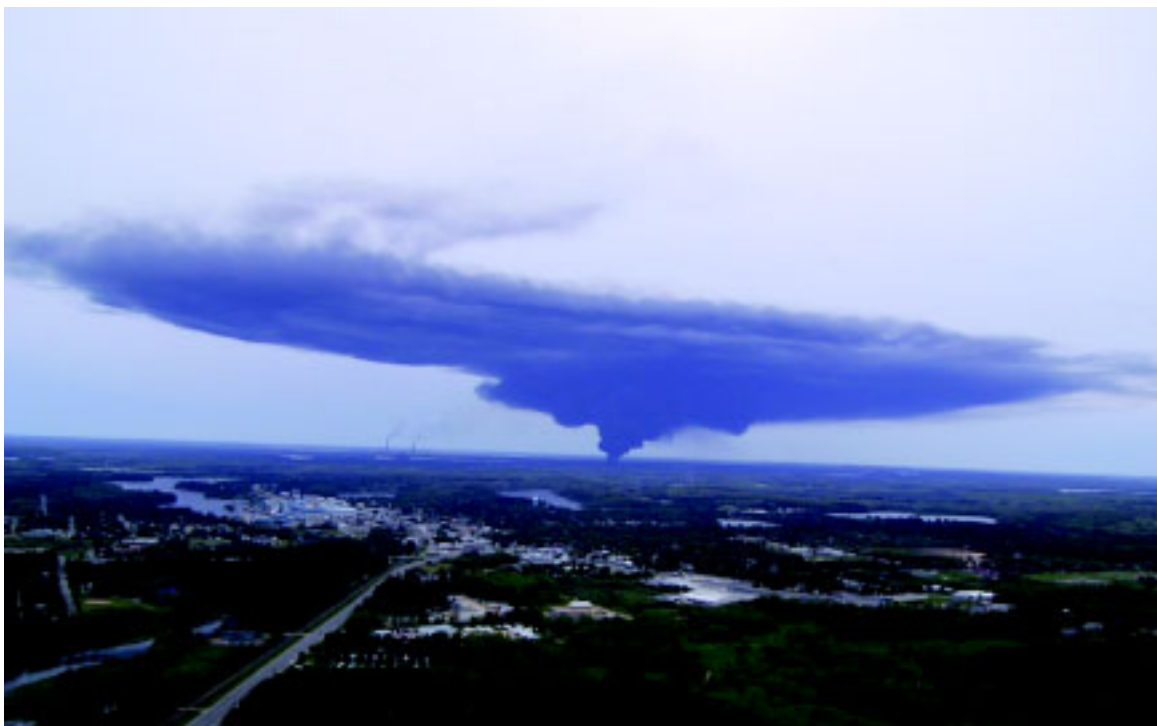
**Figure 4.** Smoke plume 1 mile high and 5 miles long.
