Evaluation of New Home Energy Efficiency

An assessment of the 1996 Fort Collins residential energy code and benchmark study of design, construction and performance for homes built between 1994 and 1999.

Summary Report

June 2002

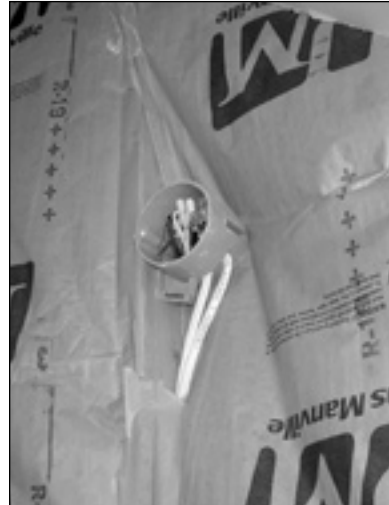
The code requires that insulation be cut to fit, without compression, around electrical and other obstructions in the insulated bay. In this case, insulation was compressed behind the box rather than cut to fit around it.

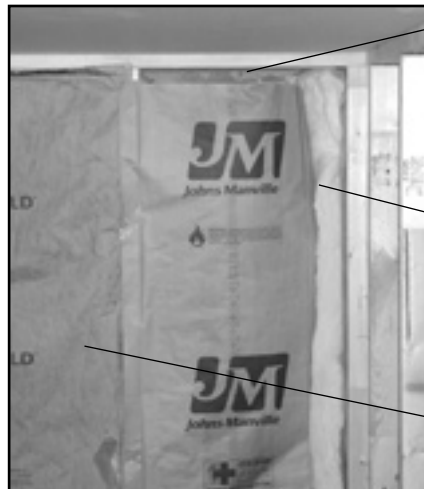
One-inch void at top of wall cavity

Batt folded rather than cut to width in non-standard-width cavity. This compressed the batt and caused air gaps

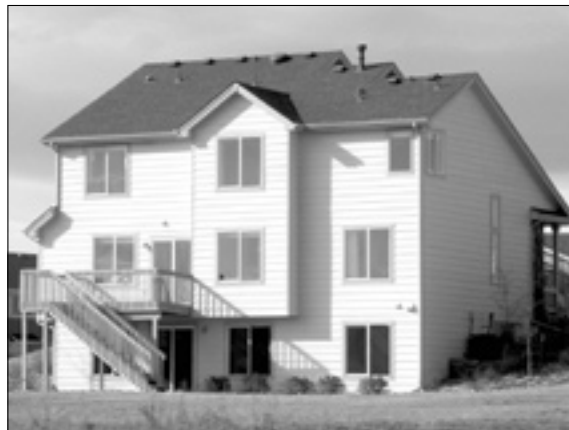
Some study homes had a lot of south-facing glass area, offering the potential for great passive solar performance. However none were designed to take advantage of the solar heat during the winter (by storing the heat) or to avoid the sun during the summer (with exterior shading). During the winter, these homes tended to have large temperature variations from one part of the house to another.

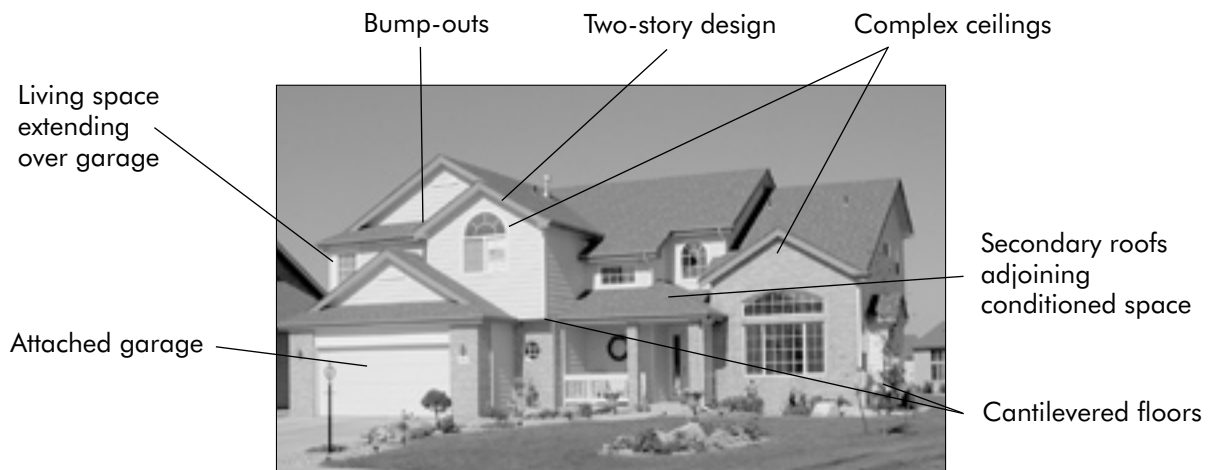
This house provides examples of many common architectural features that were associated with problems in the study homes.

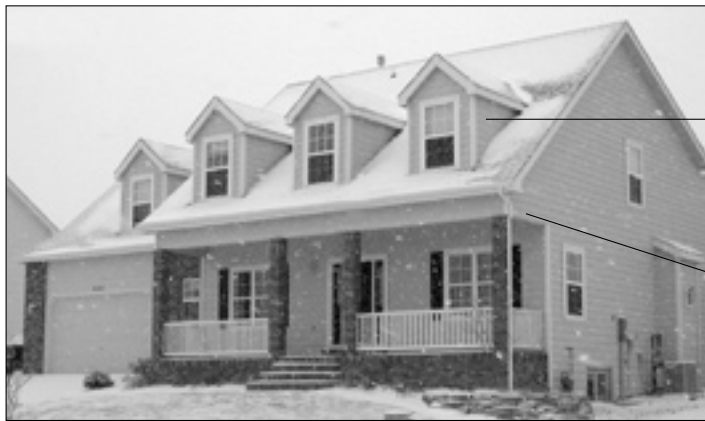
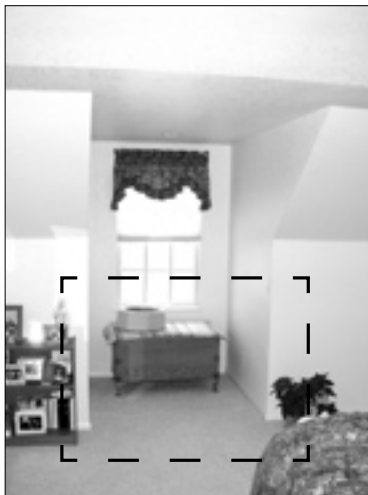
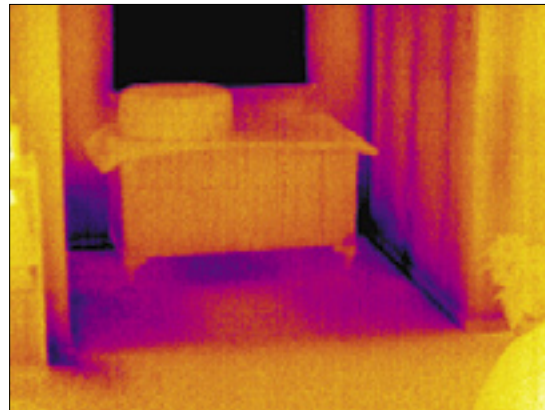
Dormer

Upper level floor
cantilevered over
front porch

The upper level dormers and cantilever floor in the house shown above posed air sealing and insulation challenges. From the interior (conventional photo lower left, infrared photo lower right), thermal flaws showed up as cold spots (dark). These can cause discomfort and provide opportunities for moisture condensation, mildew and mold growth. The owners of this house complained that the dormers were so cold that they could not use these areas during the winter.

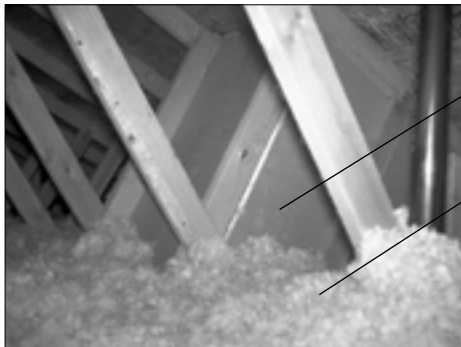
Uninsulated components, such as this skylight well, were occasionally observed.

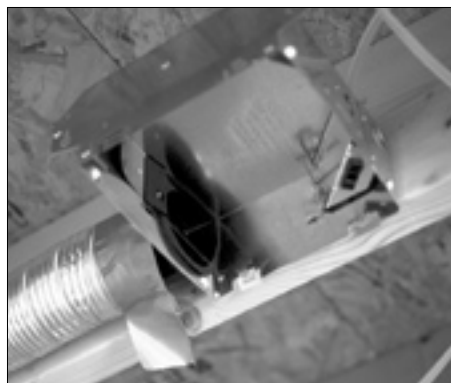
About one-quarter of study home furnaces operated near or outside of manufacturers' limits for pressure and heat rise.

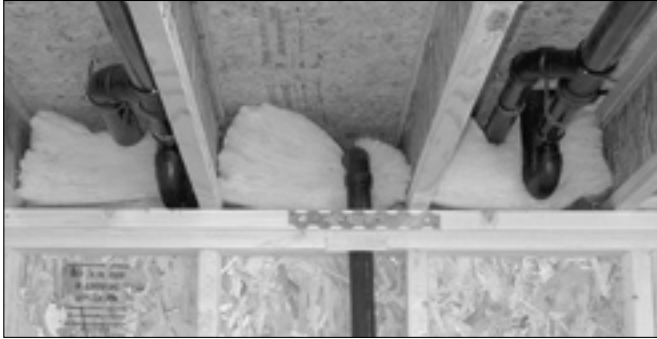
Compression of the insulation batts, voids, and the lack of contact with the subfloor above this cantilever all reduce the effective R-value of this insulation.

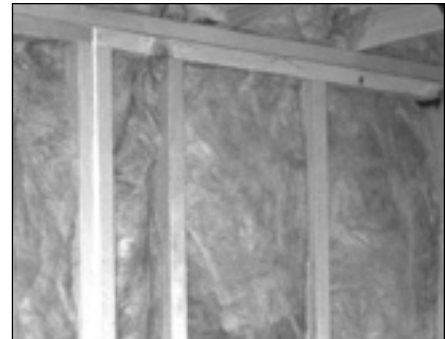
Typically-installed, unfaced fiberglass batts in a frame wall will offer reasonable performance. Note some compression of the batts in the full-width stud bays and more severe problems where a batt had to be cut to fit in a narrow cavity.

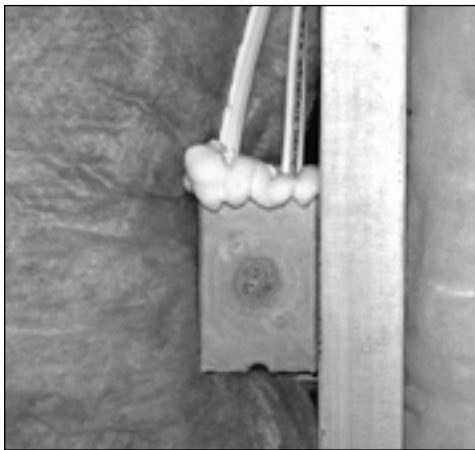
Fiberglass batts were often improperly fit around obstructions like this electrical box, creating cold spots. (This is the back of the box; code requires a minimum of R-5 insulation behind such obstructions.)

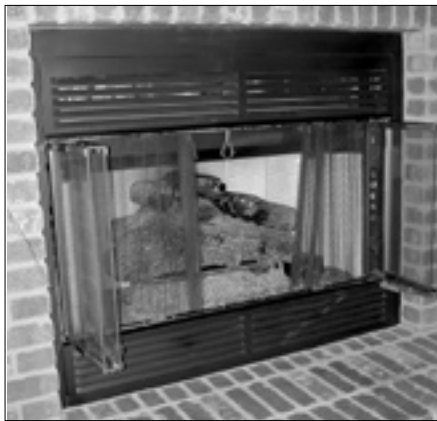
The flue, draft hood and outdoor air supply all contributed to leakage through atmospherically vented fireplaces.

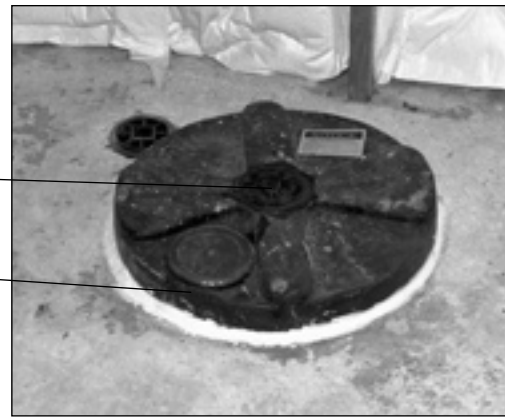
When air is drawn through an unsealed sump cover, it might bring with it radon, other soil gases or moisture.

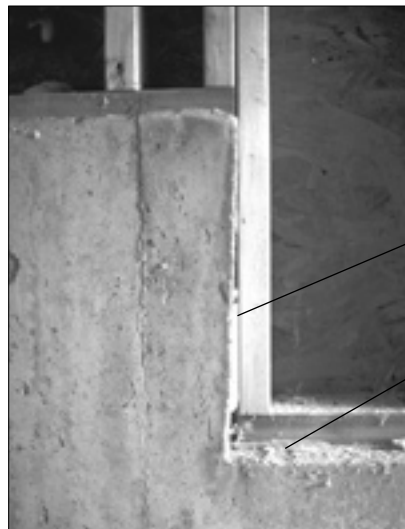
Horizontal joints between the foundation and mudsill were usually effectively sealed, but the vertical sections on a stepped foundation rarely were. In an unfinished basement, such a joint leaks directly to the outdoors.

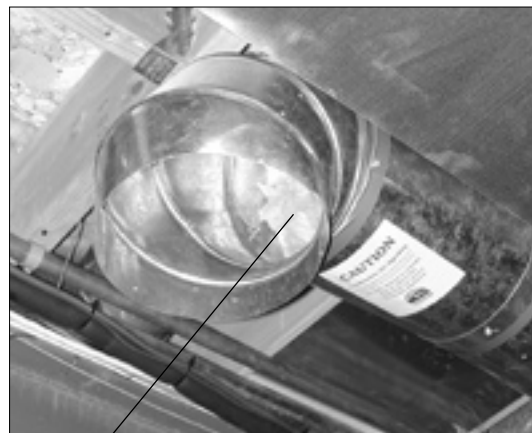
Code-required combustion air ducts, such as the one shown above, are direct openings to outside. An infrared photo of the same area (above right) demonstrates a typical winter problem: cold air is continually drawn in to replace air lost through other cracks and holes high in the house. This phenomenon contributed to cold basements and crawl spaces. In response, it was not unusual to see combustion air ducts plugged by homeowners—despite prominent labels warning against tampering with these safety devices.

Plug inserted by homeowner to stop cold draft

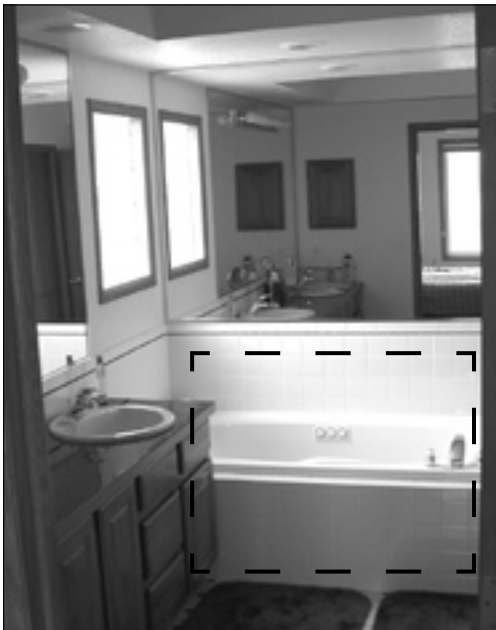
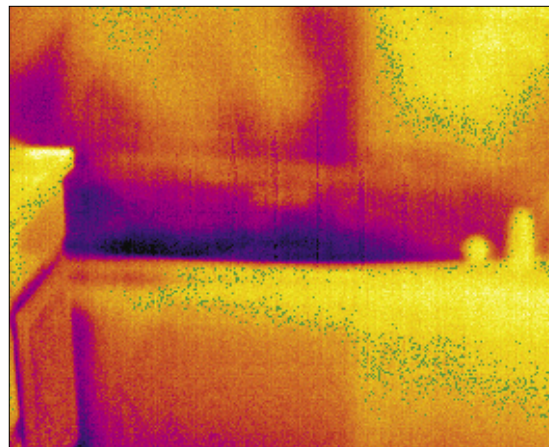
The infrared photo above shows the symptom of a missing air barrier: a cold tub. This bathtub sat against two exterior walls and over a garage. Cold outdoor air moved through or around the insulation to cool the tub. (Infrared photo taken with blower door operating.)

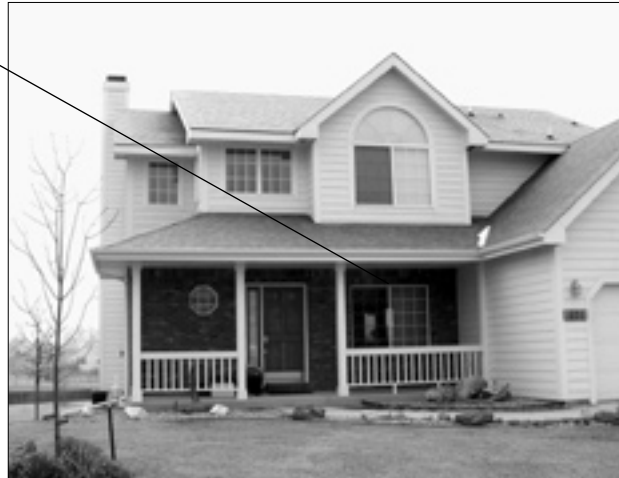
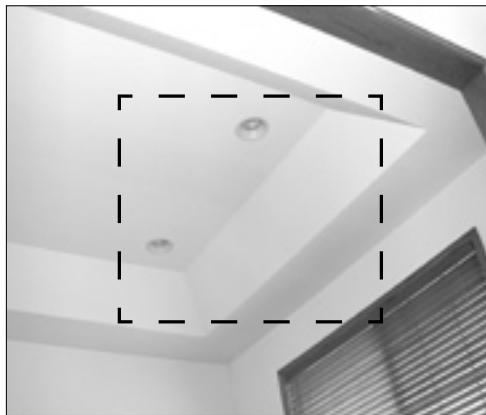
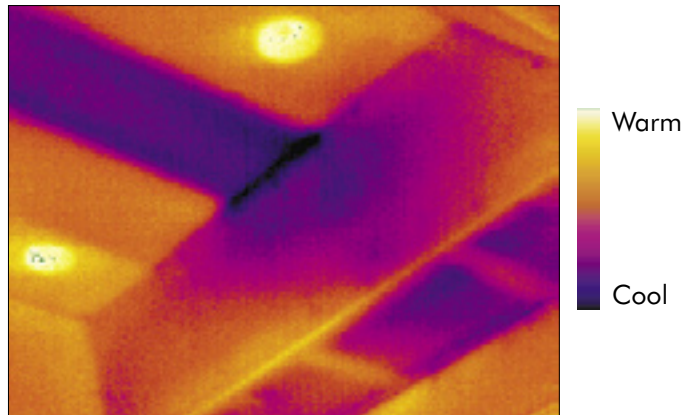
In the house shown at right, a portion of the air barrier that should isolate interior space from the porch roof was missing. As seen from the interior (conventional photo lower left, infrared photo lower right), cold air could enter the house through the joist cavity between main and upper levels. Cooling effects of this leak extended into interior partition walls at the core of the house. (Infrared photo taken with blower door operating.)

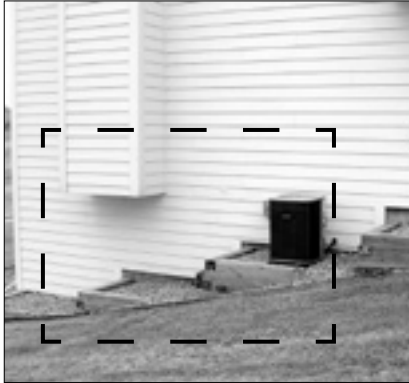
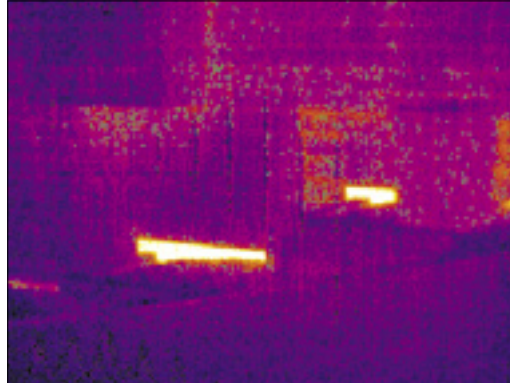
Uninsulated. Strips of concrete exposed above grade in this stepped foundation stood out as hot spots compared with the insulated frame wall and earth. Eight inches of concrete provide only about R-1 resistance to heat flow.

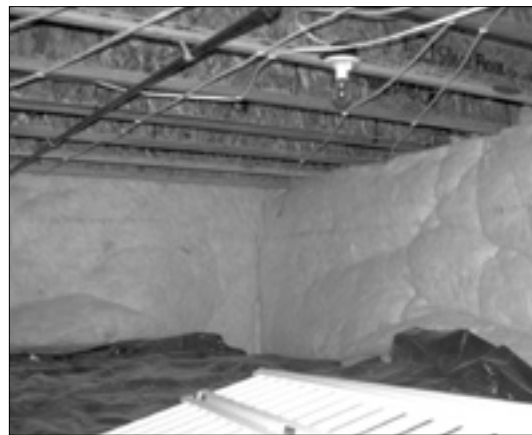
The batts hung away from the foundation by as much as 6 inches, allowing warm crawl space air to bypass the insulation.

Batts hung 18 to 24 inches short of the interior grade.

Although the code-required R-19 perimeter insulation was present in this crawl space, the rated R-value was compromised by installation flaws.

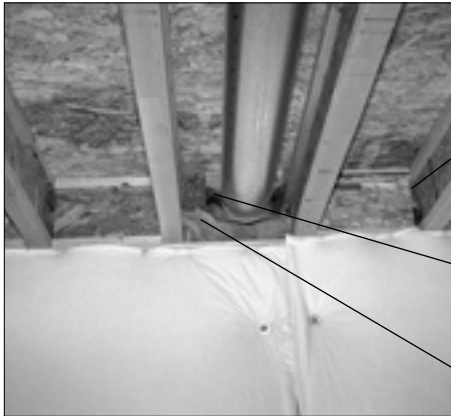
Rectangular blocking coupled with engineered "I-beam" joists left large gaps at the edges.

Blocking was removed where the heating duct penetrated the cantilever.

Insulation only filled part of the cavity.

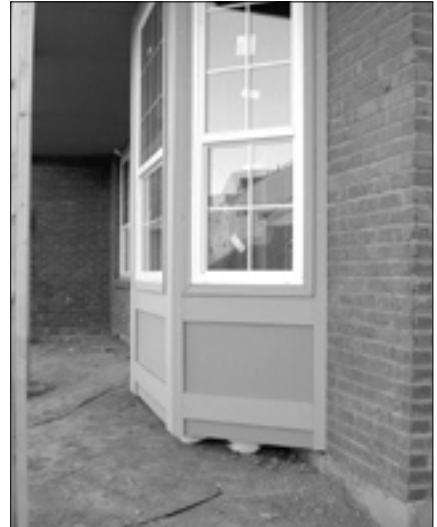
Interior view of some cantilever problems. It is not clear whether the air barrier was intended to be at the interior blocking or at the exterior soffit.

Main level cantilevers posed access challenges because they were so close to grade. There was no soffit on this one. The construction superintendent was aware of the problem and planned to dig a hole to be able to install it.

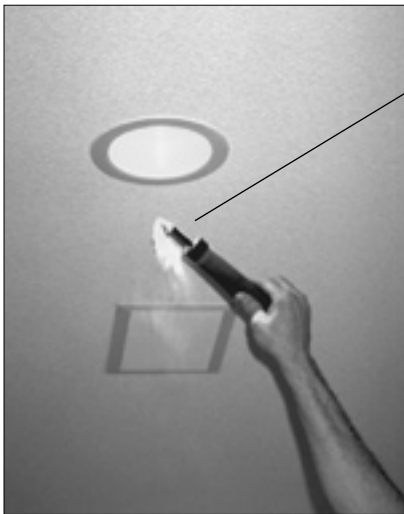
Smoke source made air movement visible.

Blower door tests often revealed large amounts of air leaking through recessed lighting located in floors with heated space above and below. This could be a symptom of leaks in the air barrier at an exterior cantilever; air moved through the floor joist cavities to exit at the light cans.

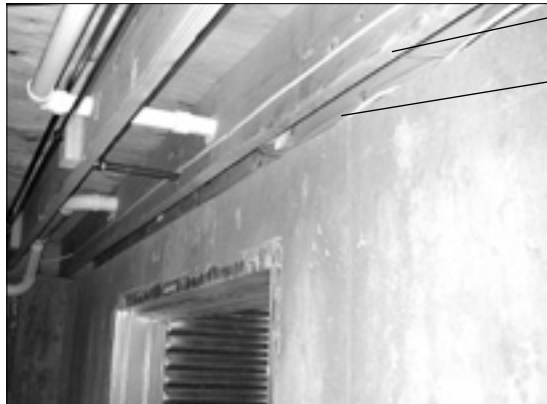
When the first floor joist was framed tight to the foundation, it left little space to insulate the rim joist. Plumbing and wiring complicated the job in this example.

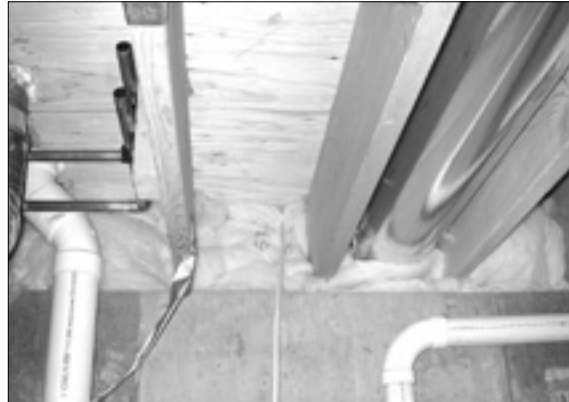
Many obstructions—such as the plumbing and ductwork shown here—made it harder to insulate rim joists effectively. Even where nothing was in the way, insulation was sometimes placed in cavities with insufficient attention to detail. Also note there was no vapor barrier to prevent moisture from reaching the rim joist.

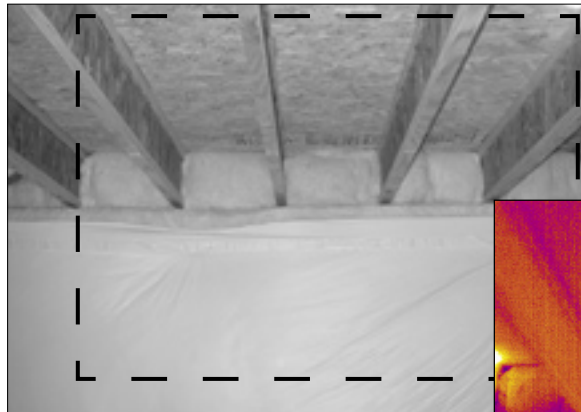
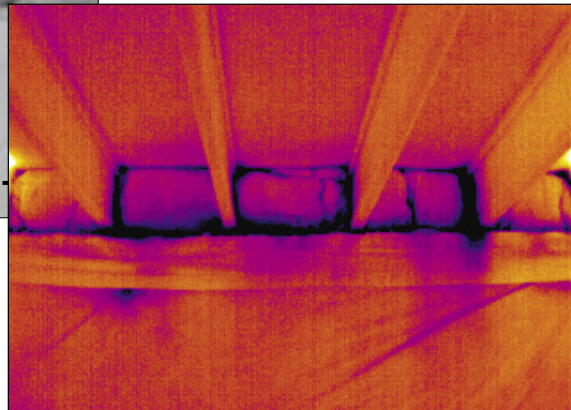
The infrared photo (right) shows the symptoms of compressed insulation and air leakage at the rim joist.

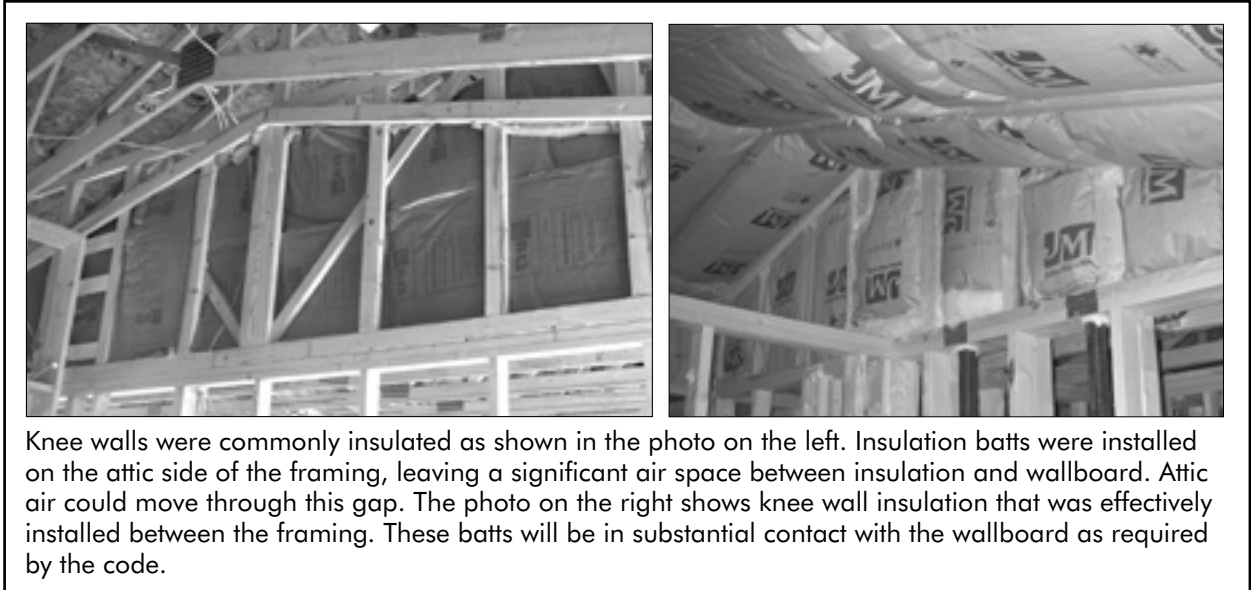
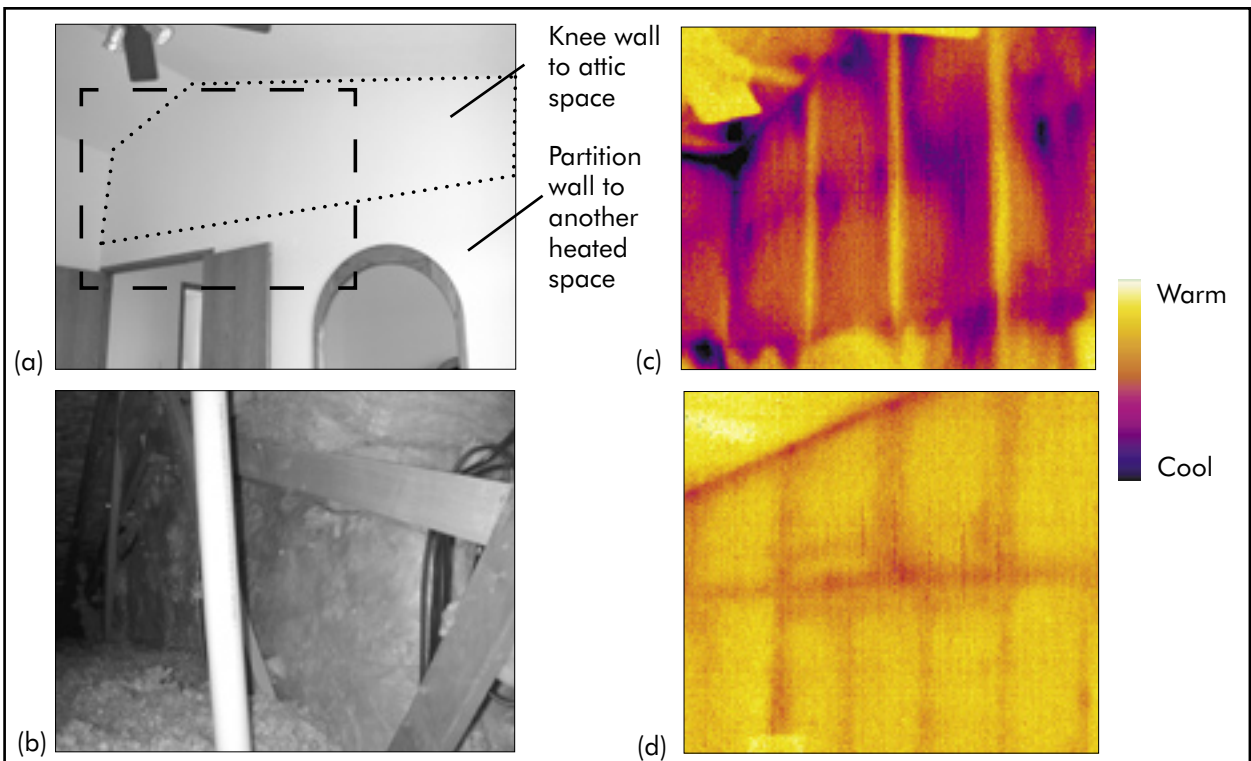
This group of photos illustrates kneewall practices and performance. Photos (a) and (b) show two views of the same kneewall. From the attic (b), the knee wall insulation appeared to be installed well. But there was a large air gap between the insulation batt and wallboard. There was also no sheathing on the attic side. There was nothing to prevent attic air from circulating and pulling heat from the gap between the insulation and wallboard. Infrared photo (c) shows an irregular temperature pattern reflecting the inconsistent thermal performance of the knee wall insulation. Note the framing was warmer than the cavities. For comparison, photo (d) shows an exterior wall in the same room. It displayed the more uniform temperature pattern of a well-insulated wall; framing was cooler than the insulated cavities.

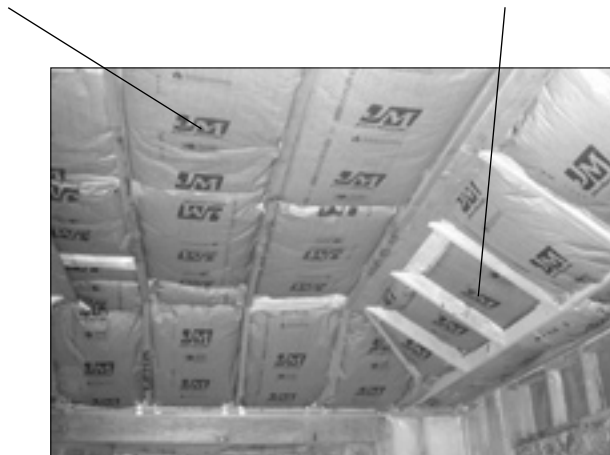
In some areas, the insulation was held back much further. This will leave gaps in which attic air can circulate between insulation and wallboard.

Vaulted and cathedral ceilings tended to have more insulation installation problems than flat ceilings.

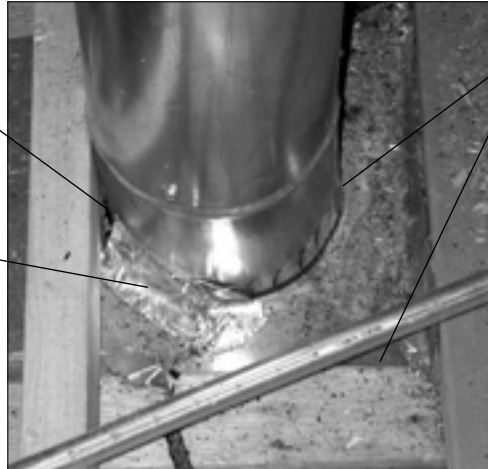
Significant gap where access to seal was difficult

Tape is a temporary seal that will probably fail in a few years.

These joints should have been fully sealed with long-lasting caulk.

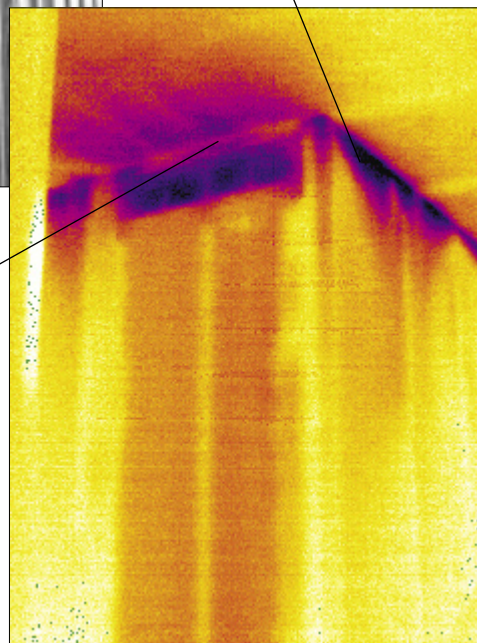
Air leaks through gaps between wallboard and framing. These gaps are skinny (1/16" to 1/8" typical) but extend many lineal feet.

Blocking above return grille and wall cavity return was very leaky

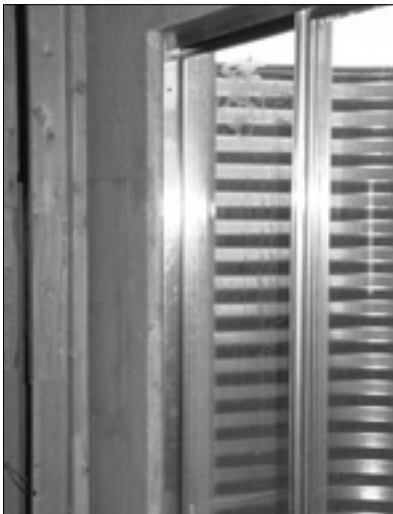
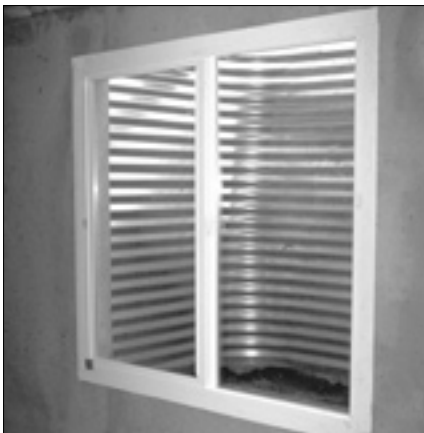
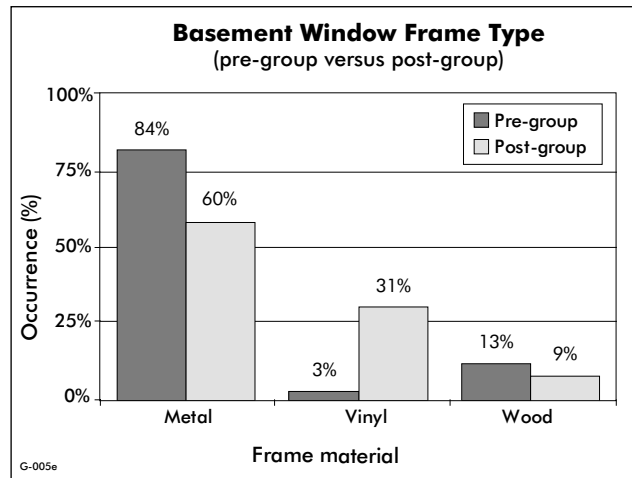
The majority of study home basement windows used metal frames. However, there was a significant increase in the use of vinyl-framed windows in post-group homes.

An aluminum frame with no thermal break, set into a steel buck poured in place with the concrete foundation (above left), offered the lowest up-front cost, yet delivered the poorest thermal performance. The use of a vinyl frame, also set into a steel buck (left), offered one step better performance.

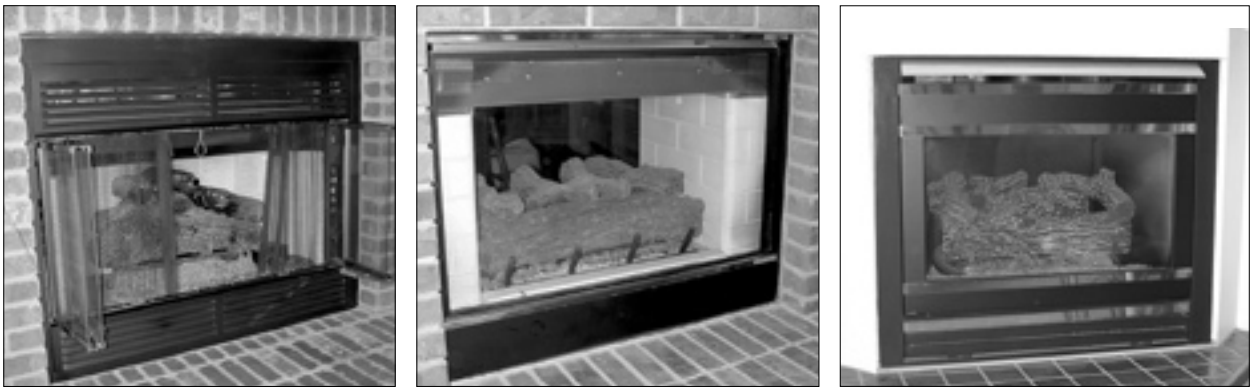
Three types of natural gas fireplaces were observed in study homes: atmospheric gas log sets with operable glass doors (left), atmospheric fireplaces with solid glass facades (center), and direct-vent units (right). The atmospheric units rely largely on house air for combustion and dilution air, whereas the direct-vent units draw all required air directly from outdoors.

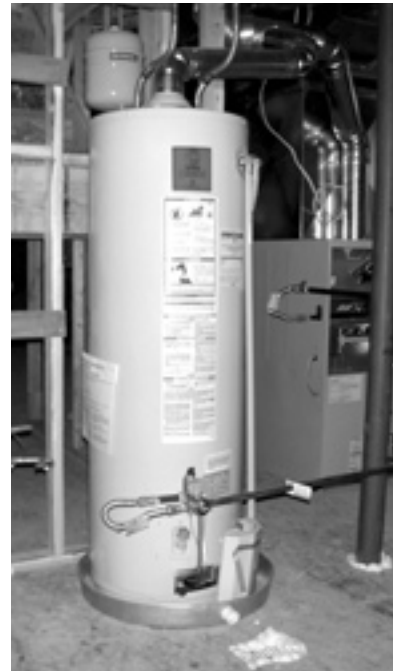
Atmospheric gas water heater

Gas-fired, atmospheric water heaters were the norm, raising concerns about combustion safety.

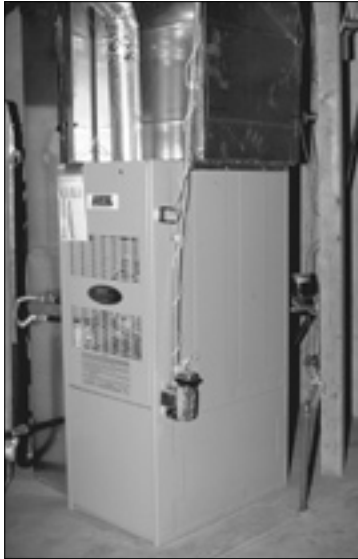
Induced-draft furnaces supplied space heating in almost all study homes.

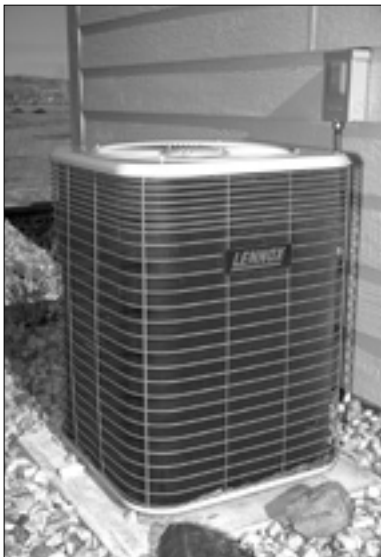
About half the study homes had central air conditioning. The compressor and condenser were located in an outdoor unit like this, with the expansion valve and evaporator coil located in the supply plenum at the furnace.

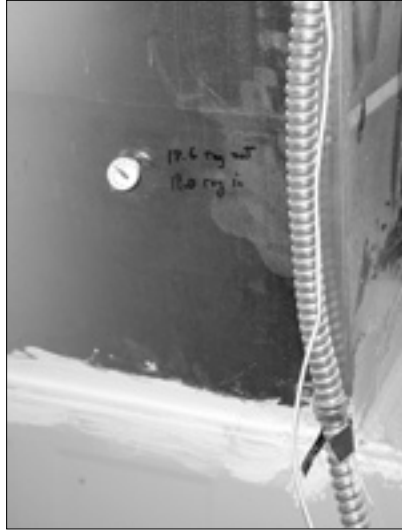
The only way to know whether a furnace is operating within the manufacturer-specified heat rise range is to measure heat rise. This test requires minimal tools and time. The testing contractor saw no evidence that heat rise had been measured on study home furnaces.

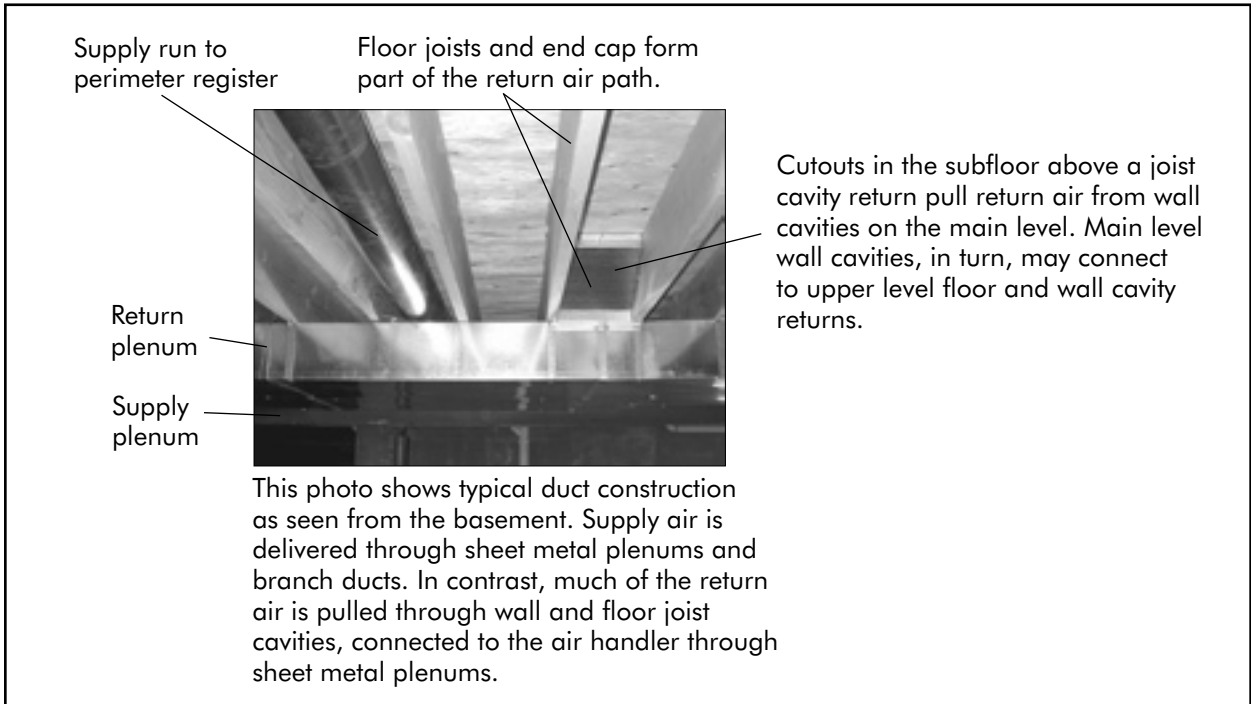
The photo below shows a basement view of duct system components in a typical study home. Residential duct systems were rarely fully specified on a set of plans; instead, the installer laid out and constructed the ductwork on site after the homes were framed. This often presented challenges to installers who had to establish paths for air flow between the air handler and every room in the house. Supply ducts were constructed of sheet metal components. Floor joist cavities and wall stud cavities often comprised a large portion of the return air ducts, coupling with sheet metal plenums near the air handler.

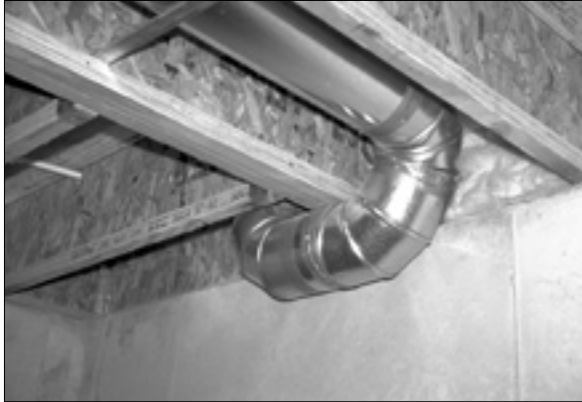
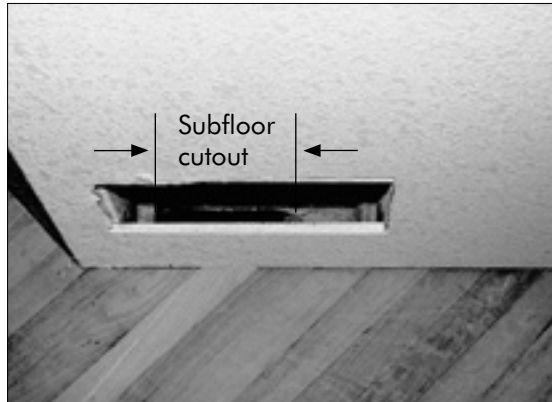
The photos illustrate construction practices that compromised duct system air flow performance. Significant flow constrictions were observed in some homes. As the duct leakage data indicates, duct leakage was an issue in every study home.

Air flow was sometimes reduced by constrictions or “choke points” at certain places in the ductwork. In the left photo, three elbows were needed to get a supply run past a structural member that could not be breached. Each elbow was equivalent to several feet of straight ductwork. The connection was made, but air flow was compromised due to large pressure drop. In the right photo, the cutout in the subfloor—that provides a path for return air back to the air handler—was much smaller than the register cutout on the wall.

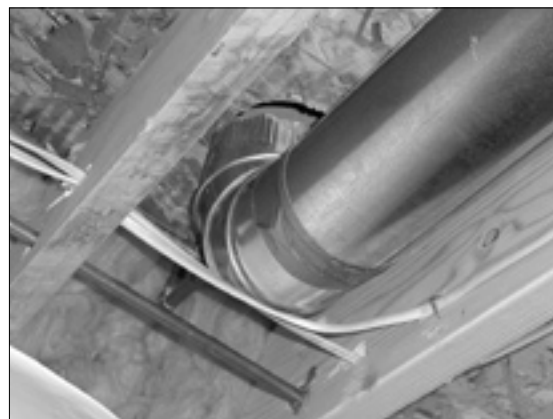
This supply duct was never connected to anything on the top end. Carpet was laid over the subfloor cutout, and the register was never installed.

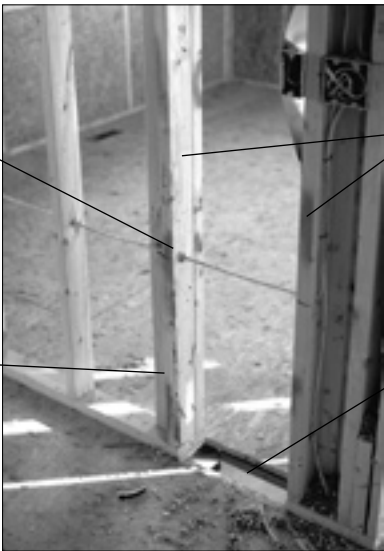
Wiring penetrations will be small leaks.

The cavity will leak everywhere there is a joint between wallboard and framing.

These wall studs formed two sides of a return duct. Wallboard will complete the other two sides.

Return air will be drawn through this cutout on its way back to the air handler.

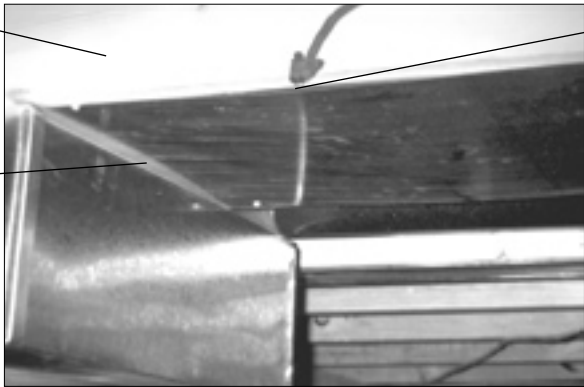
Return air was pulled through this joist cavity.

Leaky joints between sheet metal plenums and floor cavity returns

Panning did not seal to the framing.

Return leaks involved both sheet metal and building cavity portions of the ductwork.

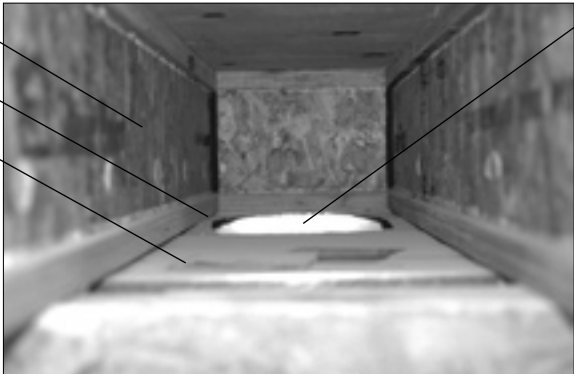
Large, unused cutout

Sometimes individual leaks were large. This sheet metal return plenum was cut open to pull air from the floor joist cavity. The return run was then moved to an adjoining cavity, but this 12" x 15" cutout was never sealed.

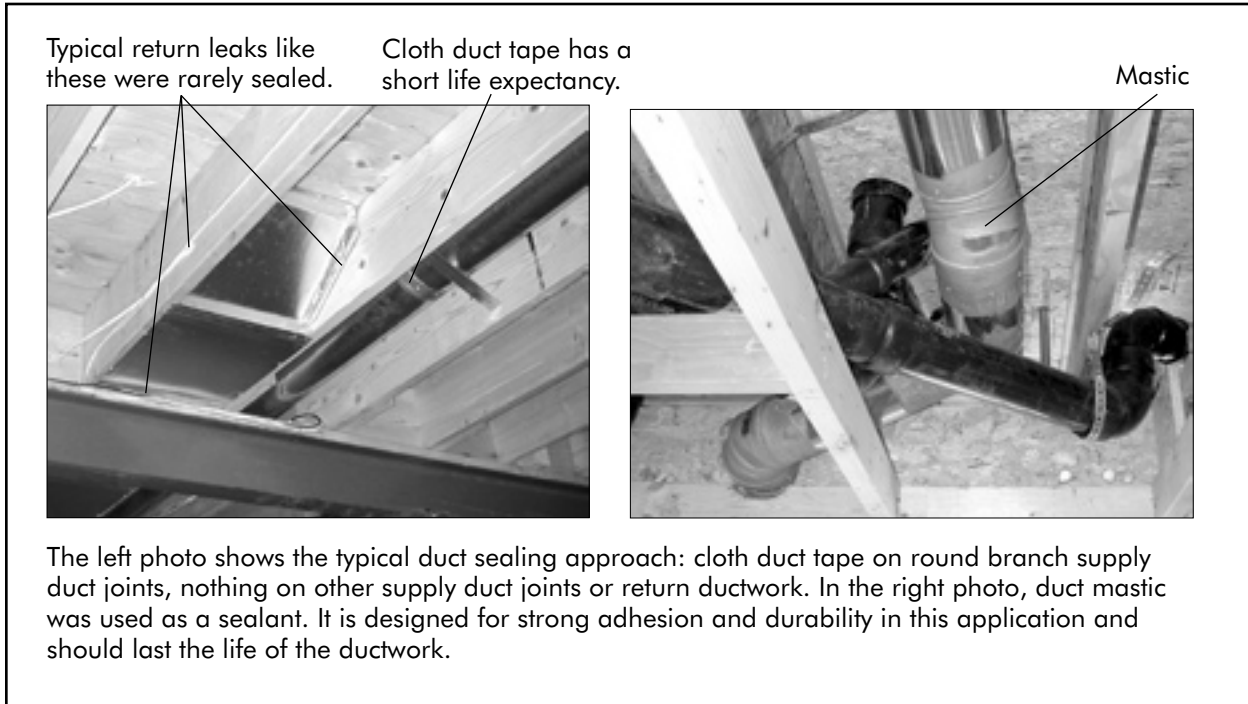
In almost all study homes, cloth duct tape was used to seal portions of the supply ductwork; in a small number of post-group homes, foil tape and/or duct mastic were used instead. In almost all homes, no sealing was observed in the rest of the system, either on the supply side or return side. The return portions of duct systems were inherently difficult to seal because of the extensive reliance on building cavities rather than dedicated sheet-metal ductwork.

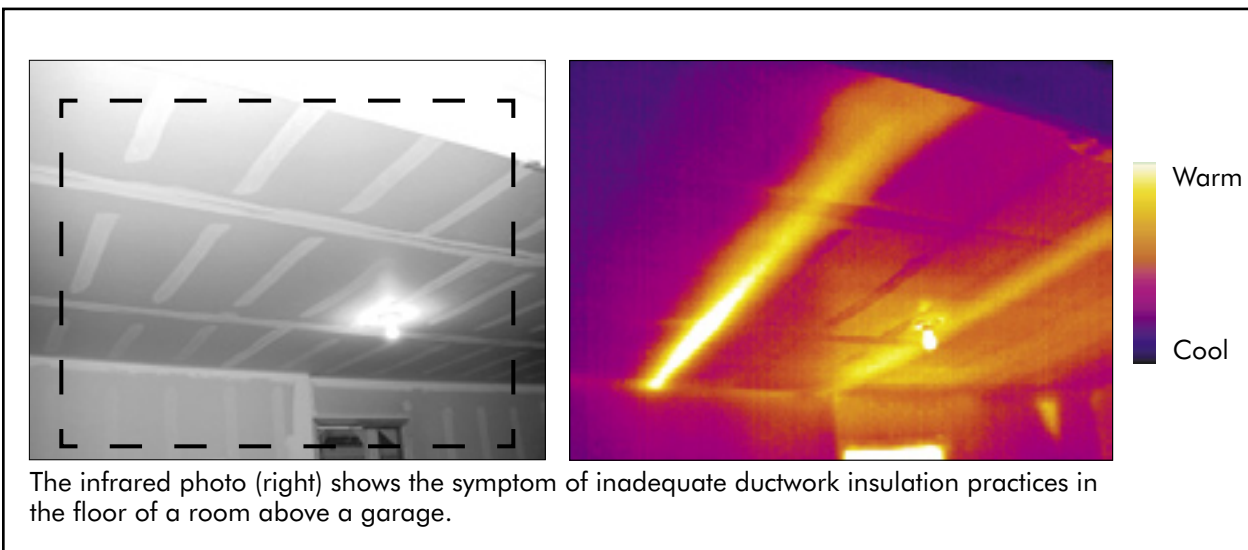
On average, return ducts were responsible for 60% more leakage than supply ducts—not surprising since much of the return system relies on building cavities. The excess of return duct leakage raised concerns about depressurized basements and combustion safety.

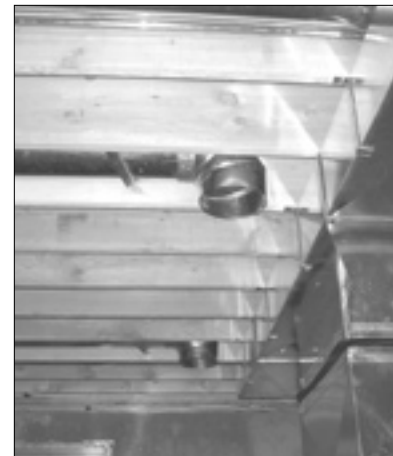
To help maintain a safe combustion environment, code requires large combustion air openings in the vicinity of atmospherically coupled combustion appliances. Testing showed that these ducts had very small beneficial effects on basement depressurization. In fact, when the wind blows in certain directions or when the exterior end terminates in an attic, ducts like these can drive the basement pressure more negative.

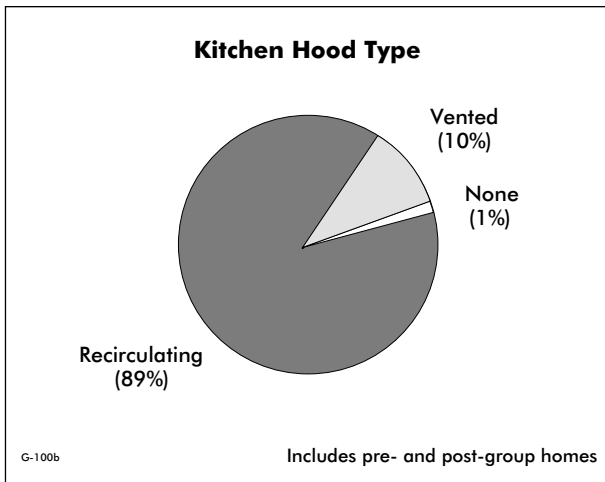
Few homes had vented hoods, even when gas ovens were present. A recirculating range hood coupled with an over-the-stove microwave oven was typical. This type of hood provided some degree of filtration but did not exhaust pollutants outdoors.

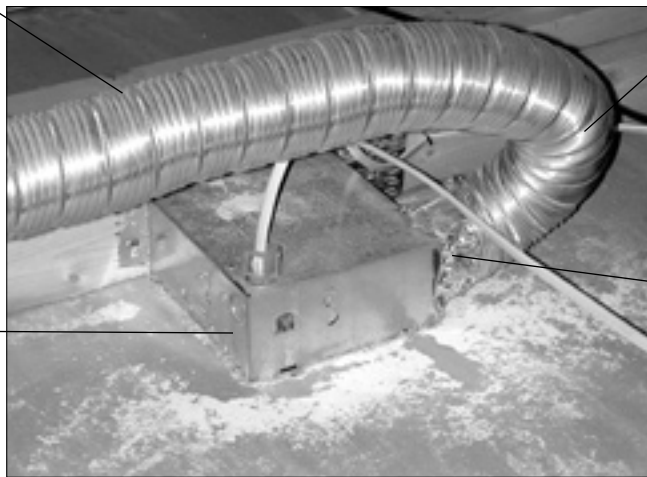
The fans were all low-cost units that garnered many noise complaints.

The tape that connected the duct to the fan housing had almost completely failed even before the attic was insulated.

One of the few indoor air quality components installed in all study home was bath fans, intended to remove moisture and odors. In the top photo, the grille on the ceiling gave no indication about how well the fan would do its job. The attic perspective in the bottom photo illustrates some of the installation details that compromised performance.

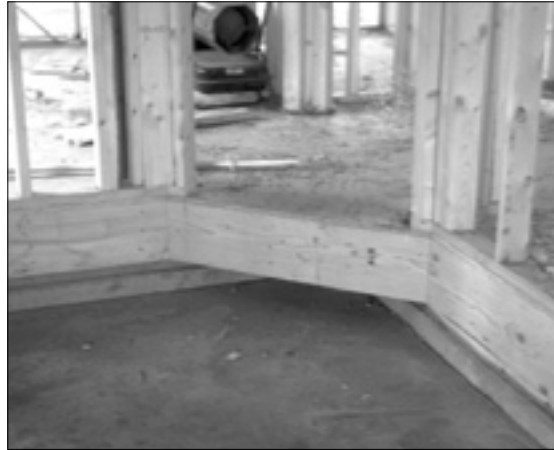
Many holes were observed between garages and houses, providing pathways for garage pollutants to move into the living spaces. This corner cantilever was liable to be a big leak because it was difficult to access to seal.

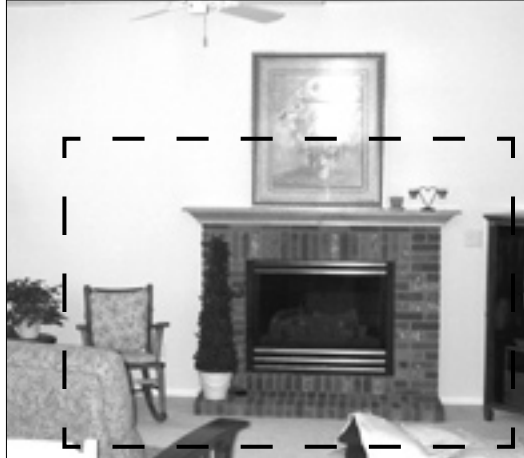
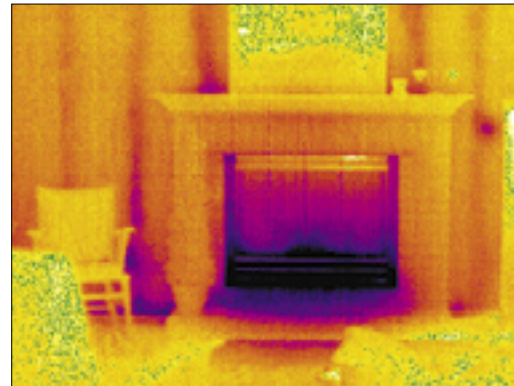
The owners of this house complained about drafts that made their living room uncomfortably cold. The infrared photo (right) shows the cold air that leaked around the fireplace unit. (This was a direct-vent fireplace, so there were no leaks between the room and the vent; all leakage was due to an incomplete air barrier in the cavity enclosing the unit.)

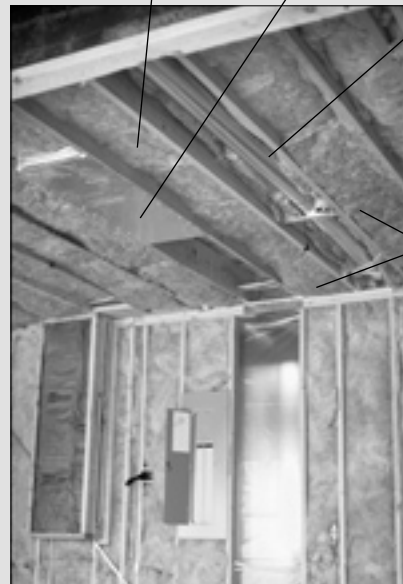
No insulation at return duct
 Six-inch thick, R-19 insulation supported insecurely against the subfloor in a deeper cavity
 Insulation difficult to install effectively around ductwork

Insulation has drooped away from floor above, leaving air space between them.

Flaws in floors built over garages contributed to poor comfort in living spaces above.

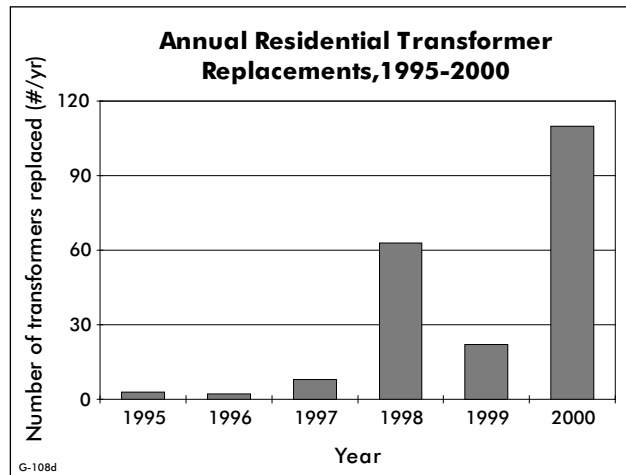
The graph shows the number of Fort Collins Utilities residential distribution transformers replaced each summer, beginning in 1995, due to overloading. Prior to 1998, a few transformers failed every summer, but the number was so small that it was not viewed as a significant issue. In the relatively hot summer of 1998, though, more than 60 transformers failed. Since then, the number

Larger homes and the increasing prevalence of residential air conditioning have caused the need to replace many distribution transformers since 1998. In response, Fort Collins Utilities increased transformer sizing criteria in 2001.

of failed transformers has remained high, varying in response to climate extremes.

Fort Collins Utilities staff responsible for planning and maintaining the electric distribution system attribute the increase in number of transformer replacements to a combination of larger homes with more electrical loads and the increasing prevalence of central AC. They believe—and the correlation with temperature supports—that AC is the largest factor.

In response to this trend, Fort Collins Utilities made two changes in 2001. First, the size of transformers serving new residential neighborhoods was doubled.

Second, a program was established to preemptively replace transformers in neighborhoods with large AC loads with larger transformers, if loading indicators suggest the existing transformers are at risk of failure. Both changes have increased the cost of delivering power.

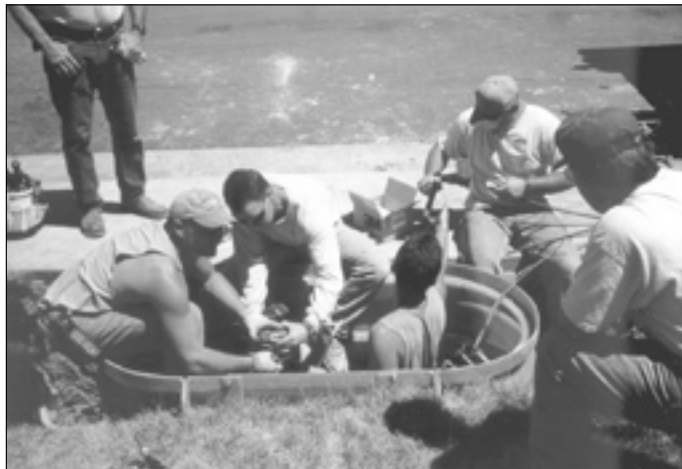
Fort Collins Utilities crew members change out a transformer that was overloaded under peak summer demand conditions.

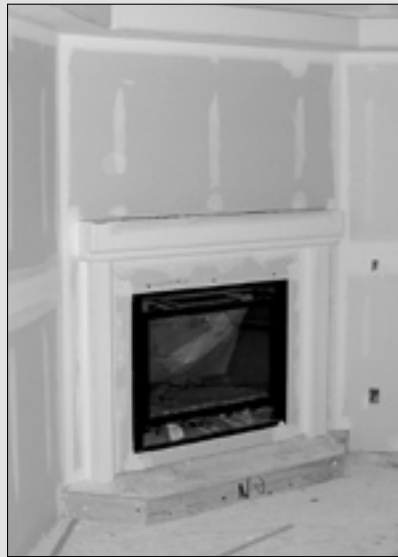
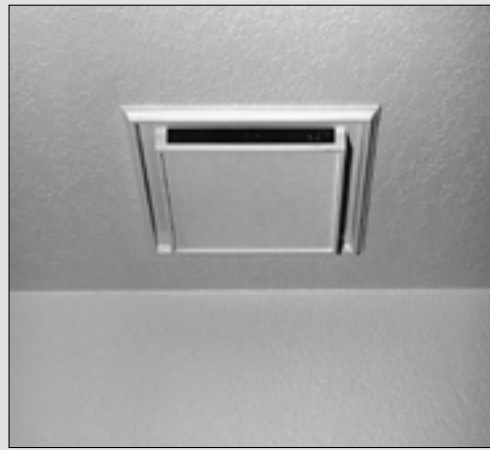
Many things are literally invisible behind the wallboard in a finished home: most of the framing, air sealing, wiring, plumbing, ductwork and insulation. For example, there is no way to see whether the insulation and air barrier were properly installed behind the fireplace or whether the bath fans were effectively vented.
