Evaluation of New Home Energy Efficiency

An assessment of the 1996 Fort Collins residential energy code and benchmark study of design, construction and performance for homes built between 1994 and 1999.

Summary Report

June 2002

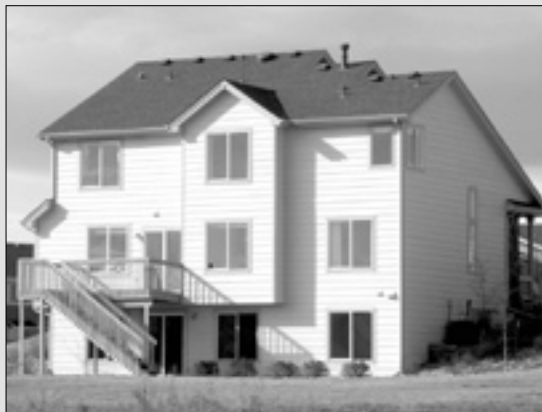
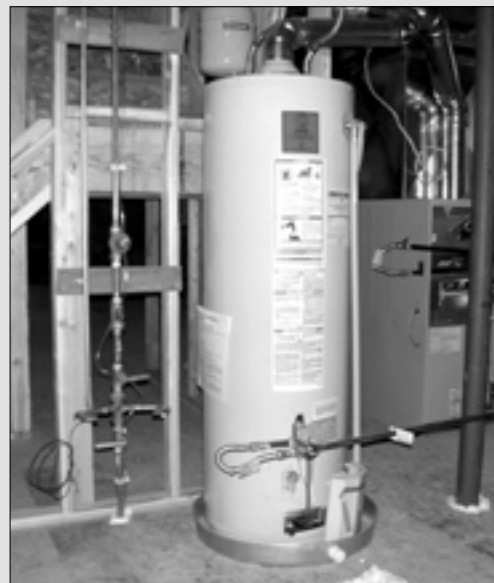
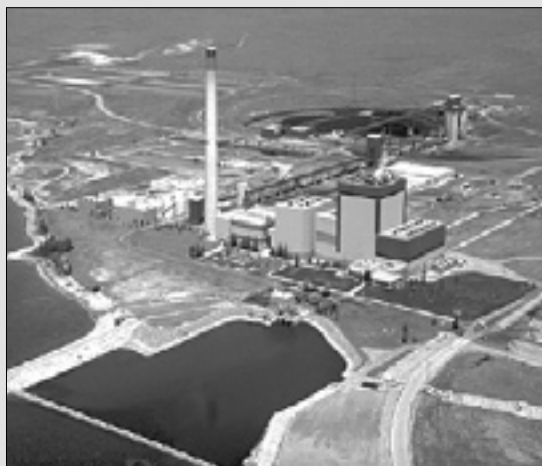
Many other aspects that are not hidden also receive little consideration in the purchase process. For example, little thought goes toward the type or solar orientation of windows, architectural features that need special attention, the efficiency or combustion safety of the water heater, or the impacts of design and construction decisions on the region's power supply needs.
