NTSB National Transportation Safety Board

Office of Marine Safety

Survival Factors

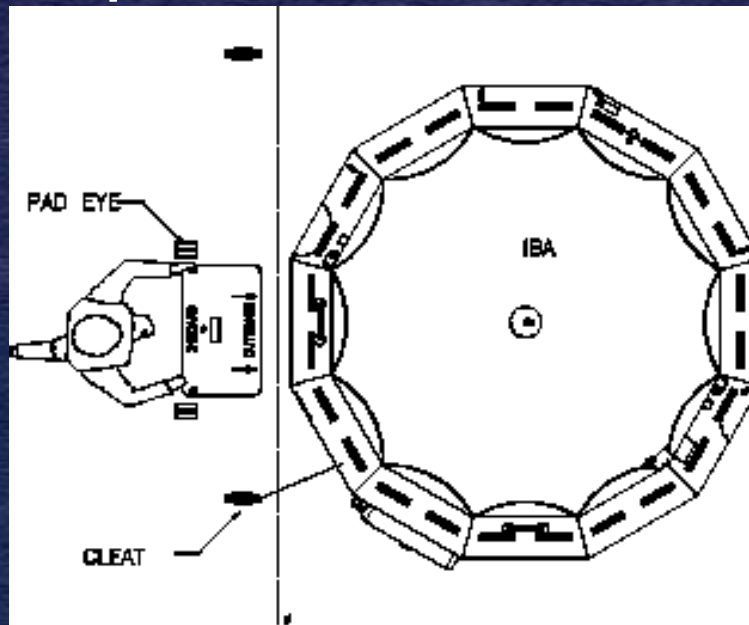
- Manufacturer testing
 - Valise upside down
 - Valise secured backwards
 - Valise packed incorrectly

Valise Upside down

- M-07-10
 - Conduct a one-time inspection and correction of all deficiencies of evacuation slides
 - Coast Guard response
 - Operator error
