NTSB National Transportation Safety Board

Gusset Plate Inspection Issues

Mark Bagnard

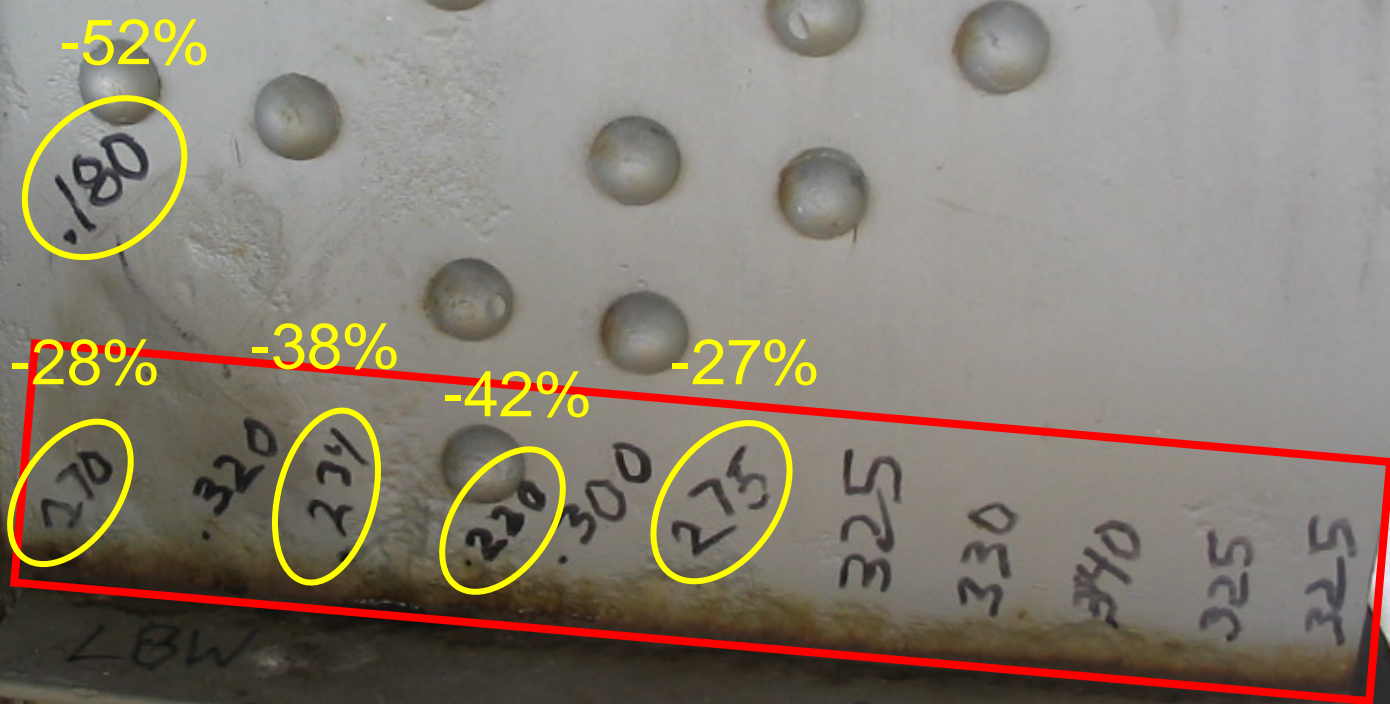
- Mn/DOT initiated gusset plate reviews of other steel truss bridges
- Review included June 2008 inspection of Highway 43 bridge in Winona
 - Ultrasonic thickness measurements revealed significant section loss in some gusset plates

Original gusset plate thickness = 0.375"

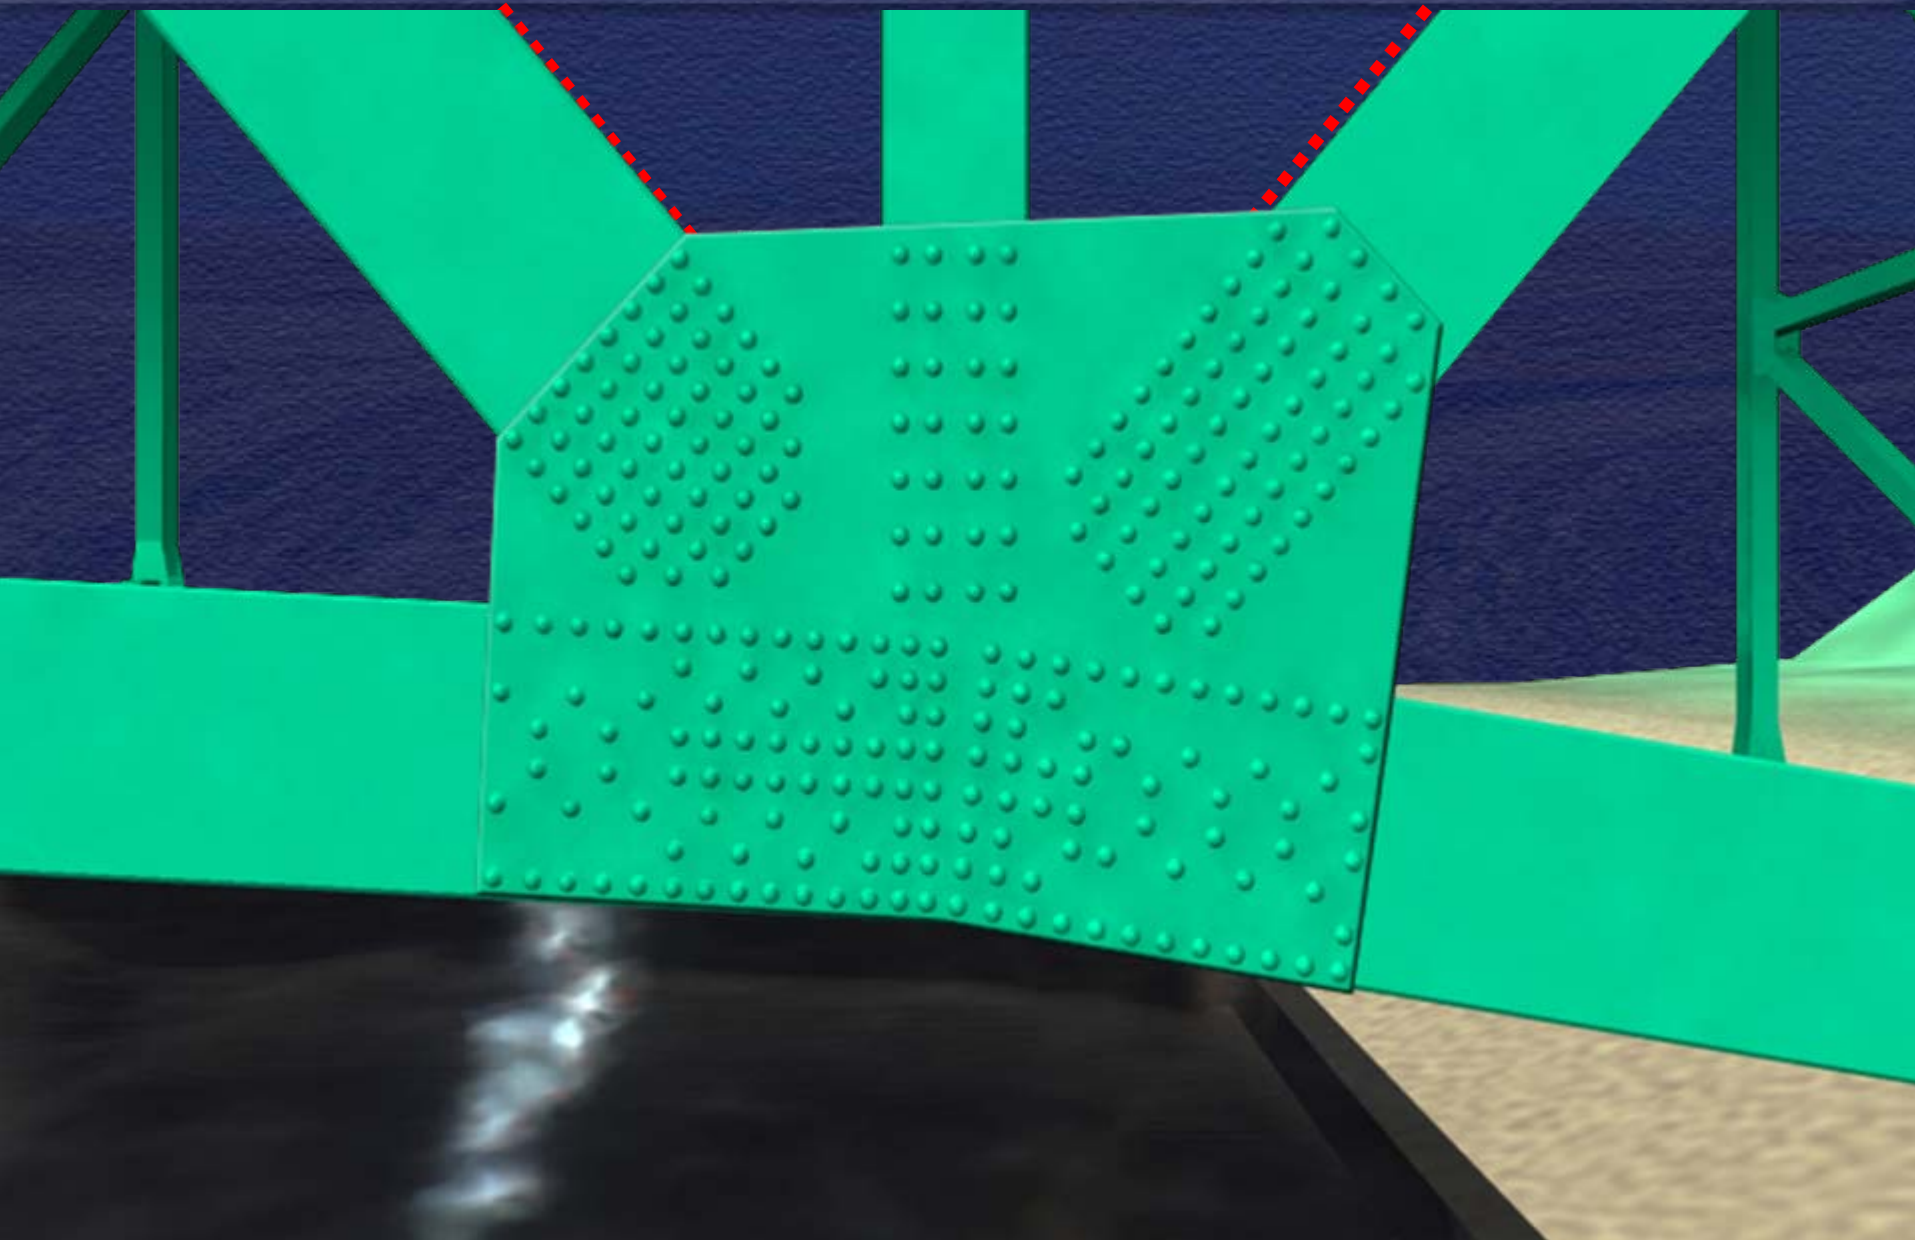
Why Corrosion May Go Undetected
