NATIONAL TRANSPORTATION SAFETY BOARD  
WASHINGTON, D.C.

} SAFETY RECOMMENDATION(S)  
H-74-1 through 3

CATASTROPHIC FAILURES DUE TO USE OF CUTTING TORCH  
TO REMOVE BUSHINGS FROM EQUALIZER BEAMS

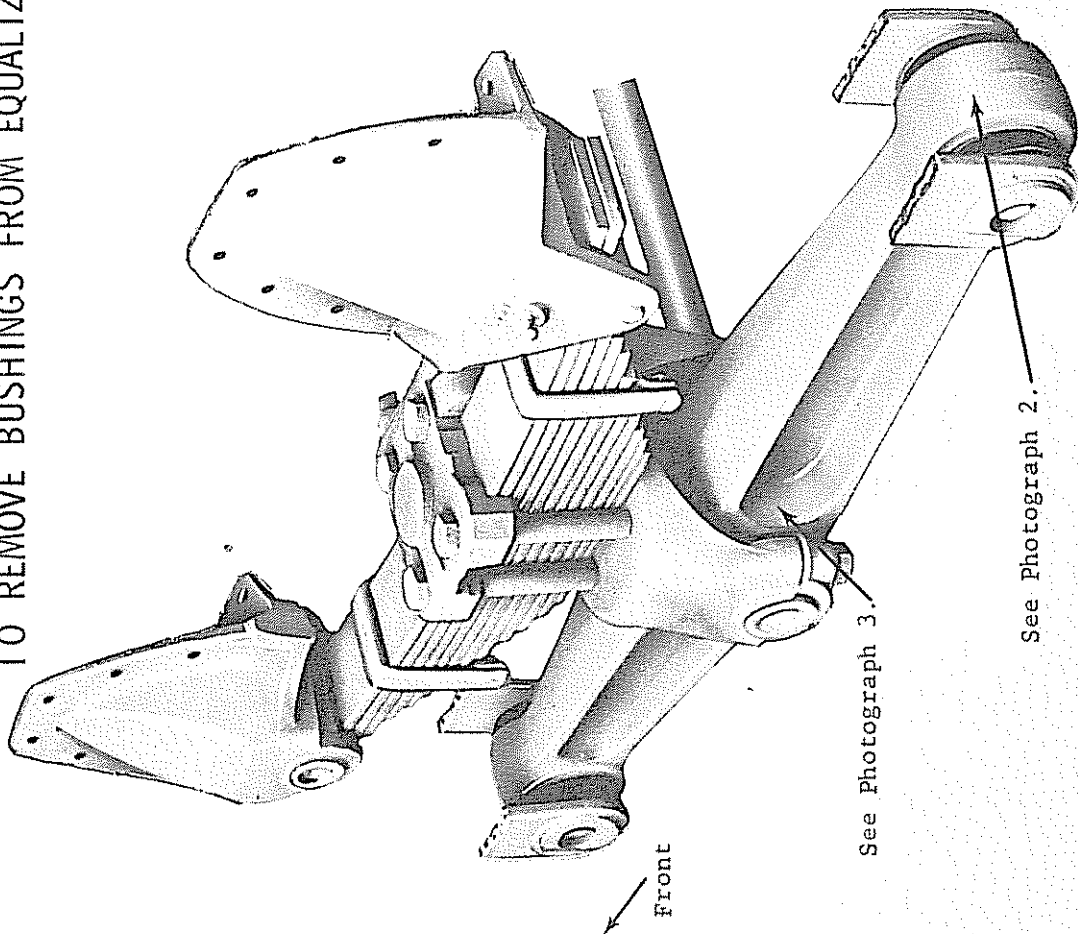
Photograph 1. Typical equalizer beam installation.

In both accidents, loss of control resulted from the failure of the left-side tandem suspension equalizer beam. Both failures occurred through one of the three bushing holes. The alignment of the tractor-tandem drive axles depends upon the structural integrity of the equalizer beams. (See Photograph 1.) In each accident, when the beam failed, the rear axle rotated rearward on the left side, which caused the tractor to steer uncontrollably toward the right.
