# National Transportation Safety Board

## Safety Recommendation

**Date:** July 17, 2008

**In reply refer to:** A-08-51 and -52

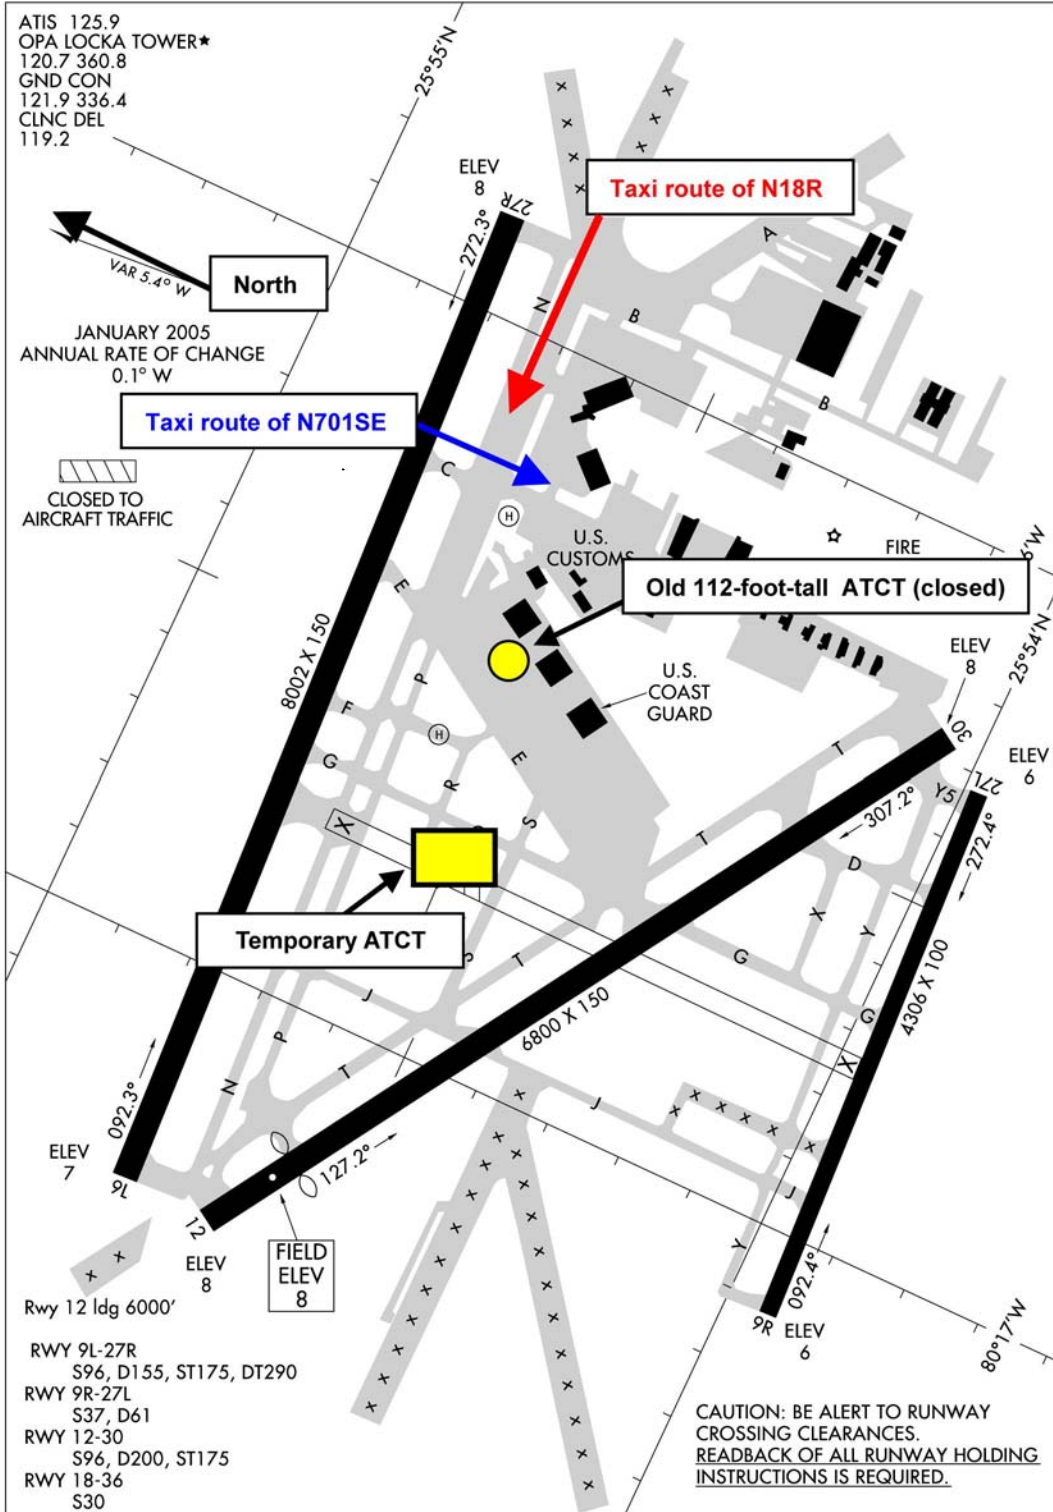
Figure 1. Diagram of Opa Locka Airport.

The recorded voice communications also revealed that, at 1148:37, the OPF local controller instructed N701SE to taxi via taxiway C to U.S. Customs after landing on runway 9L and to remain on the local control frequency. In a postaccident interview, the pilot of N701SE stated that he crossed taxiway P, saw N18R to the left out the corner of his eye, and tried to pull away by turning right but "was impacted."

According to interviews with the local controller and the ground controller working in the temporary air traffic control tower (ATCT), neither of them observed the collision. In addition, although N701SE was entering the ground controller's area of responsibility, the local controller
