Marine Accident Report

**Fire on Board the Small
Passenger Vessel
Seastreak New York
Sandy Hook, New Jersey
September 28, 2001**

**NTSB/MAR-02/04
PB2002-916404
Notation 7494
Adopted September 17, 2002**

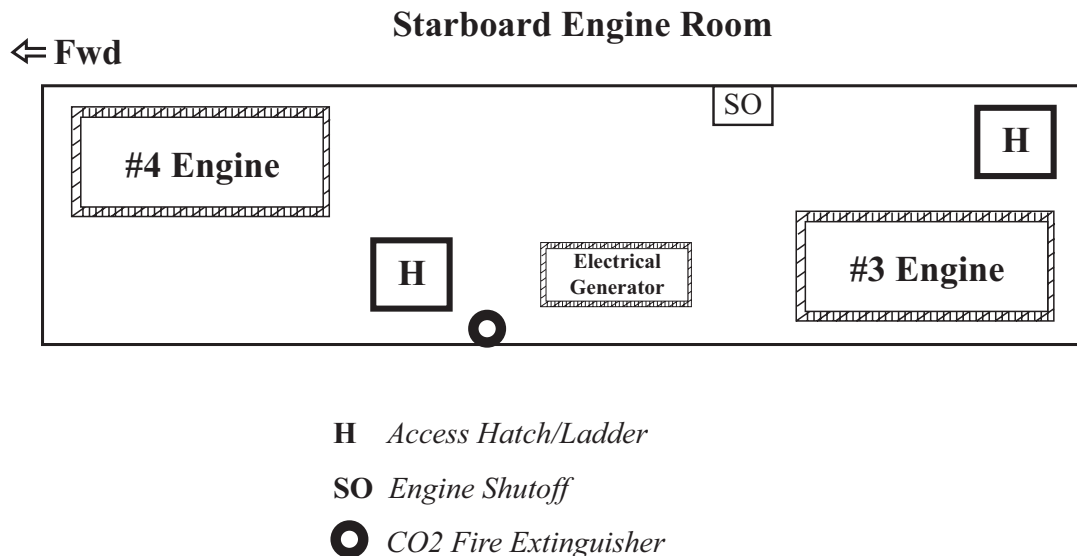
Figure 2.) He proceeded aft and inspected the starboard generator, which also appeared to be operating normally. He continued aft toward the No. 3 engine. When he stepped on the platform in front of the engine and looked over the top of the radiator, he saw a “foot-long flame” on top of the engine. He immediately went forward to retrieve a CO₂ extinguisher mounted near the forward access ladder. He grabbed the CO₂ extinguisher and pulled the pin in preparation for applying the CO₂ to the fire. With the extinguisher in hand, deckhand No. 4 went back toward the No. 3 engine. Before reaching it, he stopped at the engine shutoff switch mounted on the starboard bulkhead just forward of the engine. He said that as he reached for the switch, the engine “just ignited and blew flames across the whole room,” singeing his eyebrows and hair. Deckhand No. 4 did not activate the shutoff switch or use the CO₂ extinguisher. He dropped the extinguisher, rushed forward, and climbed up the ladder and out the engineroom access hatch. He stated that he thought his clothes were on fire and that he intended to jump overboard to extinguish the fire.

Figure 2. Sketch of the starboard engineroom of the Seastreak New York showing the arrangement of the access hatch, CO₂ fire extinguisher, shutoff switch, and main engines.
