PIPELINE ACCIDENT REPORT

NATURAL GAS EXPLOSION AND FIRE IN
SOUTH RIDING, VIRGINIA
JULY 7, 1998

NTSB/PAR-01/01

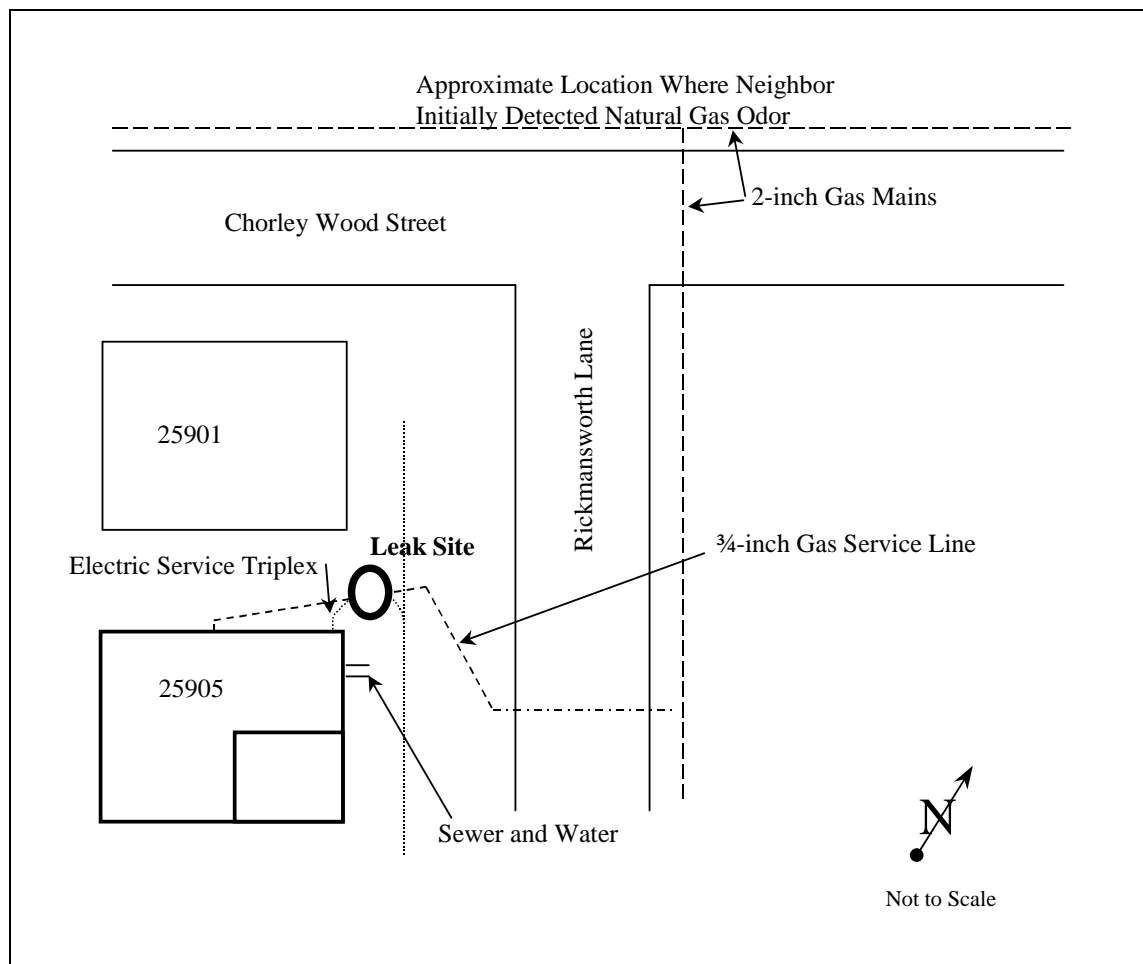
Figure 1. Accident area.

At the time of the accident, South Riding, Virginia, was a growing planned community in Loudoun County, Virginia, near Washington, D.C., and new homes were in various stages of construction. On April 22, 1998, a Northern Virginia Electric Cooperative (NOVEC) crew dug a trench and installed electrical service to a new home on Rickmansworth Lane, the home that would later be involved in the accident. Underground three-wire electrical service triplex¹ had previously been “stubbed in,” that is, installed (buried in a trench) to within a short distance of the home site so that the service line to the house could be spliced onto it when the structure was ready for electrical service. The NOVEC crew spliced onto this stubbed-in triplex an additional 23-foot section of triplex that they then attached to the house’s electric meter. (See figure 1.)
