**Pipeline Accident Report**

**Rupture of Piney Point Oil Pipeline  
and Release of Fuel Oil  
Near Chalk Point, Maryland  
April 7, 2000**

**National  
Transportation  
Safety Board**  
Washington, D.C.

**NTSB/PAR-02/01  
PB2002-916501  
Notation 7285A  
Adopted July 23, 2002**

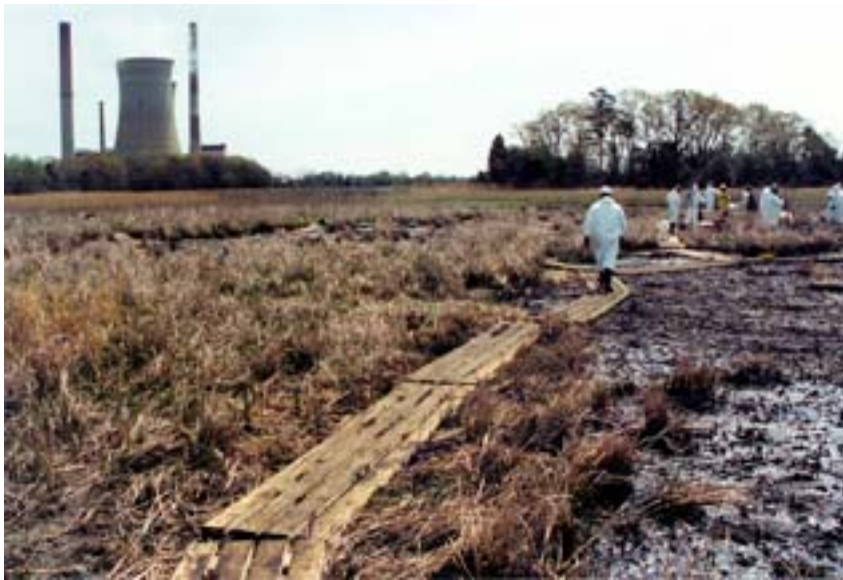
During the early stages of the response, Pepco deployed about 300 of its own employees and spill response contractors to assist with the oil recovery efforts. (See figure 6.) Pepco response personnel were on rotating 8-hour shifts. The EPA Federal On-Scene Coordinator noted that those coming on shift typically were not briefed before or after arriving at the scene. Little information was shared between shifts of employees. Pepco response officials stated that they often were not included in the meetings conducted by the EPA Federal On-Scene Coordinator. In some cases, they could not attend such meetings because it was physically impossible; the space provided for the meetings was inadequate to accommodate all those wishing to attend. Pepco indicated that because of these problems with the meetings, some of the orders of the Unified Command were not clearly communicated to its personnel.<sup>16</sup> At the same time, some meeting attendees were not essential to the response effort.

**Figure 6.** Response personnel working on wooden mats in the marsh.

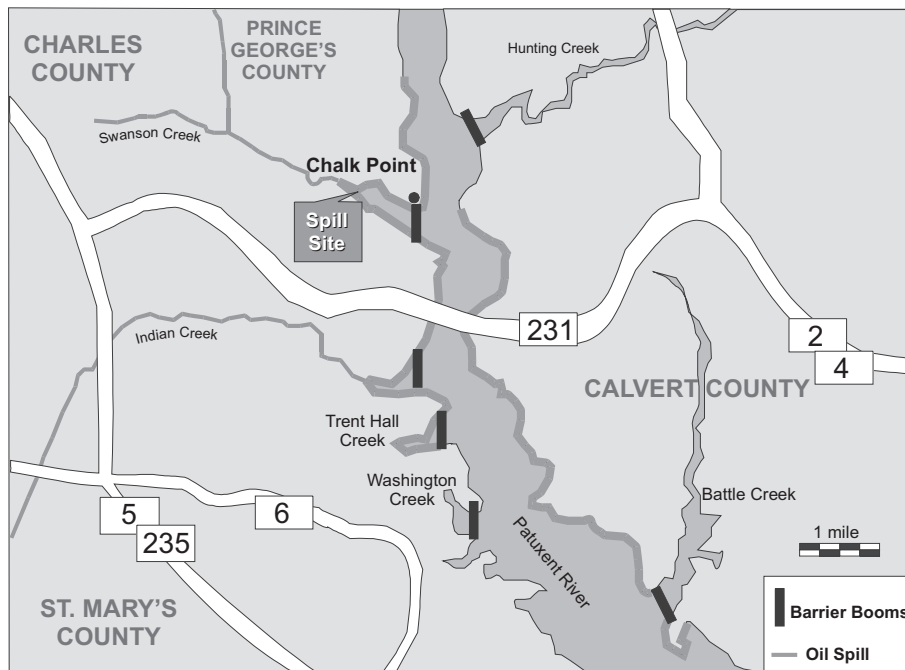
**Figure 8.** Spill site map showing creek boom placements and range of oil spill.
