NATIONAL TRANSPORTATION SAFETY BOARD

SYSTEMS GROUP CHAIRMAN FACTUAL REPORT ADDENDUM, AIRCRAFT CONTROL CABLE TEMPERATURES

A. ACCIDENT: DCA03MA022

AIRCRAFT: Raytheon Model 1900D, N233YV, operated by Air
Midwest Airlines, d.b.a. USAirways Express flight 5481

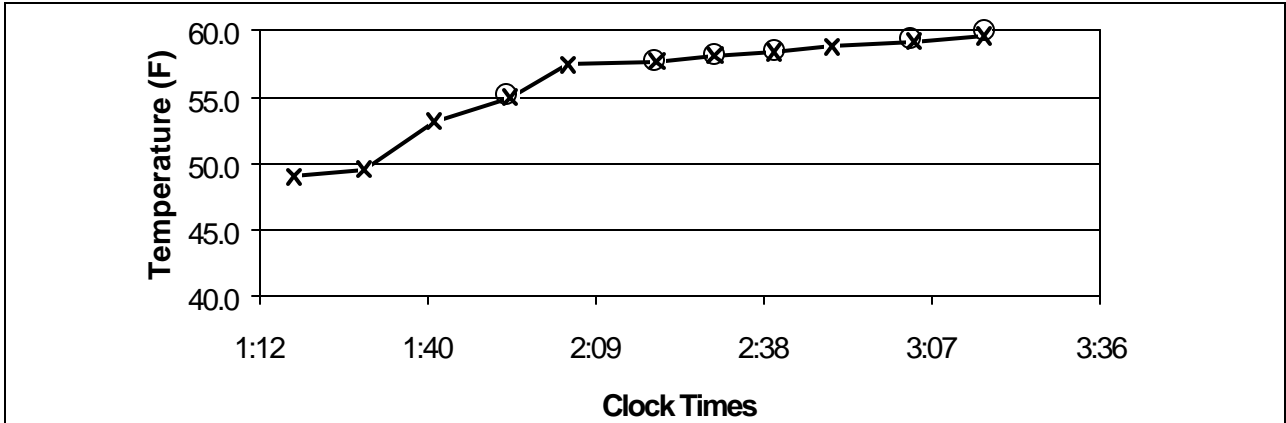
Chart 5. Cable temperature beneath forward cabin, about 125 inches from front of cable route. Circled points denote fill data.

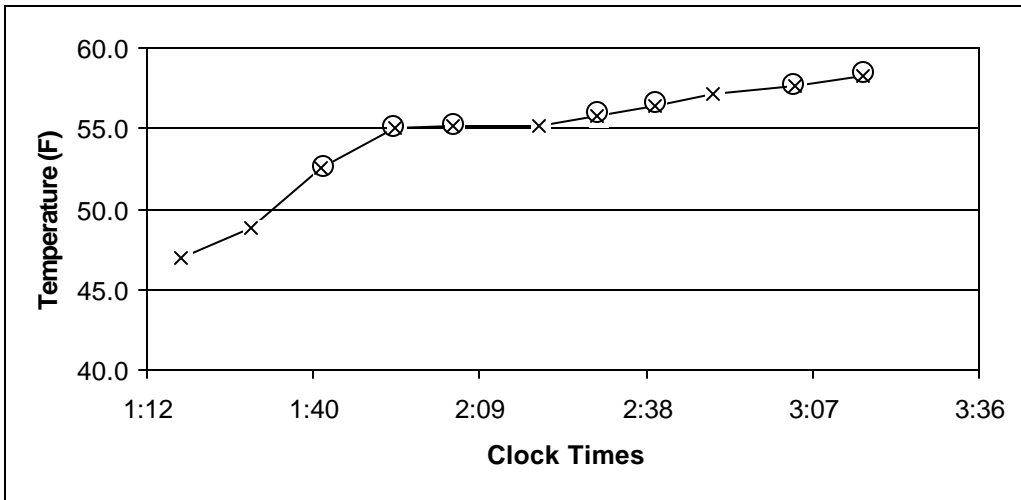
Chart 6. Cable temperature beneath mid cabin, about 245 inches from front of cable route. Circled points denote fill data.

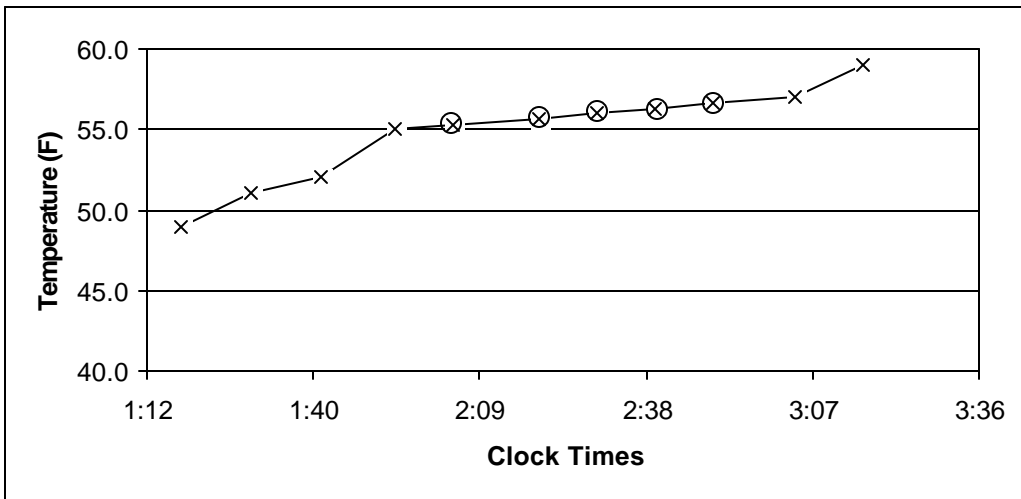
Chart 7. Cable temperature beneath aft cabin, about 305 inches from front of cable route. Circled points denote fill data.

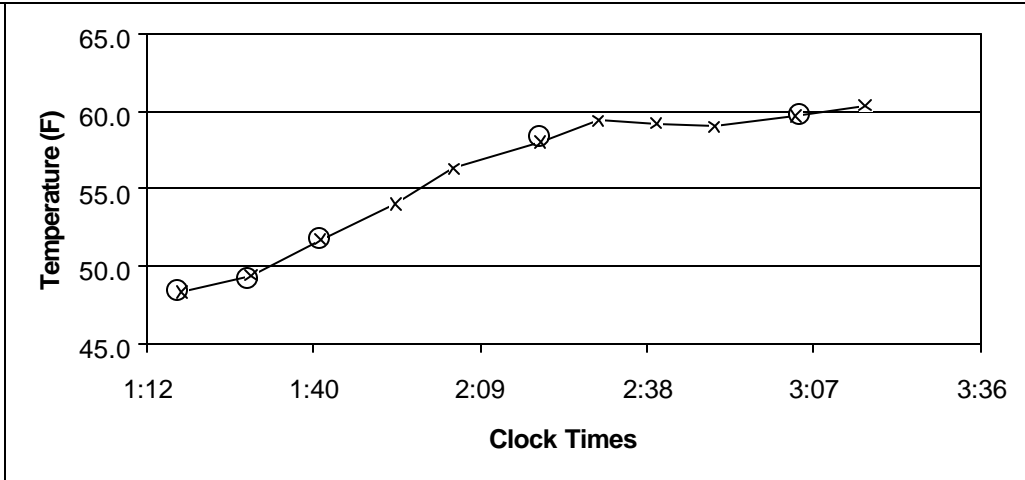
Chart 8. Cable temperature beneath cargo compartment, about 395 inches from front of cable route. Circled points denote fill data.

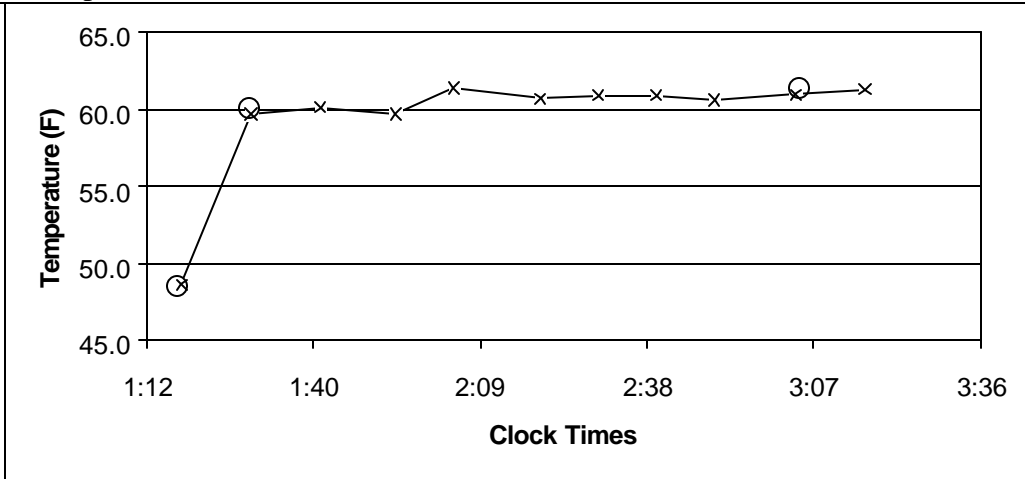
Chart 9. Cable temperature at turnbuckles in aft fuselage, about 510 inches from front of cable route. Circled points denote fill data.

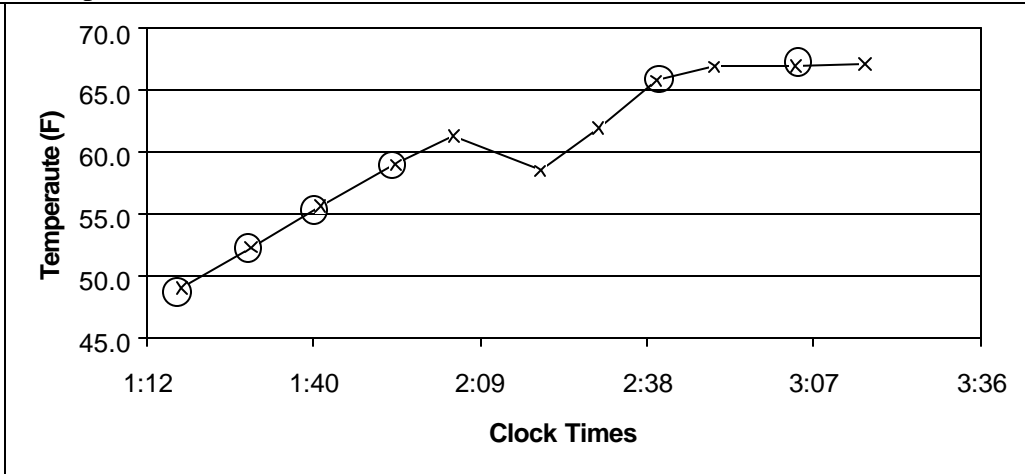
Chart 10. Cable temperature at aft bellcrank at top of tail, about 620 inches from front of cable route. Circled points denote fill data.
