NATIONAL TRANSPORTATION SAFETY BOARD

SYSTEMS GROUP CHAIRMAN'S FACTUAL REPORT

A. ACCIDENT: DCA03MA022

Location: Charlotte-Douglas International Airport, North Carolina
Date: January 8, 2003
Time: 0848 Eastern Standard Time
Aircraft: Raytheon Model 1900D, N233YV, operated by Air Midwest Airlines,
d.b.a. US-Airways Express flight 5481

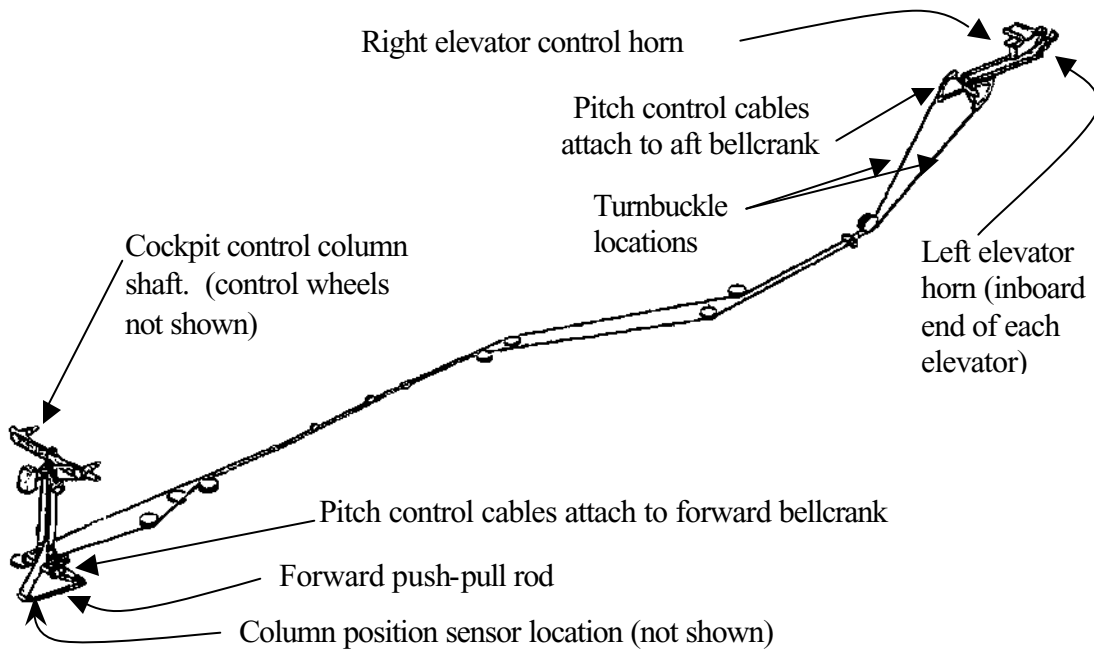
Figure 1. Primary Pitch Control System

The Model 1900D involved in the accident was equipped with a mechanically operated pitch control system, (Reference Figure 1 and Attachment 2). The horizontal tail surfaces are mounted at the top of the vertical stabilizer. Each side of the horizontal tail has an elevator and the inboard trailing edge of each elevator has a cut-out for a single partial-span trim tab. The forward outboard corner of each elevator has a balance weight that is rounded and is located behind the horizontal stabilizer when the elevator is near neutral.

The elevators are each connected by separate rods to a single aft elevator bellcrank. The aft elevator bellcrank is located within the junction of the vertical and horizontal stabilizers and has two springs connected to the aircraft structure. The spring tension is toward the nose-down direction. Control cables lead down the vertical tail from the aft bellcrank to a set of turnbuckles in the base of the tail. The 3/16-inch diameter cables are routed to beneath the rear cargo compartment, through pulleys and the aft pressure bulkhead seals. The control cable paths then route through additional pulleys to the forward control cable bellcrank, located beneath the pedestal and First Officer's floor. The forward bellcrank is connected to the bottom of the "T" control-column by an adjustable-length push-pull rod (Ref. Figure 5). The control-column pivots fore-aft on bearings that are attached to the control column support arm. These bearings are located about seven inches above the location where the push-pull rod connects to the column. A universal joint connects each end of the top of the control column to tubes carrying the Captain and First Officer control yokes. Each control yoke tube slides fore-aft on sets of three rollers.

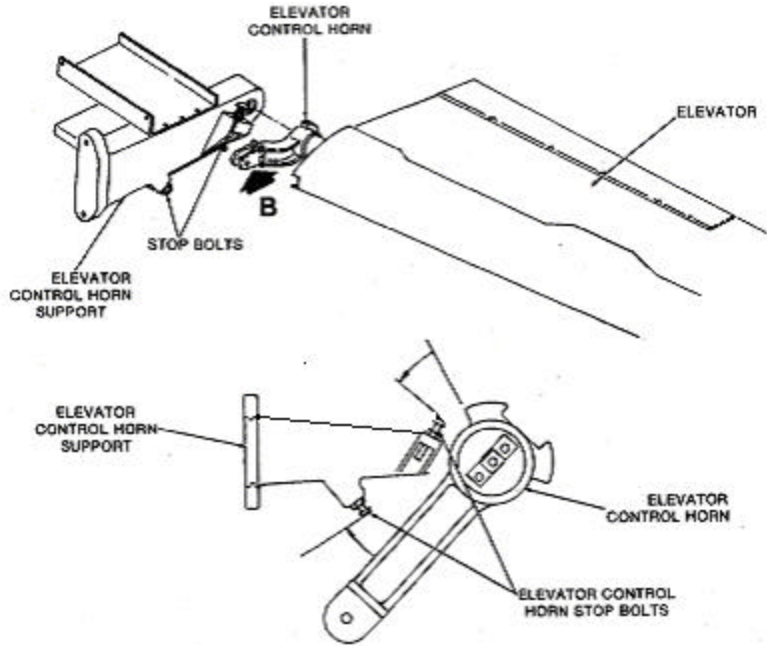
Figure 2 – elevator control horn and control horn stop bolts

The elevator control horn is located at the root of each elevator; it is connected to the elevator assembly by a shaft. (Ref. Figure 2) At the accident site, the rivets connecting the elevator control horn to the elevator shaft were inspected for security. The rivets were found to be tight and the horns were solidly fixed to the left and right elevator shafts, reference Photograph 1. The horns moved freely in their respective bearings.

The primary stop bolts for the pitch control system are located on the left and right elevator control horn supports. They are accessible by removing the aft stabilizer fairing. At the accident site, the four primary stop bolts were found attached to the control horn support and safety-wired. The length of each stop bolt was measured from the top of the bolt to the structure at the base of the stop nut. The results of the measurements are shown in Table 1.

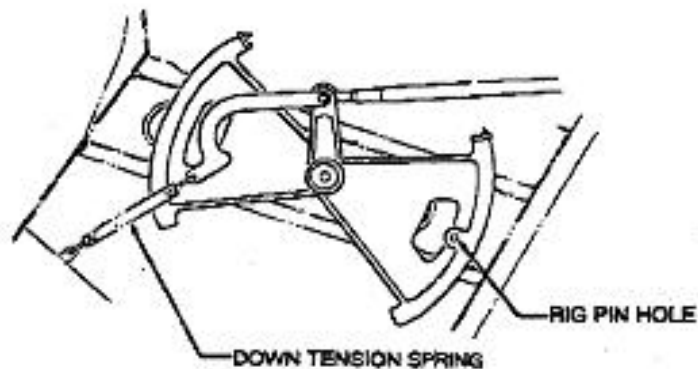
Figure 3. Aft Bellcrank and Down Tension Spring, (two total).
(Left edge of figure is toward nose of airplane.)

Both left and right down tension springs were located in the area of the aft bellcrank. The right tension spring was found with its upper end not attached to its respective link; its lower end was attached to structure. The structure that forms the lower attach point was fire damaged. The left tension spring was found with its upper end attached to its respective link in the most forward of four holes; its lower end was attached to structure. A visual examination of the spring showed that the spring was not totally relaxed. (Ref. Figure 3 and Photographs 7 and 8).

Examination of the tension springs at the NTSB Materials Laboratory revealed partial surface melting of the bellcrank, adjacent to the right spring attachment link (upper end of the spring). A globule of re-solidified metal was noted adjacent to the lower end of the spring. Magnified visual examination of the disconnected end of the right spring and the right linkage showed no evidence of unusual wear patterns, scratching, or other damage related to the separation of the spring from the link.

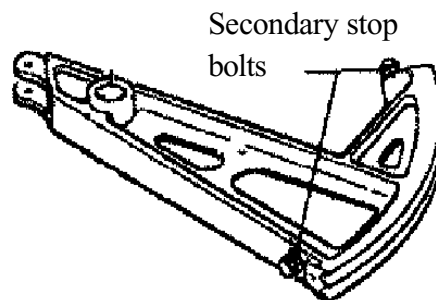
Figure 4. Forward bellcrank showing secondary stops

The forward pitch control bellcrank was seen in the intact airplane, in Wichita, located beneath the cockpit floor and the bellcrank contained the secondary stop bolts (Ref. Figure 4). In the cockpit wreckage, the bellcrank was located in an area of fire and impact damage; the bellcrank was found fractured into two pieces. The fracture surfaces of the bellcrank did not exhibit the black soot covering seen on the side surfaces of the bellcrank and surrounding materials. The secondary control stop that was nearest to the body of the bellcrank was found bent, with a sharp burr on the head of the bolt. The extension was 0.93 inches from the top of the bolt to the base of the exposed threads at the stop-nut. The stop at the end of the bellcrank arm was straight and the extension was 0.65 inches. The primary pitch AND and ANU cables were found attached to the bellcrank as shown in Figure 1.

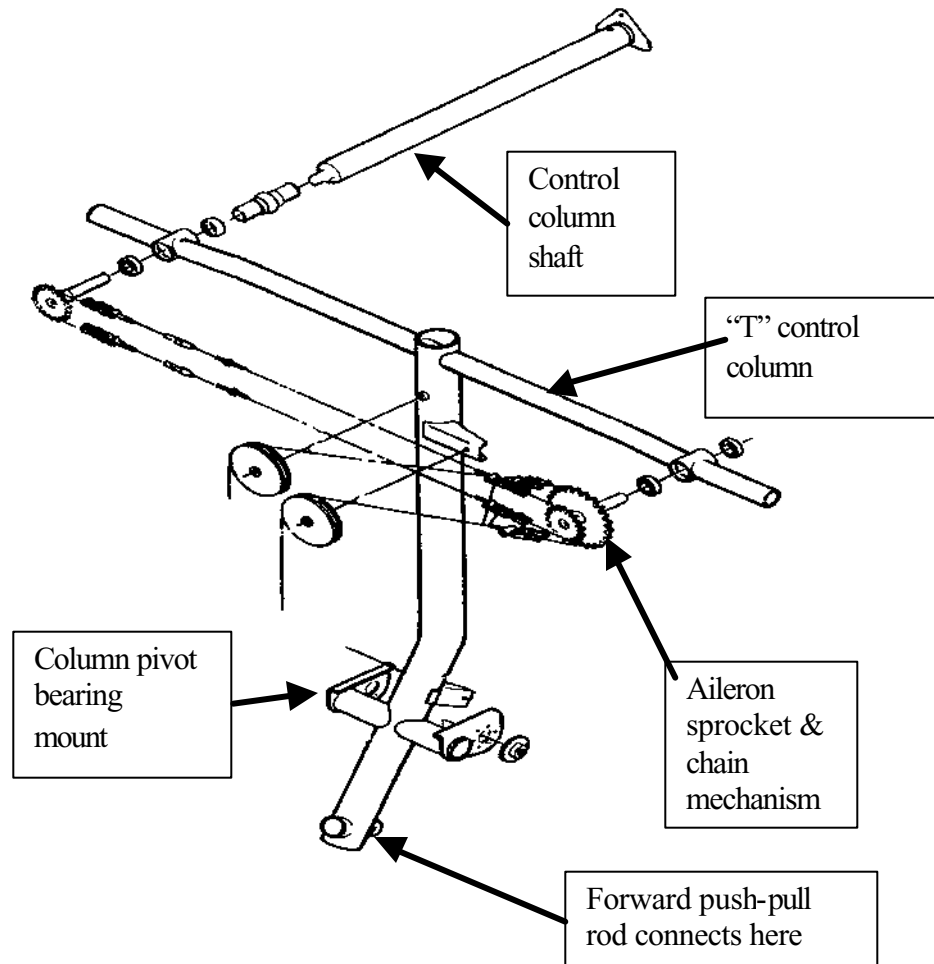
Figure 5. Control column assembly

At the top of the control column assembly are two control wheels (also known as control yokes) for the Captain and First Officer. Each control wheel is mounted on a plate located on the aft end of a tube assembly that is installed through the instrument sub-panel control column supports. Each control column support contains a set of three rollers that support the respective tube assembly. The forward end of each control wheel tube assembly is connected to a universal joint at each outboard end of the "T" column. In the mid-portion of the Captain's tube is a hole for a (ground) gust lock and corresponding hole are located on the support for the tube. (Ref. Photograph 12) A sprocket and chain mechanism mounted at the forward end of each tube connects the rotational movement of the wheels and is routed downward to the aileron control cables. The control column pivots at the lower section of the column and the forward pitch quadrant push-pull tube connects to the control column 7 inches below the pivot point. (Ref. Figure 5)

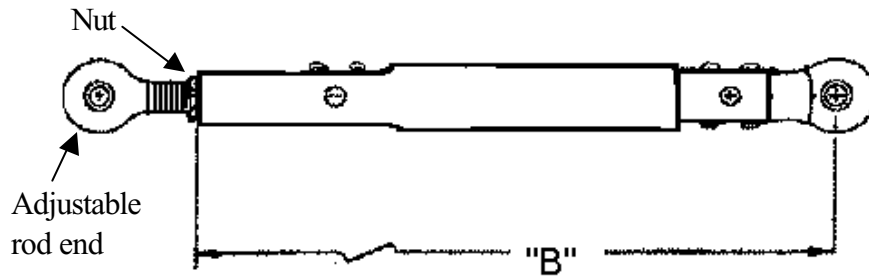
Figure 6. Sketch of forward push-pull rod

The push-pull control rod was found beneath the control pedestal in the cockpit and the aft end of the tube assembly was attached to a portion of the forward bellcrank. The adjustable rod end at the forward end of the tube assembly had six threads exposed and was bent. At the accident site, the length of the tube assembly could not be accurately measured due to a bend in the tube and a more severe bend in the rod-end.

Drawing 50-524433	Measurements at NTSB Lab
Dimension "B"	14.03 inch (50-524433)	13.99 inch
Nut P/N MS21083N6	(0.251 to 0.282) 0.2665" nom	0.270 inch
Rod End P/N MS21151-8	6 threads = 1.0035 " (calculated from drawings)	1.07 Inches
Total Tube assembly length:	15.30 inches (calculated from drawings)	15.33 Inches:
