**GROUP CHAIRMAN'S
REPORT OF INVESTIGATION
SOUND SPECTRUM STUDY**

**American Airlines Flight 587
DCA02MA001**

**Belle Harbor, NY
November 12, 2001**

Group Chairman's Sound Spectrum Study

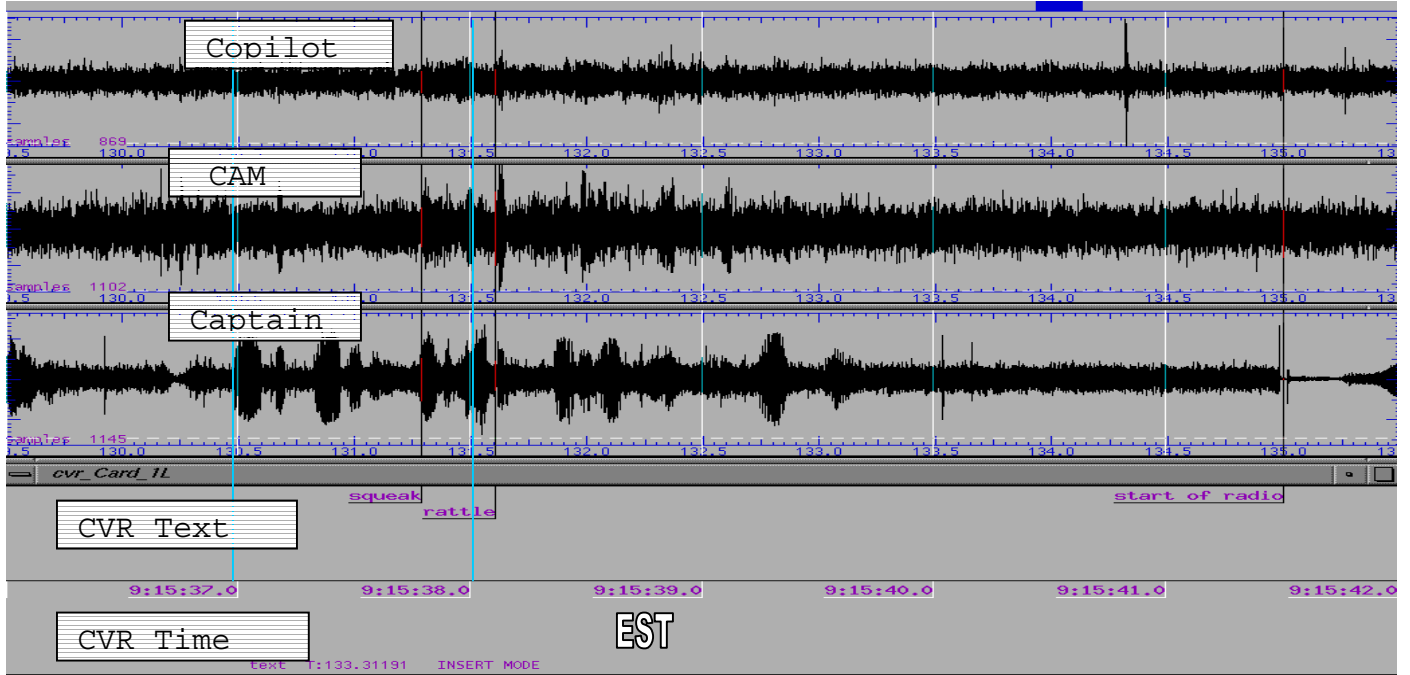
CHART 9 (shown with legend)

To aid in the documentation of the events heard during the final few minutes of the CVR, the Sound Spectrum Group produced an annotated timeline. Charts 9 thru 16 depict the waveform of the three useful CVR channels (Co-pilots radio/hot microphone channel top trace the cockpit area microphone (CAM) channel, middle trace and the Captains radio/hot microphone channel bottom trace). The selected text annotations found at the bottom of the charts are comments taken from the CVR Group transcript. Time depicted along the bottom horizontal axis of the charts is shown in both arbitrary elapsed seconds and in CVR hours:minutes:seconds EST time. Chart 9 is shown with the channel assignments annotated and with the text and time labeled.
