# NATIONAL TRANSPORTATION SAFETY BOARD

MATERIALS LABORATORY FACTUAL REPORT

Report No. 02-083

Place : Belle Harbor, New York  
Date : November 12, 2001  
Vehicle : Airbus A300-600, N14053  
NTSB No. : DCA02MA001  
Investigator : Brian Murphy, AS-40

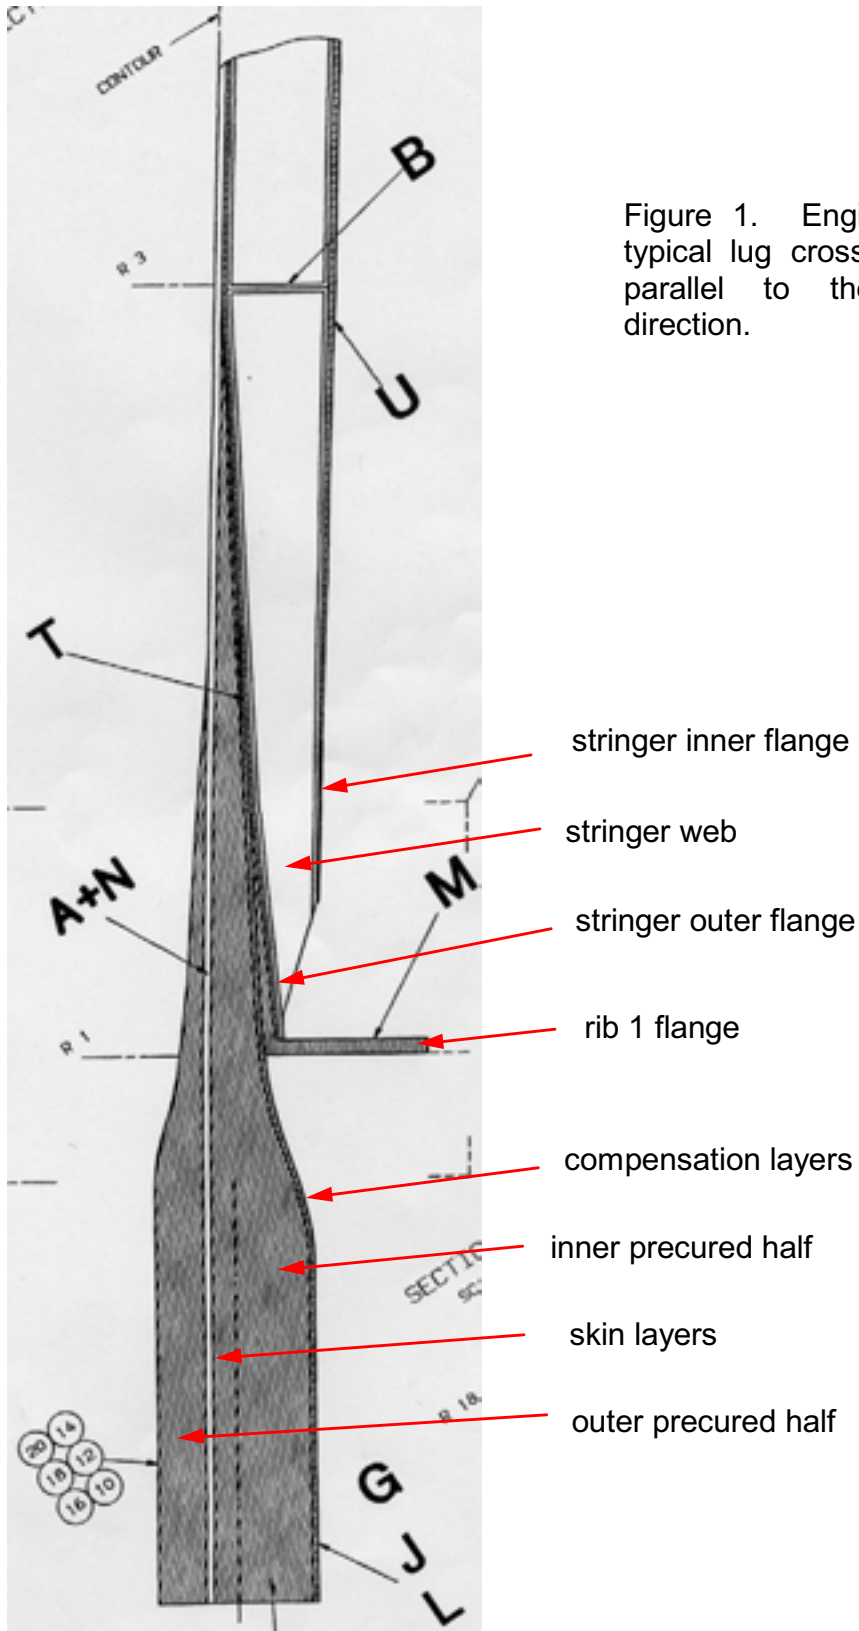
Figure 1. Engineering drawing of a typical lug cross section in the plane parallel to the zero-degree fiber direction.

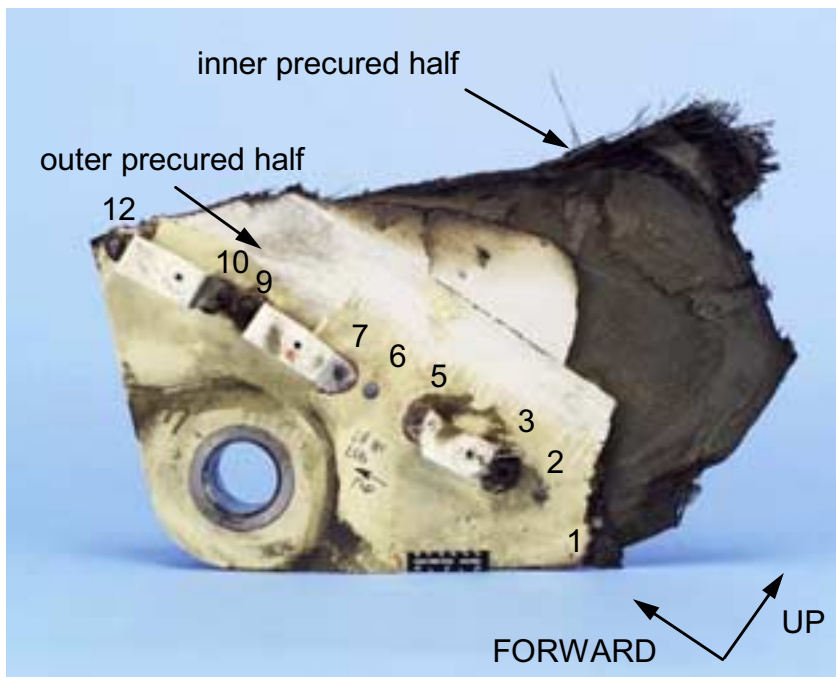
Figure 26. Overall view of the lower piece containing the lower portion of the fracture at the left aft lug, viewed looking to the right.

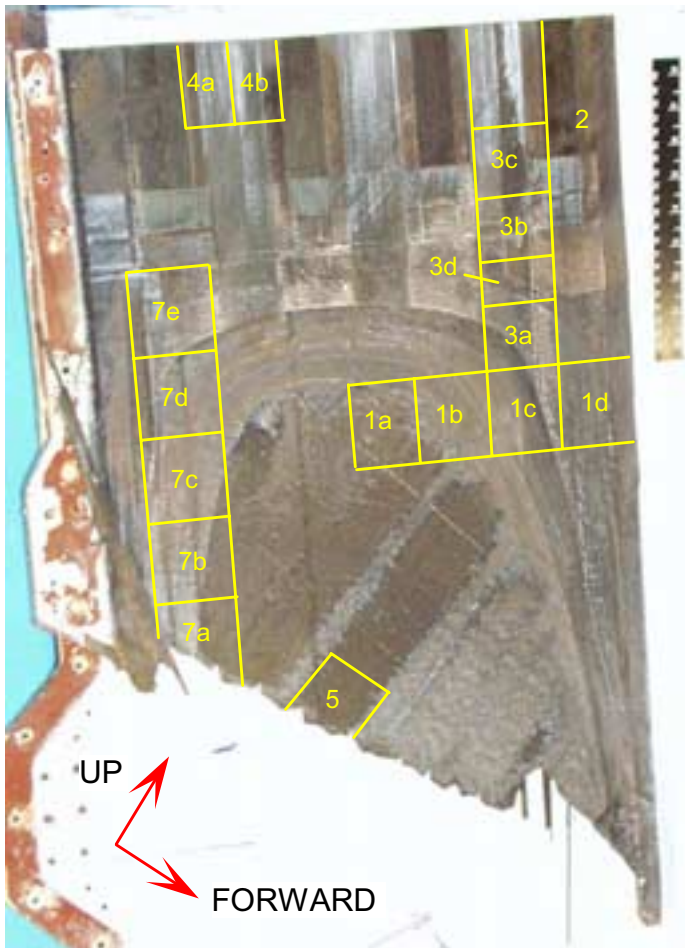
Specimens were cut from the skin section (figure 29) and the stringer module structure at the lower end of the upper piece (figure 30) to facilitate microscopic examination of the interlaminar fracture surfaces using SEM. Not all cut specimens shown in figures 29 and 30 were examined using SEM, and the specimens that were examined

Figure 29. Specimens cut from the skin section at the left aft lug fracture area for examination using SEM.

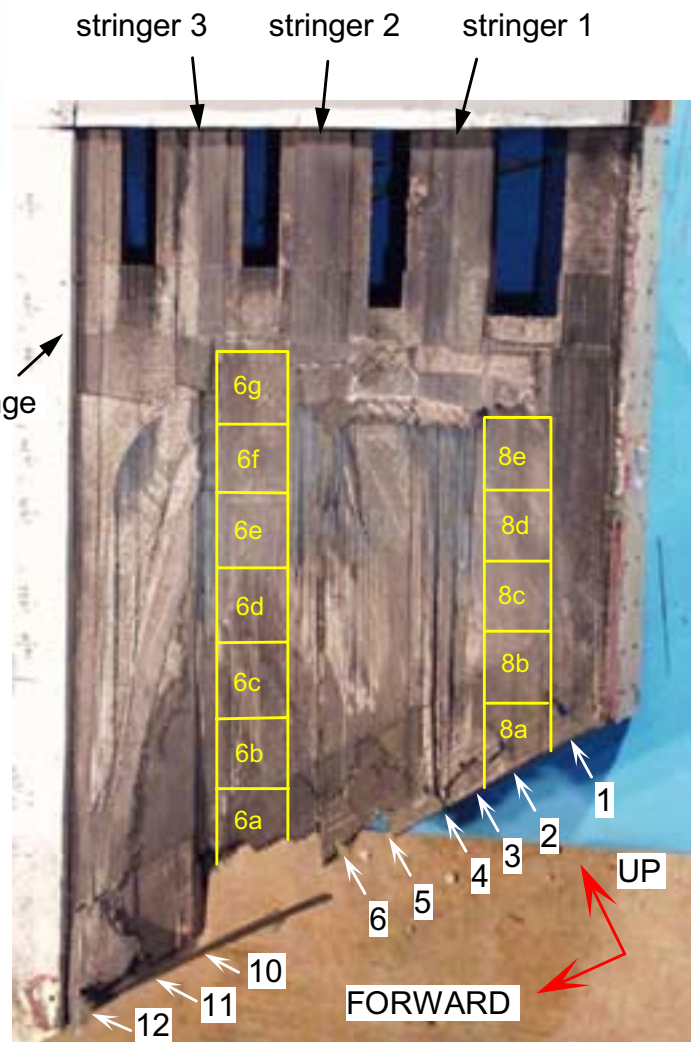
Specimens LA6 and LA8 were cut from the stringer module structure at the lower end of the upper piece (figure 30). The surfaces of these two specimens had identical morphology, with tape fibers and imprints from the stringer outer flange layers over +45-degree fabric, and the fracture features observed were also similar. In general, the hackles that were observed pointed upward parallel to the stringer structures. The crack propagation directions were generally to the aft and upward, except in specimen LA8e, where the crack propagation direction was more forward and upward.

Figure 30. Specimens cut from the stringer module structure of the upper piece for examination using SEM. Rib 1 fastener holes are numbered at the bottom of the part.

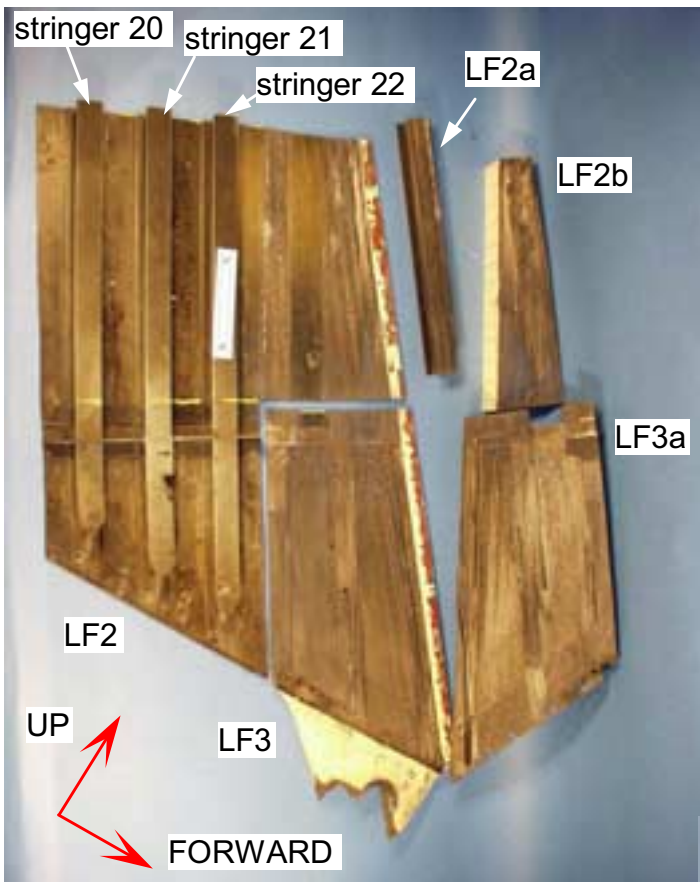
In order to expose the interlamina fracture surfaces between the stringer module and outer flange layers above rib 1, three cuts were made using a diamond bandsaw. The mating pieces are shown after cutting in figure 54. The first cut was 19 inches from the top of the part (9 inches below rib 3 and 19 inches above rib 2). The second cut was made approximately 2 inches above rib 2 from the front spar back to just aft of the flange of stringer 23. After making these first two cuts, the lengths of the stringer 23 and front spar flange between those two cuts (pieces LF2a and LF2b, respectively, in figure 54) came free from the rest of the part. The third cut was made just aft of the flange of stringer 23 up from the position of rib 1 to 2 inches above rib 2, where it intersected the second cut. Three ribbons of zero-degree tape, each approximately 1 inch wide, bridged between the two pieces and were snipped with wire cutters to finish separating the piece (piece LF3a in figure 54). One ribbon of tape that bridged the two pieces was along the aft flange of stringer 24, and was cut at a location approximately 8 inches above rib 1. The second ribbon of tape was along the forward flange of stringer 23, and was cut approximately 2 inches below rib 2. The third ribbon of tape was along the aft flange of stringer 23, and was cut approximately 4 inches below rib 2.

The surface layer of specimen LF2b-1, cut from the upper end of piece LF2b (figure 54), also was zero-degree tape making up the stringer outer flange, with imprints of -45-degree fabric fibers. This specimen was part of the front spar flange, almost directly above the position of stringer 24, and the tape layers from that area continued up to this point. Hackles were observed pointing in all directions. The crack propagation direction was generally upward and toward the aft with respect to the zero-degree fiber direction, which was shown by river marks in matrix pockets and also by the faint bands<sup>5</sup> seen in figure 61.

Figure 54. Mating pieces after cutting to expose the interlaminar fracture above the left front lug. Arrows indicate UP and FORWARD for the main pieces LF2 and LF3.

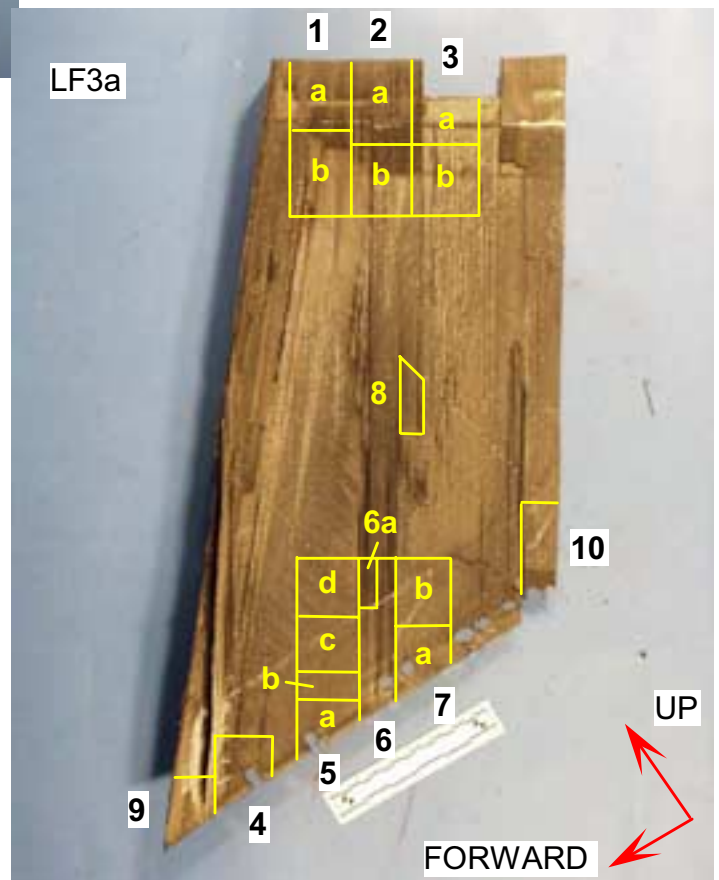
Several specimens were cut from the inner part containing the stringer structure labeled piece LF3a (as shown in figure 55) for microscopic examination of the fracture surfaces in the SEM. The specimens (LF3a-1, LF3a-2 and LF3a-3) at the top of piece LF3a straddled the position of rib 2. Specimens LF3a-1a and LF3a-1b were cut apart directly through the rib 2 web. Specimens LF3a-2a and LF3a-2b also straddled the web of stringer 24, which ran up from rib 1 but ended at rib 2. Two specimens were also cut from the top and bottom of piece LF2a (part of stringer 23), and a specimen was cut from the fracture surface at the top of piece LF2b (part of the front spar flange). Each specimen was cut into a piece approximately 2 inches on a side using the diamond bandsaw and/or a low-amplitude vibrating saw with the diamond-edged blade.

Figure 55. Specimens cut from section LF3a for examination in the SEM.

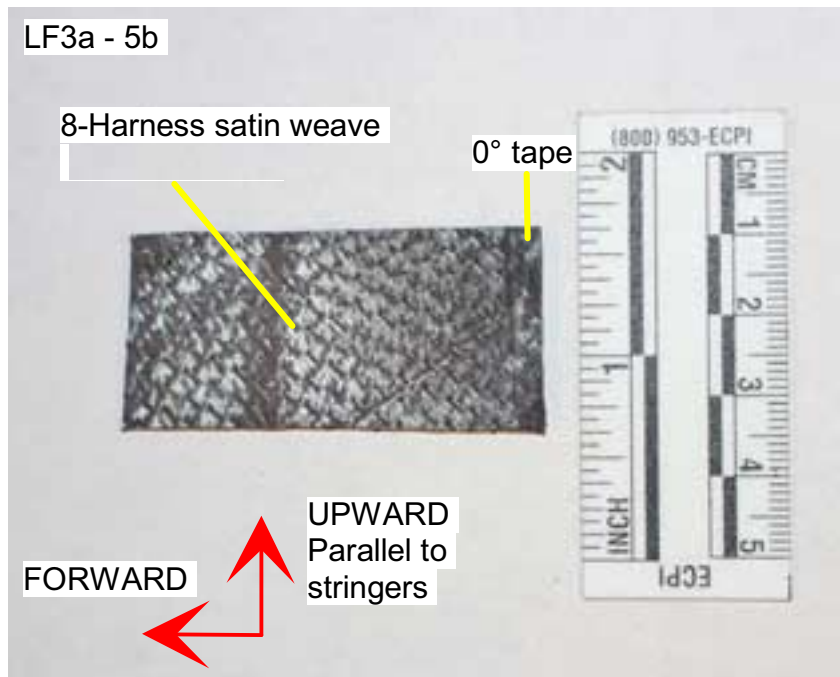
For SEM observation, all of the fracture surfaces were sputter coated with a layer of gold/palladium. All but one of the specimens (specimen LF3a-5b from the main interlaminar fracture on piece LF3a, shown in figure 56) were cleaned in deionized water in an ultrasonic cleaner.

Figure 56. Fracture surface from specimen LF3a-5b.
