# NATIONAL TRANSPORTATION SAFETY BOARD

MATERIALS LABORATORY FACTUAL REPORT

Report No. 02-077

Place : Belle Harbor, New York  
Date : November 12, 2001  
Vehicle : Airbus A300-600, N14053  
NTSB No. : DCA02MA001  
Investigator : Brian Murphy, AS-40

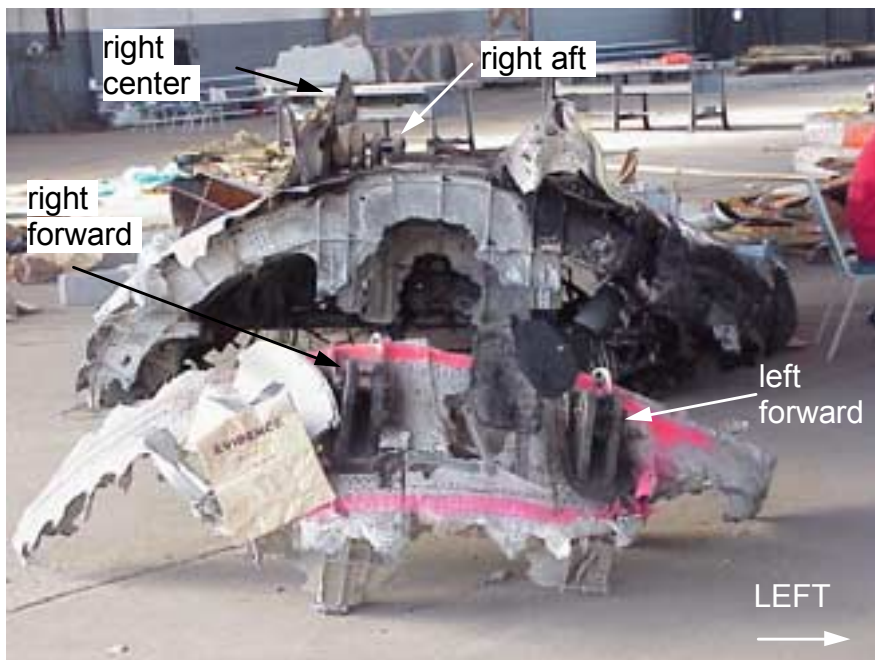
Figure 1. Overall view of the fuselage pieces as examined at Floyd Bennett Field. The vertical stabilizer is shown in the background.

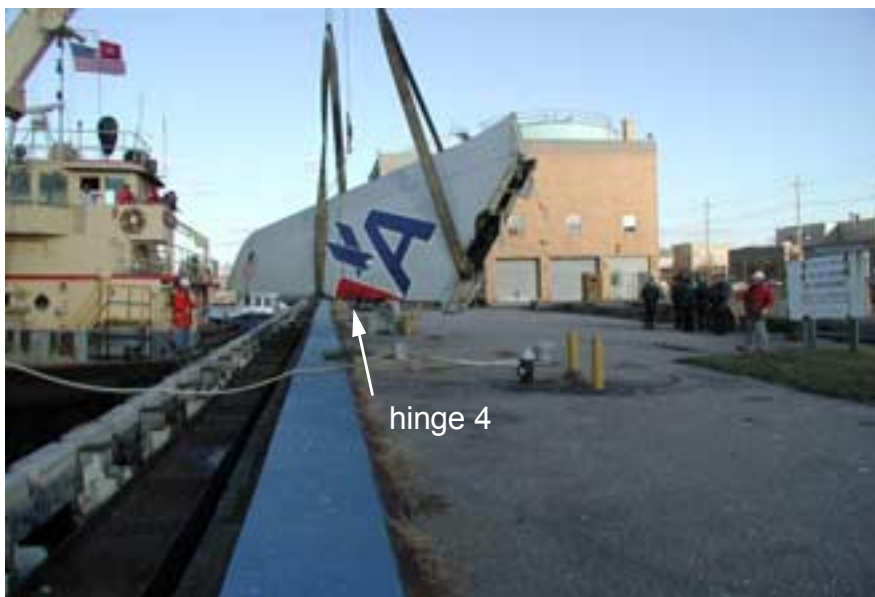
Figure 3. Recovery photo showing the vertical stabilizer being hoisted from the water. Note hinge 5 is not visible and the control rods are swept aft under the strap at the lower end.

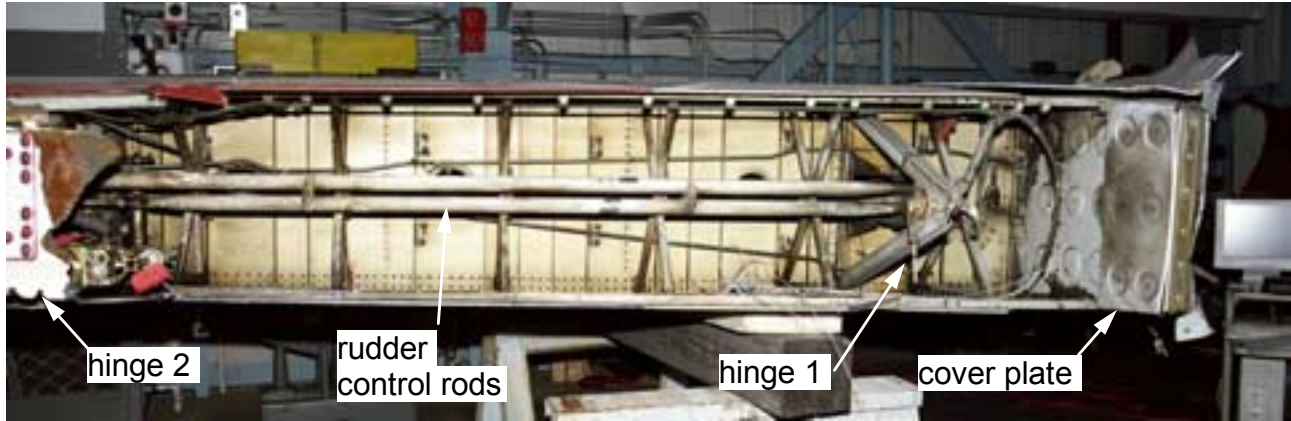
The rib 3 forward section left hand diagonal channel was fractured at the front spar/skin panel junction as shown in figure 28.

Figure 28. An unlabeled arrow indicates the fracture in the rib 3 diagonal channel as viewed from below.

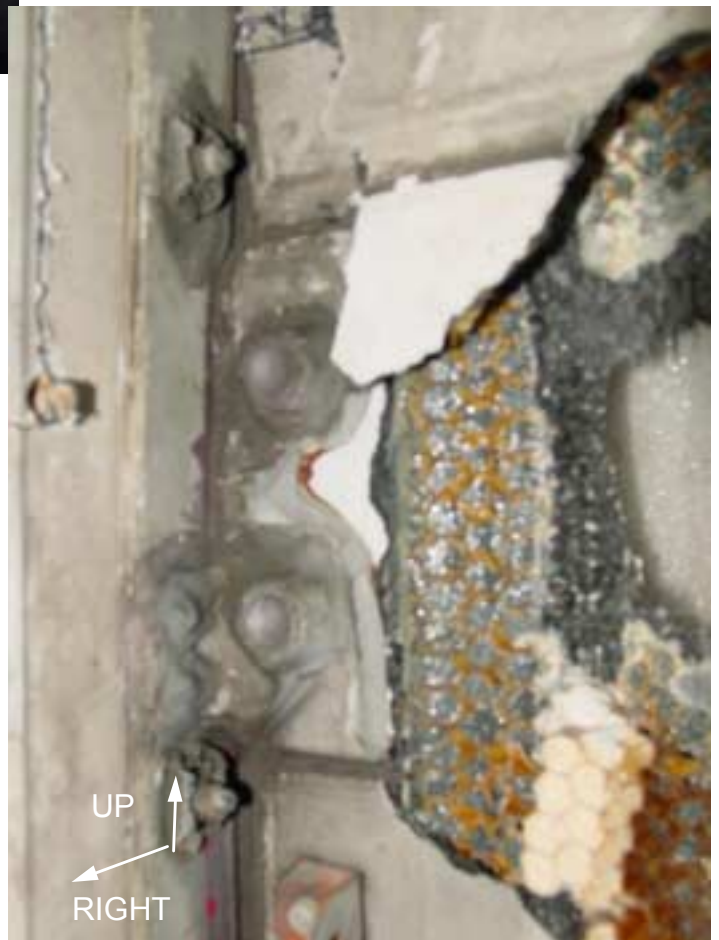
Figure 33. View of the right side hinge 2 aft fitting piece that remained attached to the rudder.

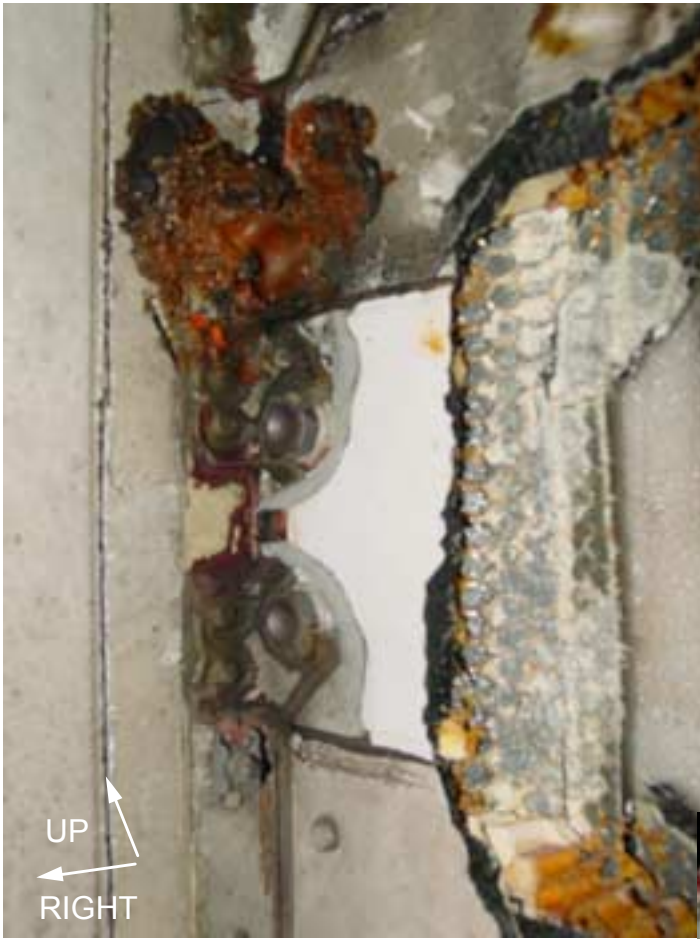
Figure 34. View of the right hinge 3 aft fitting pieces that remained attached to the rudder.

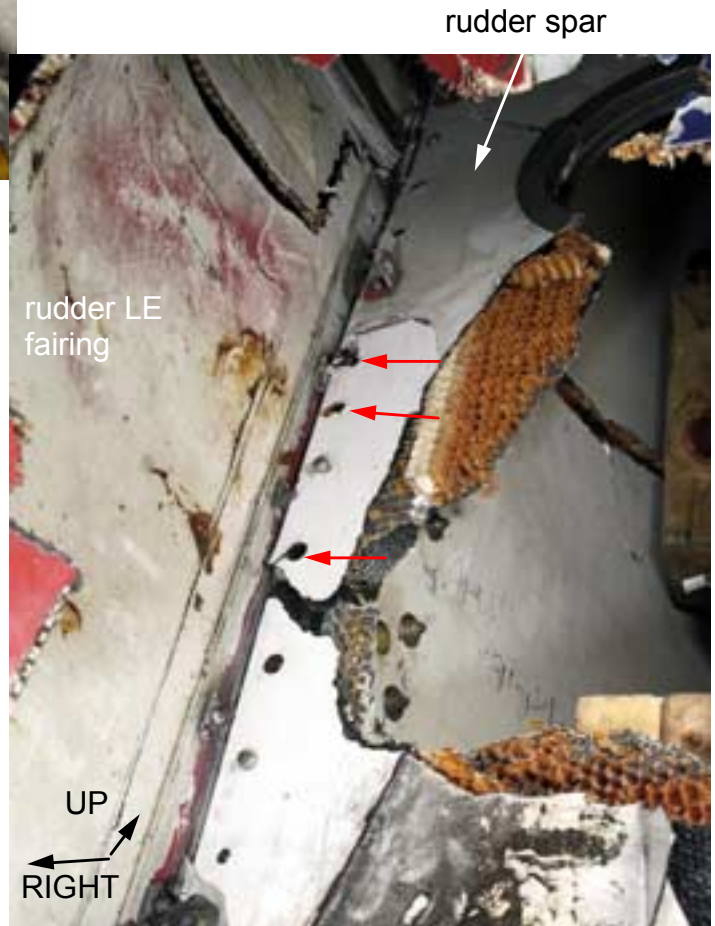
Figure 35. View of the right hinge 4 aft attach area on the rudder spar. The piece of the aft fitting that remained attached to the rudder is shown. Unlabeled arrows indicate attach bolt holes that remained with the large upper rudder piece (including skin piece BRHS and CLHS).

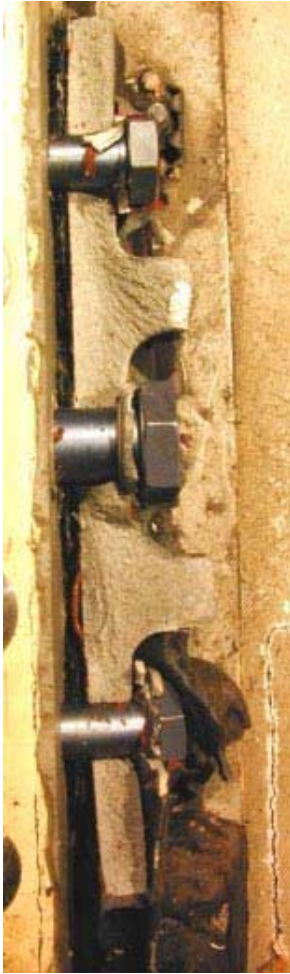
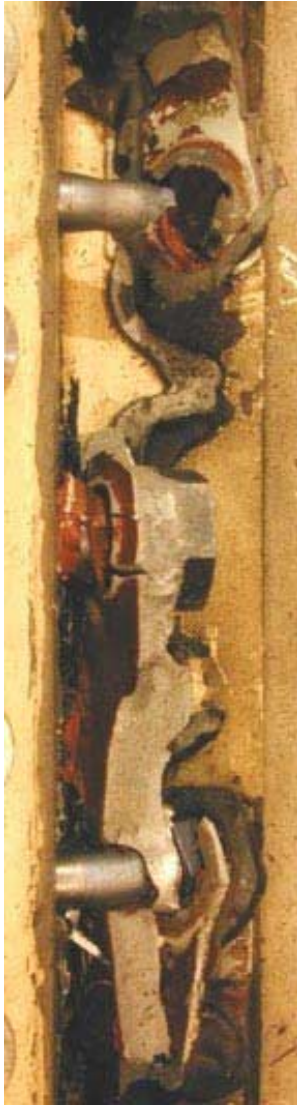
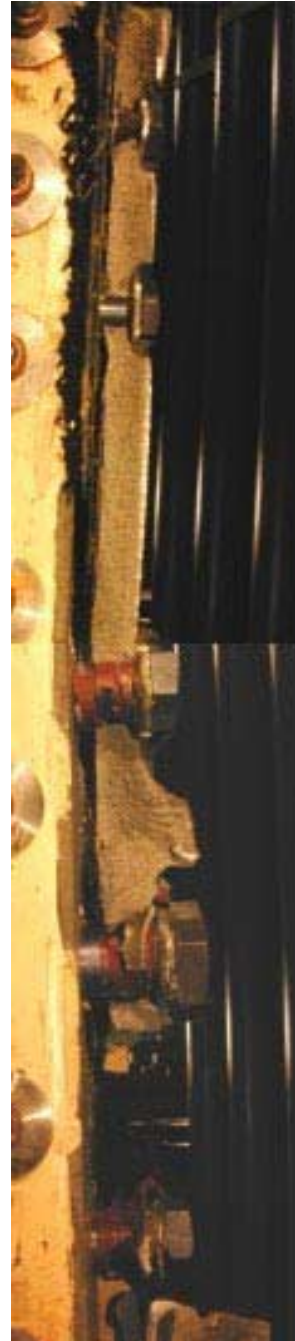
Figure 36. View looking to the left of the left sides of the hinge 2, 3, and 4 aft fitting pieces that remained attached to the rudder, showing fracture surfaces and deformation.

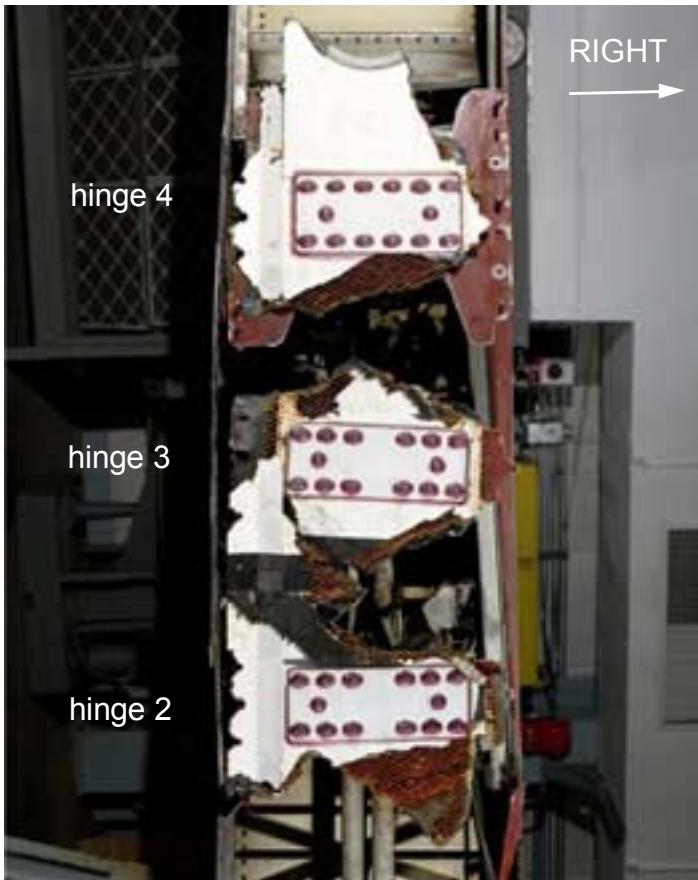
Most of the rudder spar web had translaminar fractures in this area, and the shape of the fractured area corresponded to the shape of the pieces remaining attached to the hinge fittings shown in figure 37. The pieces of the spar web between the hinges that

Figure 37. The hinge 2 to 4 fittings and attached rudder spar pieces that remained attached to the vertical stabilizer as viewed looking forward.

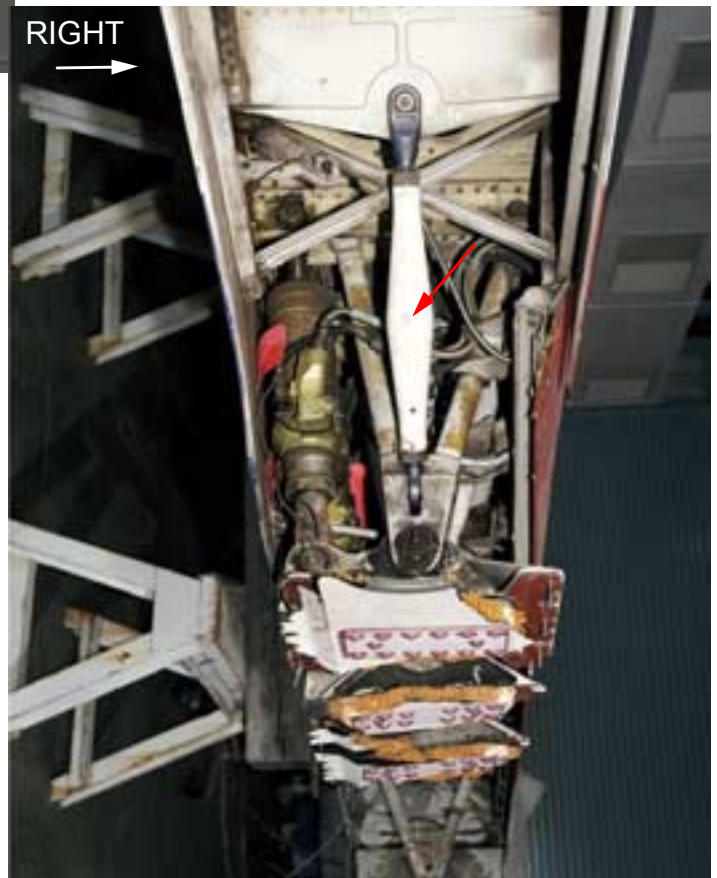
Figure 38. Another view of the hinges 2 to 4 as viewed looking down and forward. The vertical support strut is shown also. An unlabeled arrow indicates damage on the upper side of the support strut.

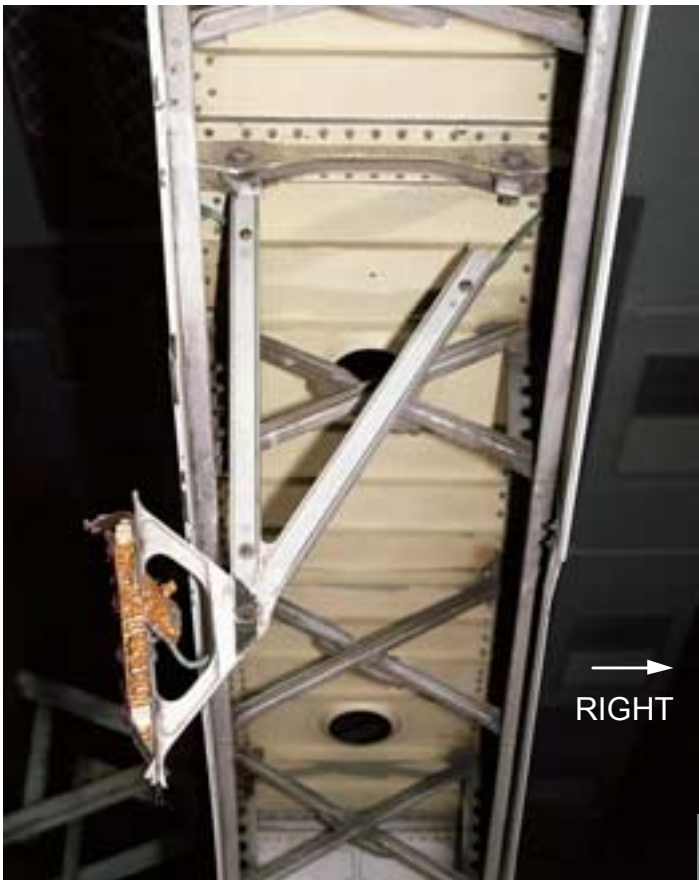
Figure 42. View of the hinge 5 aft fitting and rudder spar adjacent to the rudder LE fairing hinge 5 cutout (shown after fairing pieces below and fasteners above the cutout were removed). Unlabeled arrows indicate marks in the rudder spar corresponding to contact with the lower side of the cutout.

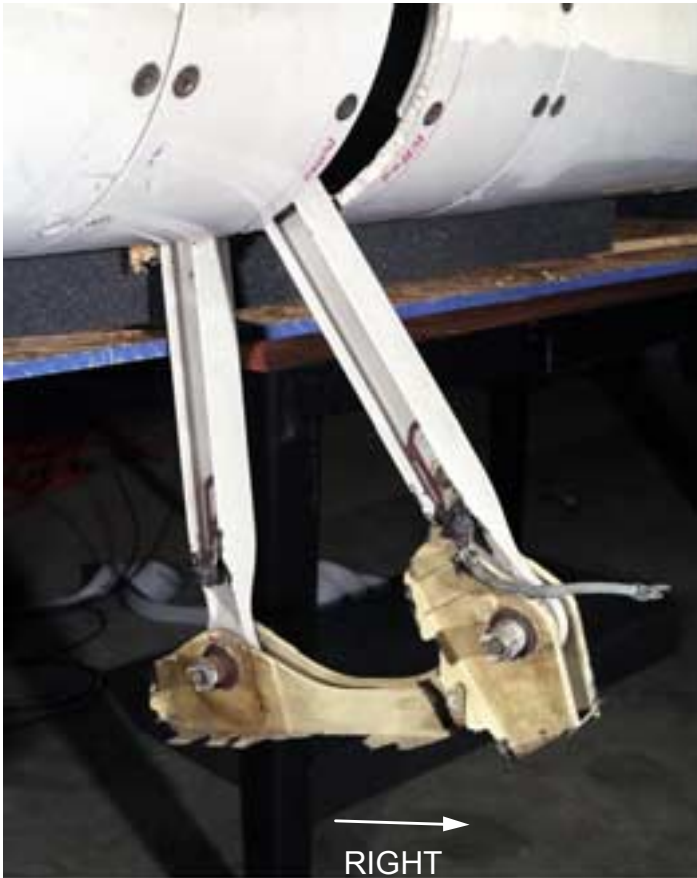
Figure 43. The hinge 6 forward fitting arms and attached vertical stabilizer rear spar attach angles that remained attached to the forward fitting as viewed looking up and aft. The "right" arrow is shown relative to the forward fitting, and the rudder is in a TEL position relative to the forward fitting.

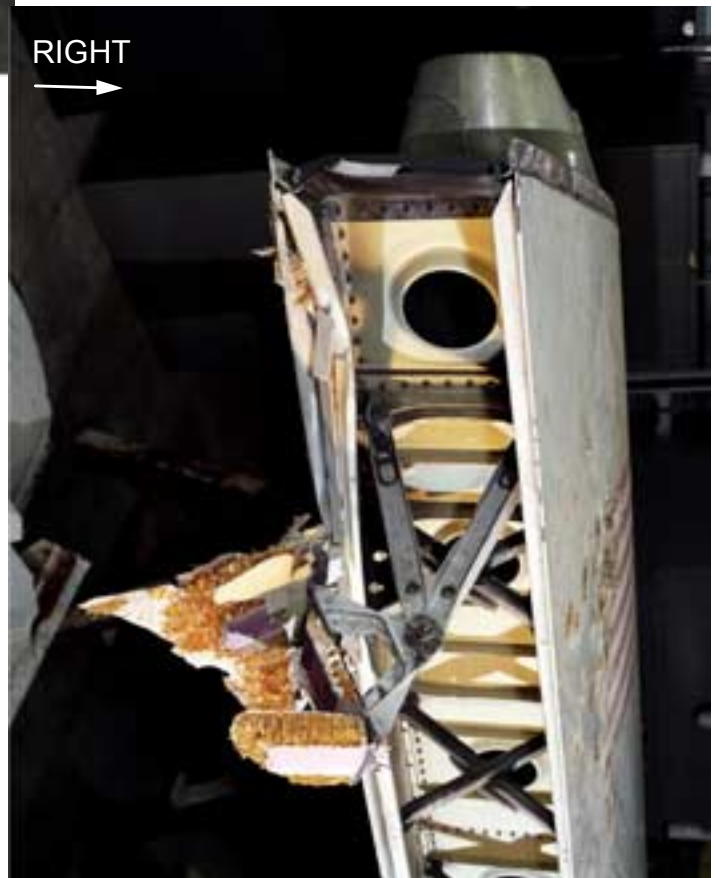
The rudder spar web was fractured at the hinge 7 attachment location and remained attached to the aft hinge fitting as shown in figure 44. The right spar "Z" shaped attachment flange was fractured just above and below the aft hinge fitting. The left spar flange was fractured just above the aft hinge fitting and 19 inches below the hinge fitting.

Figure 44. The hinge 7 fittings and attached rudder pieces that remained attached to the vertical stabilizer as viewed looking forward.

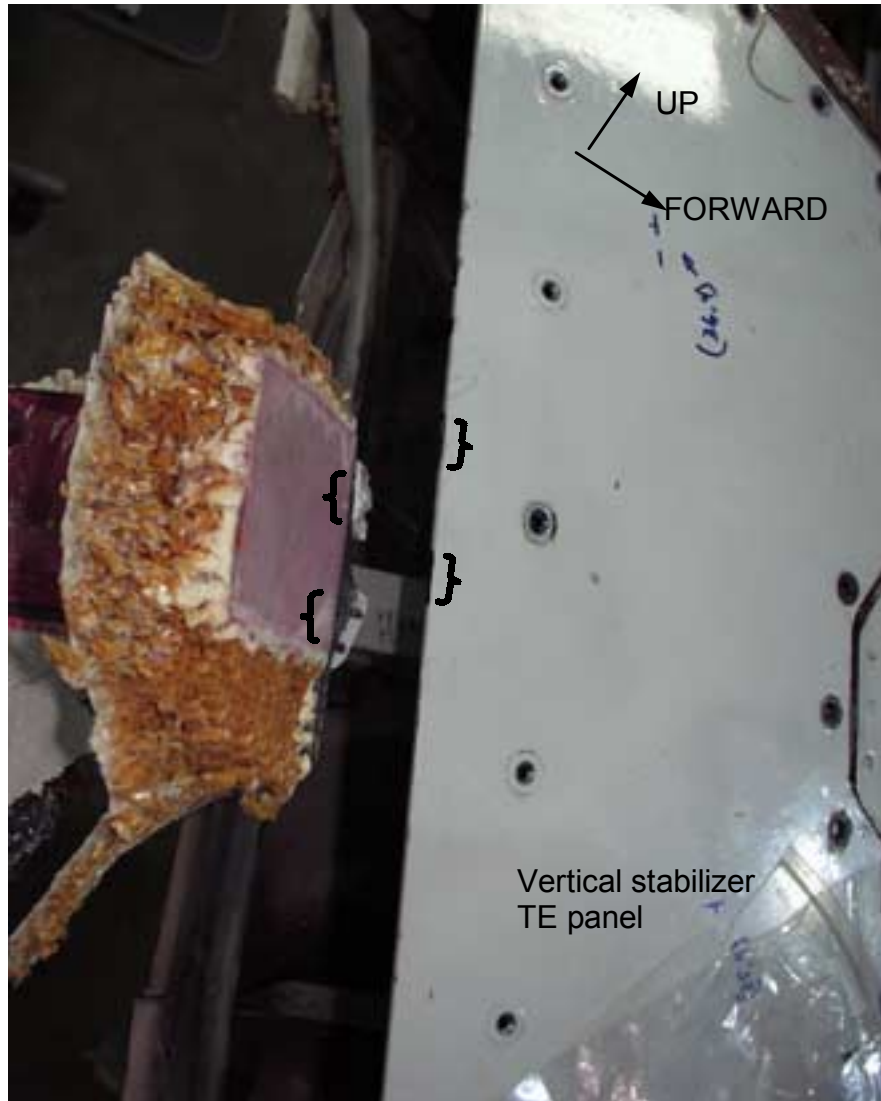
Figure 45. Another view of the hinge 7 fitting from the right side. Brackets indicate fractured and deformed angle brackets on the aft fitting and corresponding marks on the vertical stabilizer TE panel. Note that fasteners for the TE panel were removed.

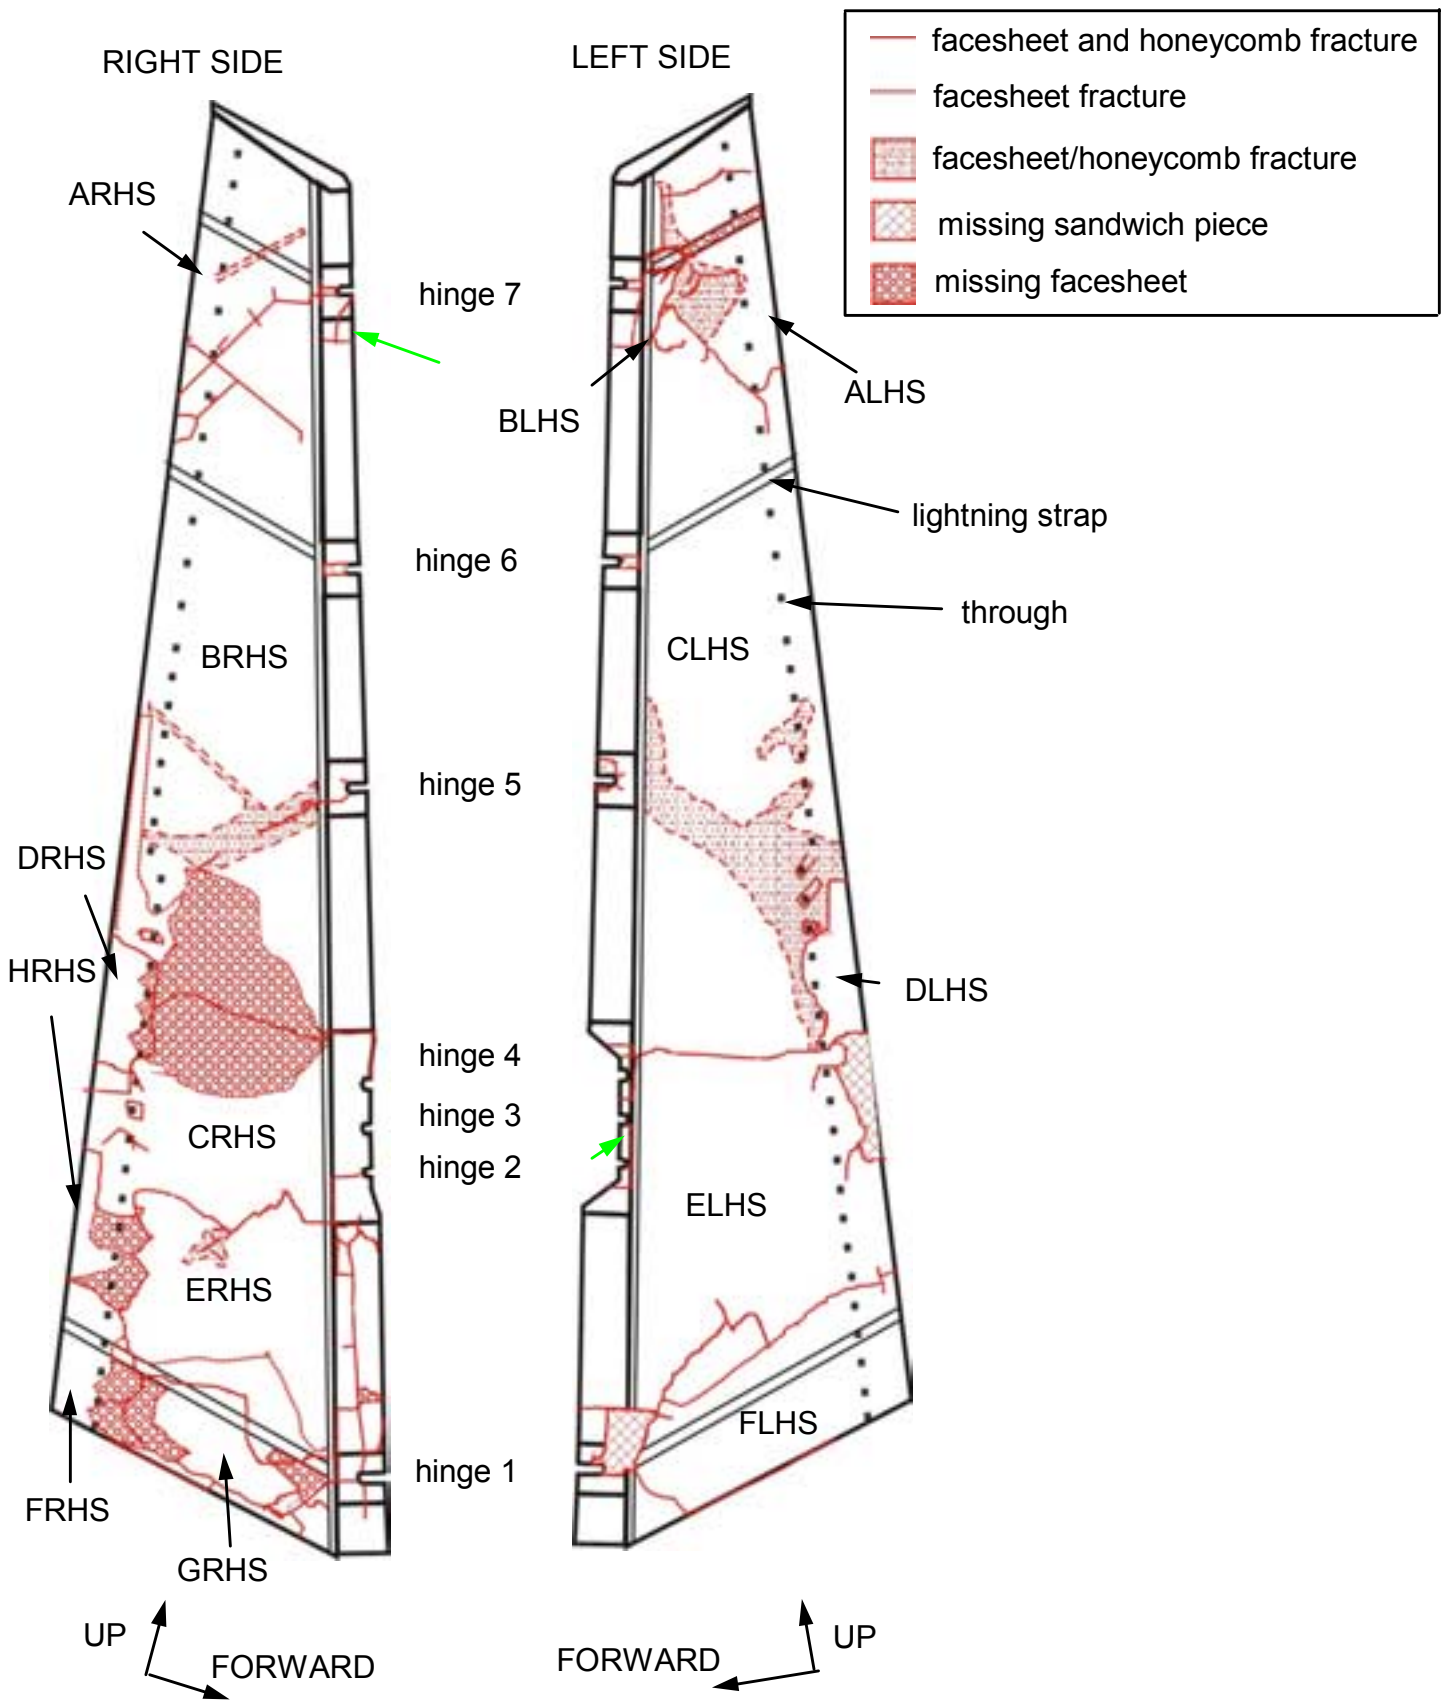
Drawings showing the approximate fracture locations for the rudder skin panels are shown in figure 47. In describing the damage, the skin panel labels shown in figure 47 will be used for reference.

Figure 47. Drawings of the right and left sides of the rudder showing the approximate locations of fractures and missing pieces. Unlabeled green arrows indicate fairing pieces that were found on land. Piece GRHS was also found on land.

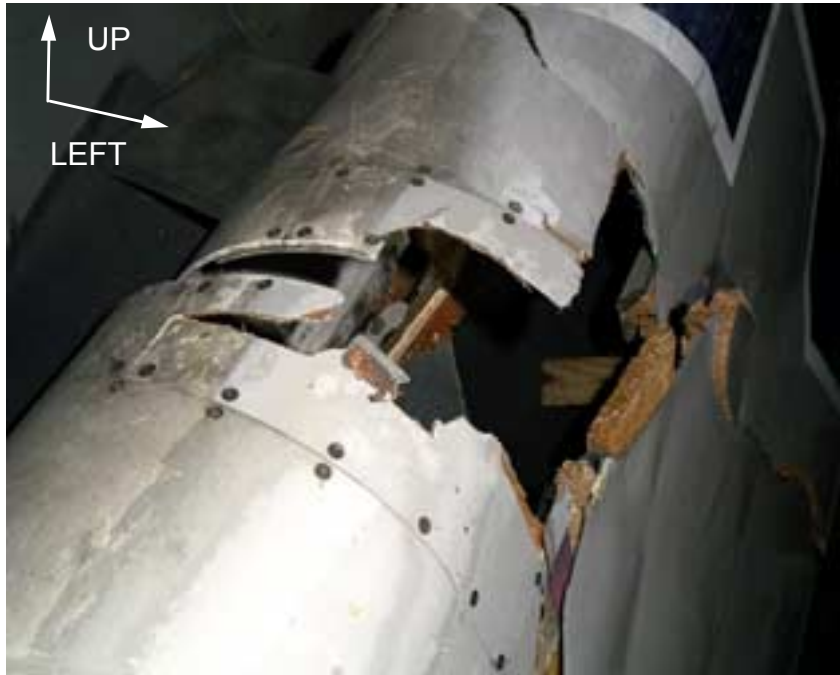
Figure 48. The left side of the LE fairing at hinge 1 as viewed looking mainly aft.

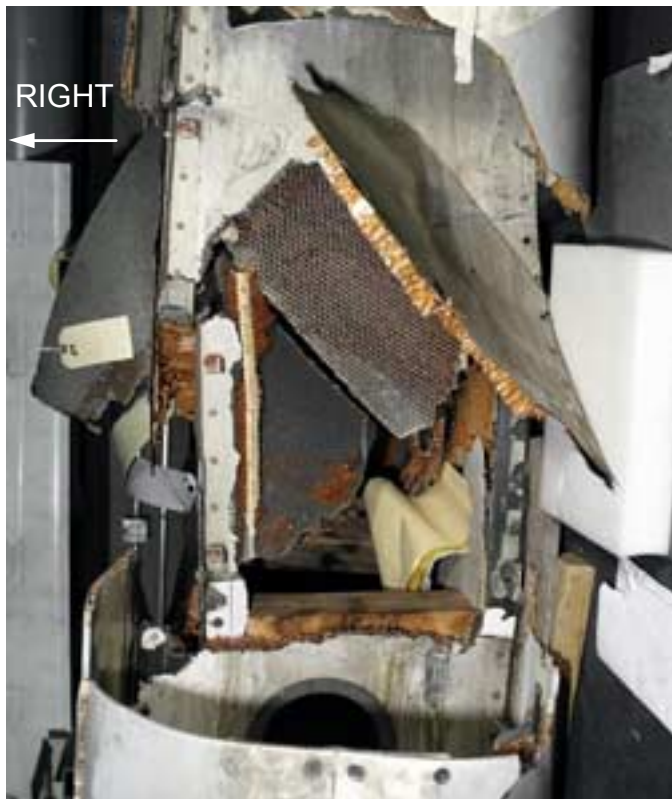
Figure 51. View of the rudder spar at hinge 1 looking mainly aft with fractured pieces of the LE fairing removed.

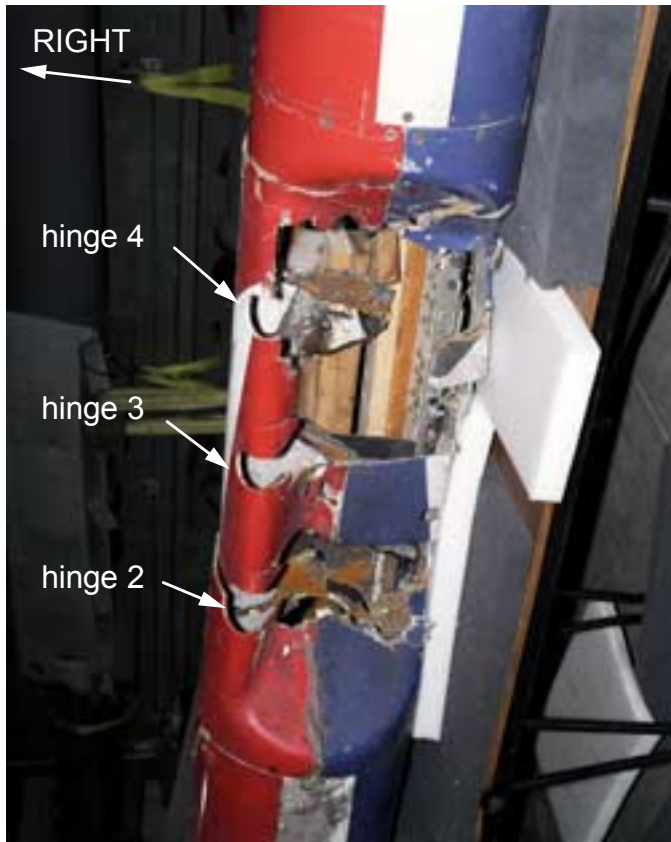
Figure 52. The LE fairing at hinges 2 to 4 as viewed looking mainly down and aft.

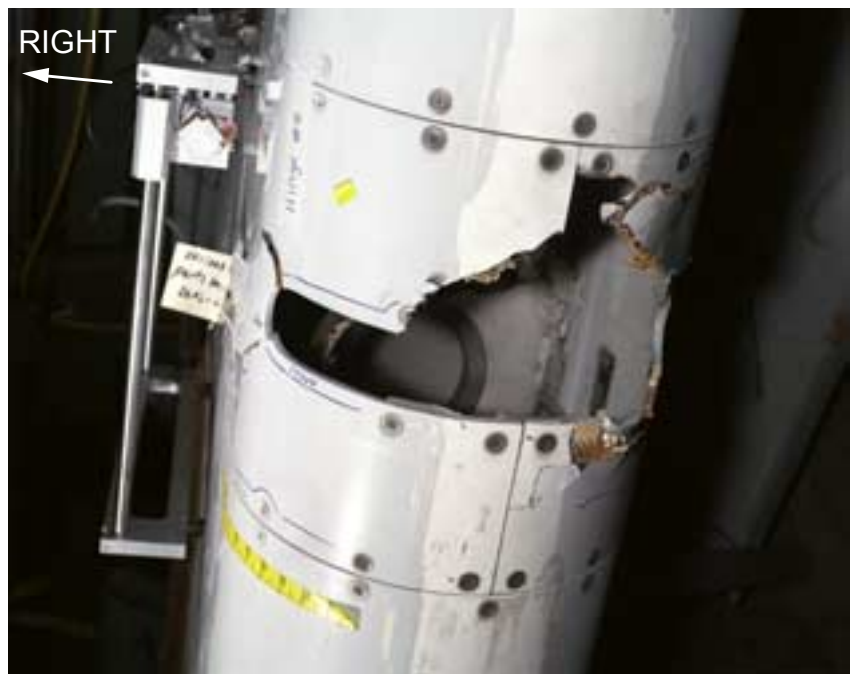
Figure 53. The LE fairing at hinge 5 as viewed looking mainly down and aft. Lamb wave equipment used for nondestructive examination is shown in the background on the right skin panel.

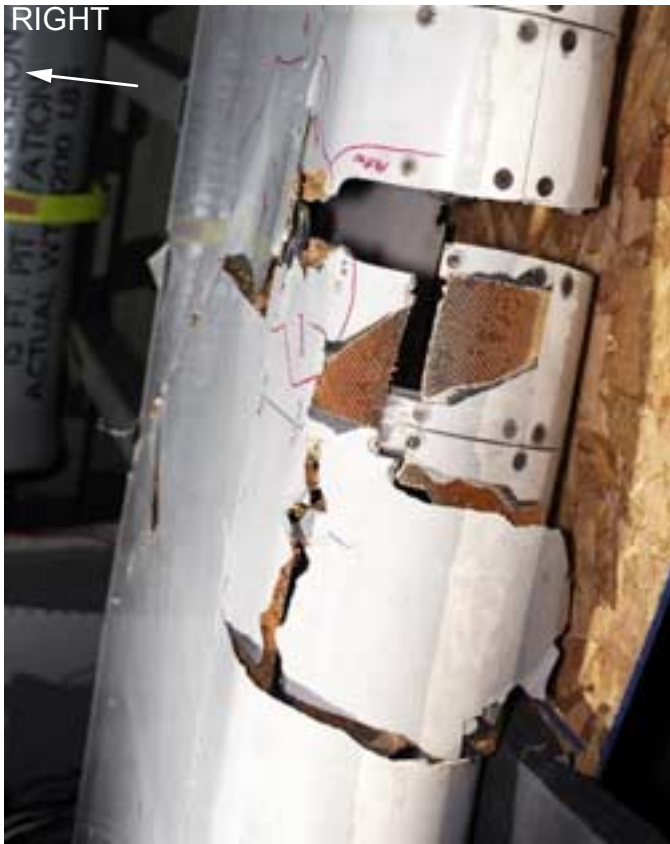
An overall view of the LE fairing at hinge 7 is shown in figure 57. The LE fairing had multiple fractures below the hinge 7 cutout. One of the pieces below the cutout was recovered on land. Material was missing from both the right and left ends of the cutout, and the width of the missing material appeared to correspond to the width of the forward fitting arms.

Figure 57. View of the LE fairing at hinge 7.

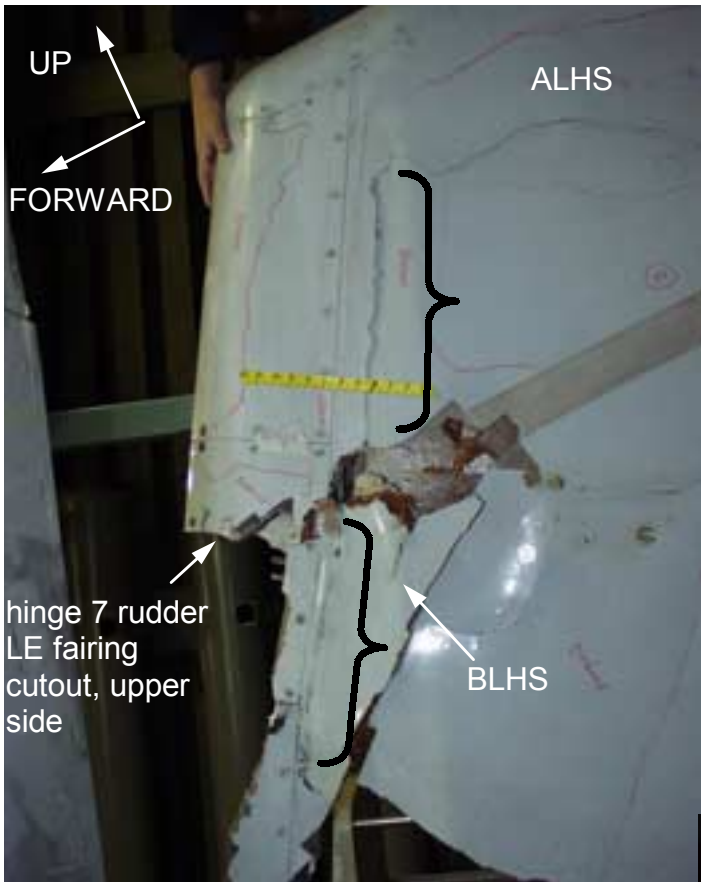
Pieces ALHS and BLHS had damage corresponding to heavy contact between the rudder left side and the vertical stabilizer left TE panel. A view of the damage on the rudder is shown in figure 63 with pieces ALHS and BLHS shown in their respective positions. Above hinge 7 on piece ALHS, the line of contact damage was nearly parallel to the rudder spar. Below hinge 7 on piece BLSH, the damage was not parallel to the rudder spar.

Figure 63. Left side view of pieces near hinge 7 where bracket indicate damage consistent with contact with the vertical stabilizer TE panel.

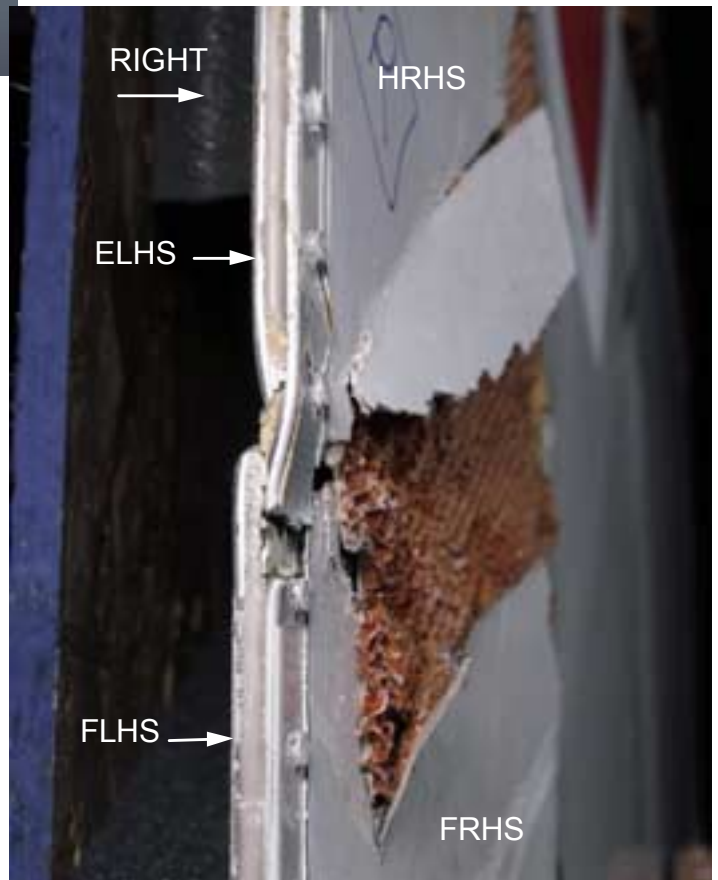
The metal trailing edge strips were fractured at many locations along the length of the rudder. The lowest fracture, shown in figure 64, was 36 inches above the lower rib,<sup>5</sup>

Figure 64. Fracture at the trailing edge between pieces FRHS and FLHS and pieces HRHS and ELHS showing local deformation of the metal trailing edge strips.

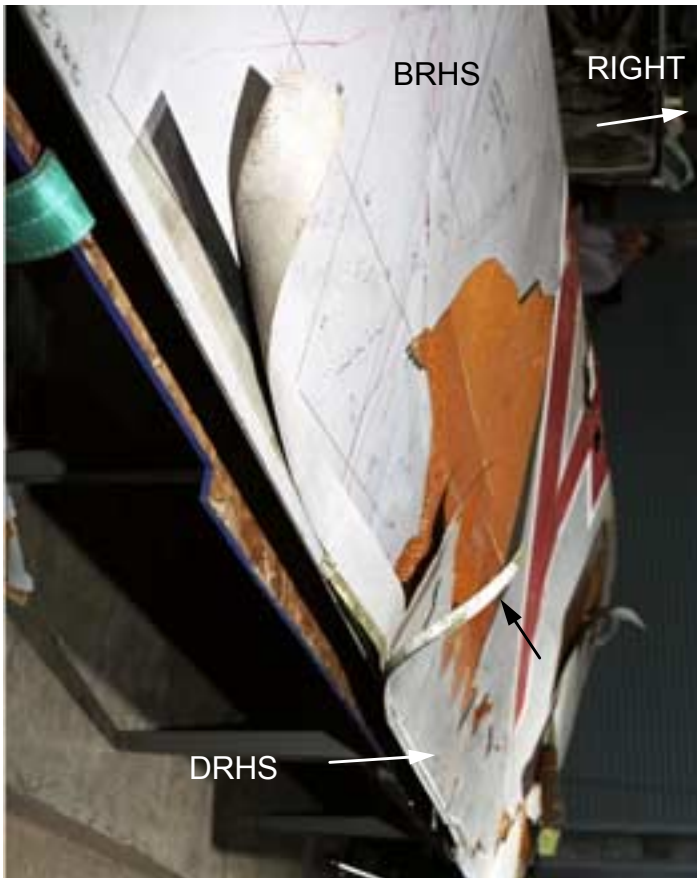
On the right side, the metal strip was separated at 159 inches above the lower rib, a location corresponding to a junction between the manufactured ends of two metal strip pieces. The upper portion of the metal strip had a general bend and twist as shown in figure 67 consistent with piece DRHS rotating upward and twisting counterclockwise (as viewed looking up) relative to piece BRHS.

Figure 67. The trailing edge of the rudder as view looking down and forward. An unlabeled arrow indicates the right trailing edge strip generally deformed near the upper end of piece DRHS.

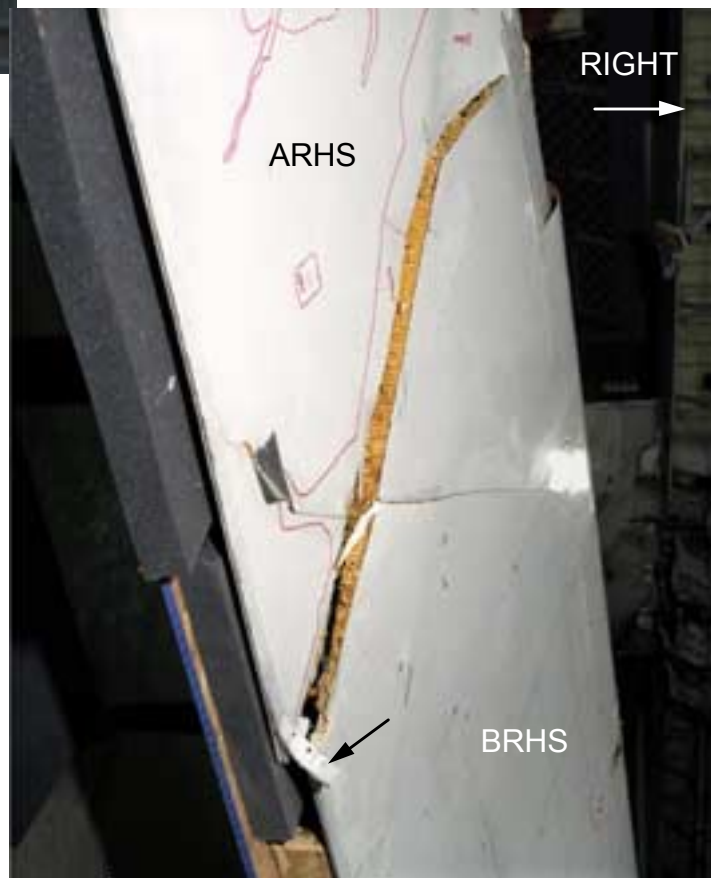
The uppermost fractures of the trailing edge metal strips were aft and below hinge 7 between pieces BRHS and ARHS on the right and between pieces CLHS and ALHS on the left. An overall view of the right side is shown in figure 68. The local deformation on both sides of the fracture was consistent with pieces ARHS and ALHS bending to the right and aft relative to pieces BRHS and CRHS.

Figure 68. The rudder trailing edge aft of hinge 7 as viewed looking mainly forward. An unlabeled arrow indicates the fracture at the trailing edge between pieces ARHS and BRHS showing local deformation of the metal trailing edge strip.

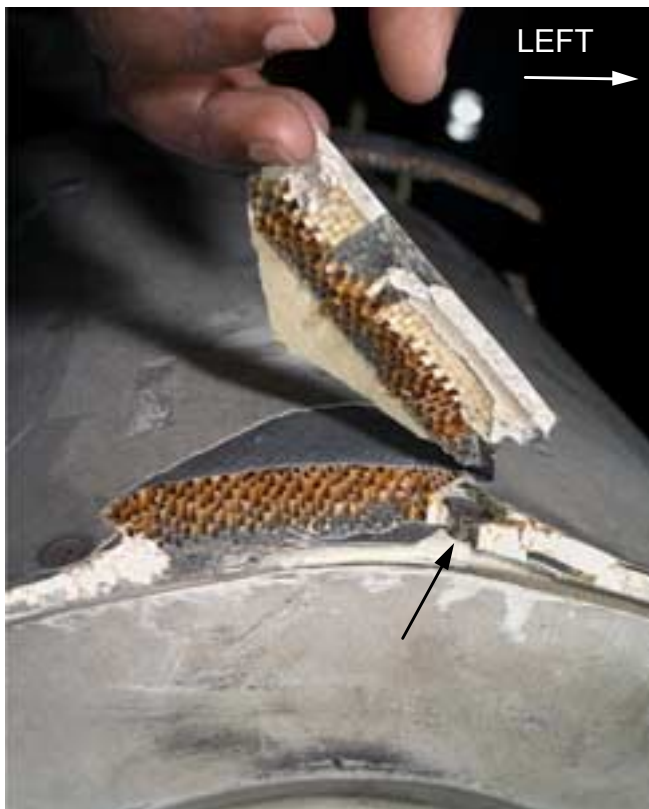
At the lower end of the LE fairing near the centerline, material was peeled from right to left as shown in figure 70. The fiberglass filler in the honeycomb cells was sheared on the right side of the damage. The right side of the washer for the fastener at the centerline was bent forward.

Figure 70. Damage at the lower end of the LE fairing as viewed looking upward and aft. An unlabeled arrow indicates the bent washer at the centerline fastener.
