**F. APPENDIX B**

## INSPECTION PROTOCOL

ESWNG-70032/02

**Subject:** Fin box and rudder inspection on aircraft A300-600, MSN 420 at NASA Langley Research Center in Hampton, Virginia / USA.

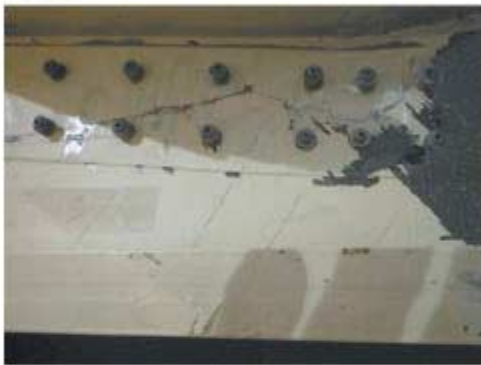
9

Fig.10: Photo documentaion of Findings 7-11 between center spar and front spar

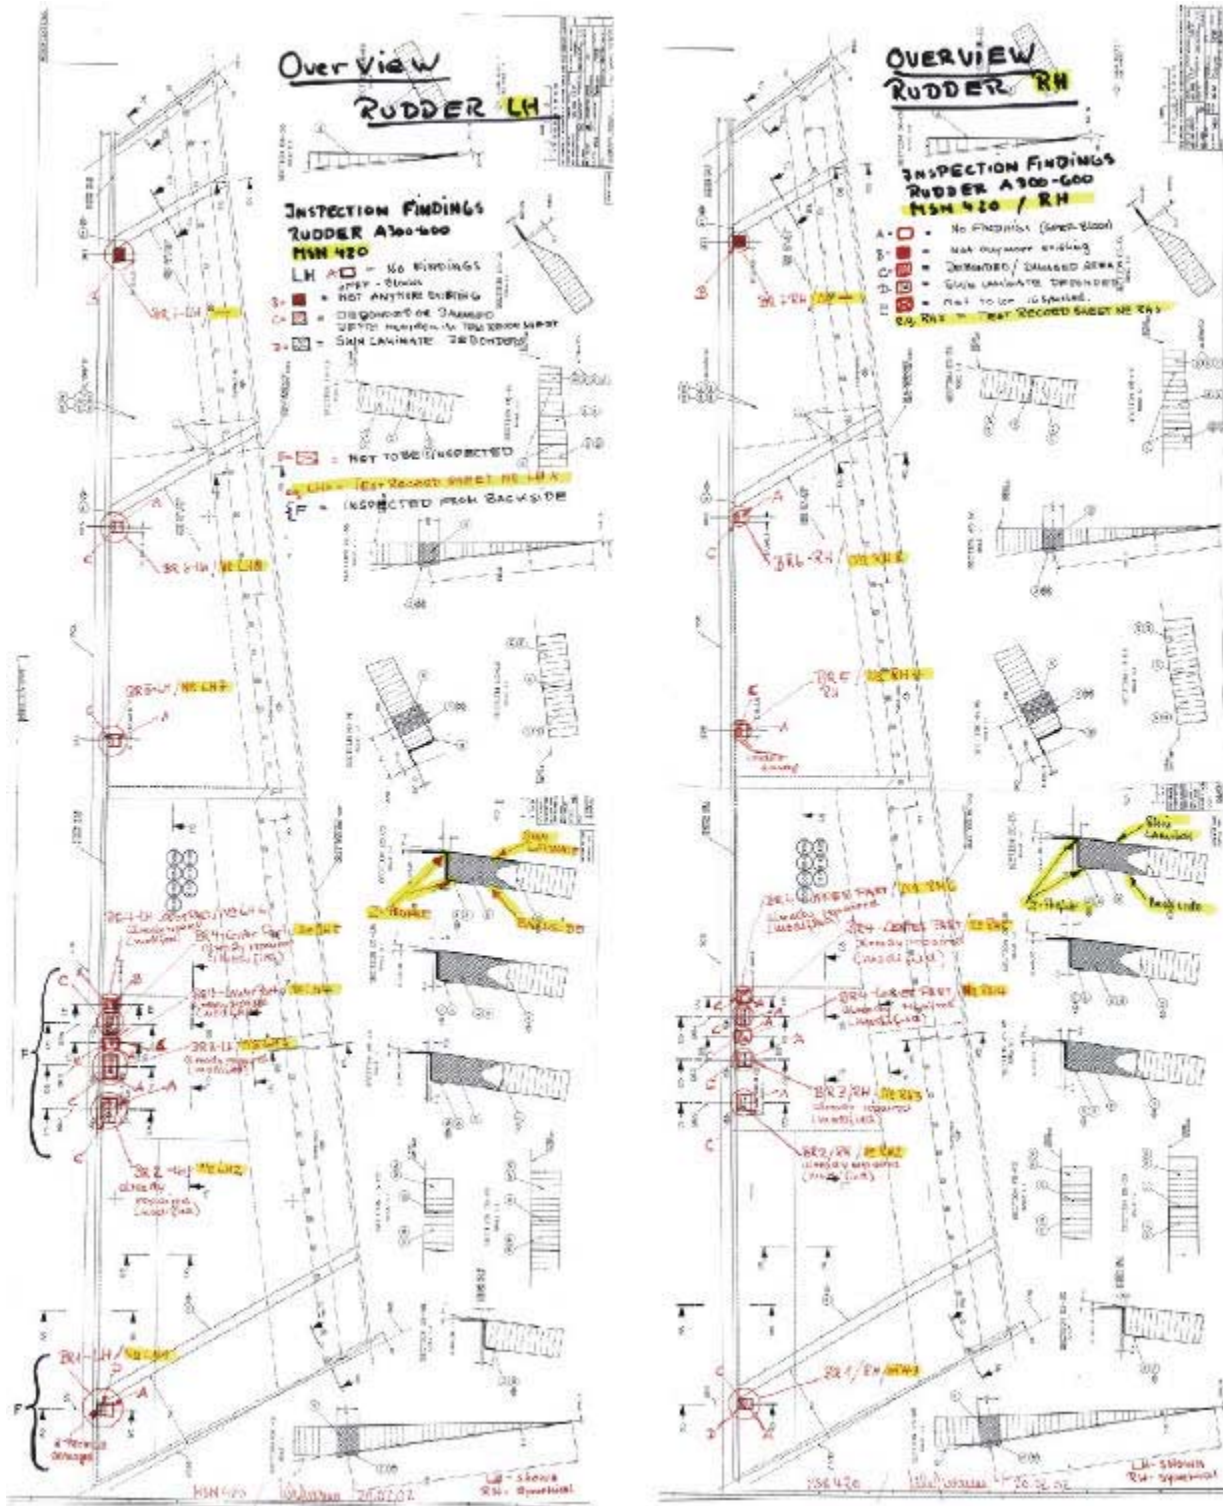
Record Sheet - Hinge Attachment Area BR1 LH **55-40-04**  
Figure 408

Z-PROFILE DEBONDED

DEBONDING/DELAMINATION

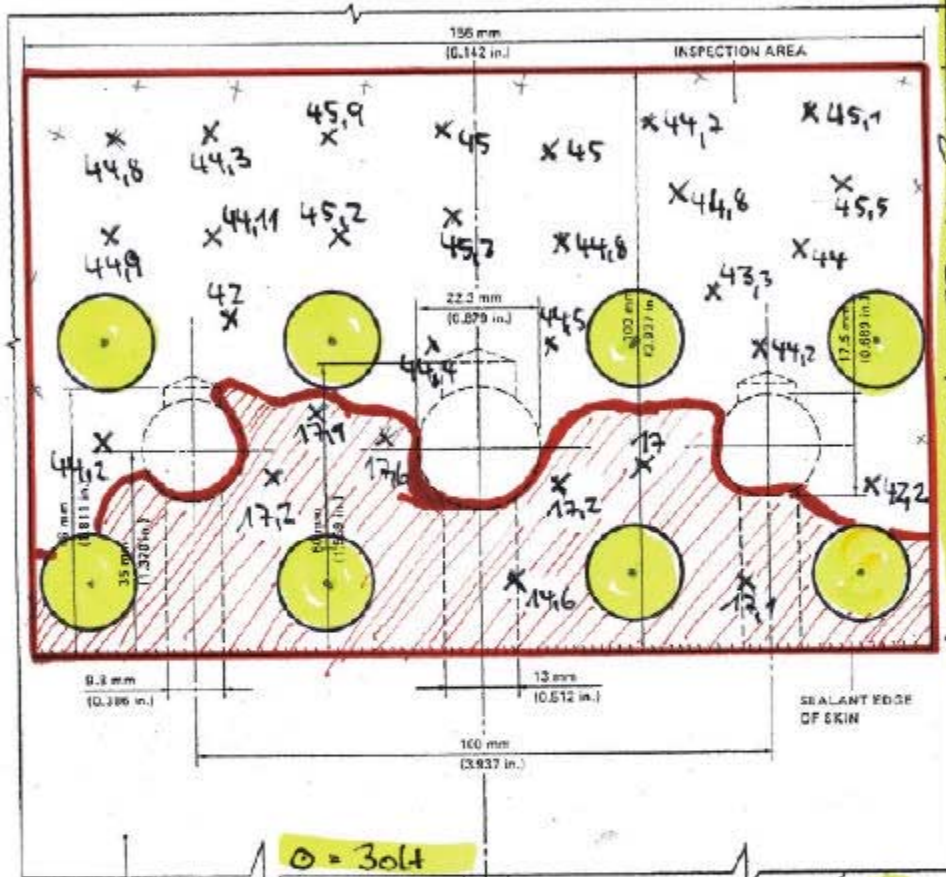
Record Sheet - Hinge Attachment Area BR2/LH  
 Figure 409

DEBRUIVING/DELAMINATION  
 x x x mm ( in.) = DEPTH OF INDICATION

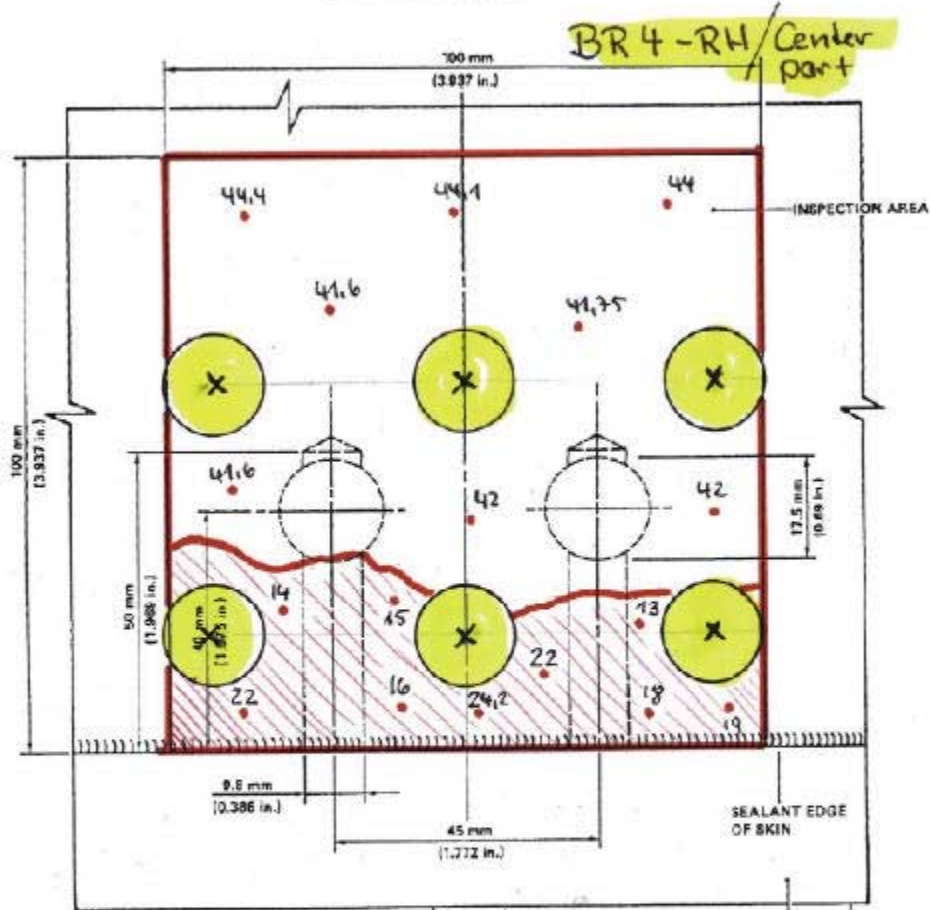
(X) - Rivets/bolts (area already repaired.) STAT30/BR4  
 DEBONDING/DELAMINATION  
 x x x (mm) (in.) = DEPTH OF INDICATION  
 HINGE  
 RH SIDE SHOWN  
 ATTACHMENT STRIP FOR LE ACCESS PANEL

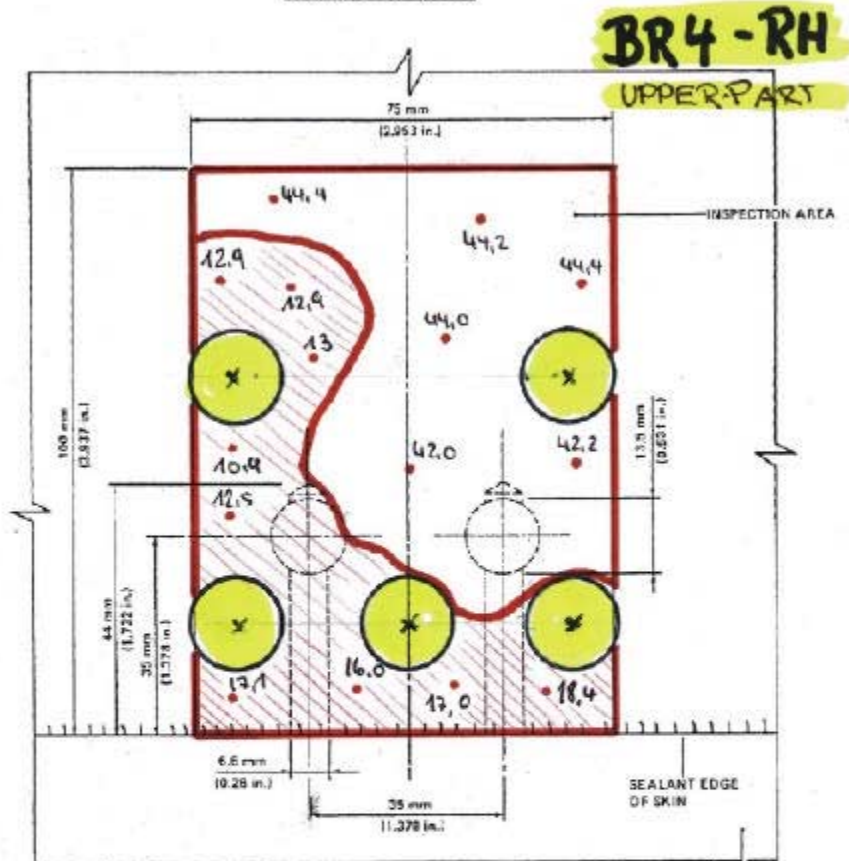
FWD  
 (x) Rivets/Bolts (area already received)  
 ▨ DESONDING/DELAMINATION  
 x x x (mm) (in.) - DEPTH OF INDICATION  
 LH SIDE SHOWN HINGE RH SIMILAR  
 ATTACHMENT STRIP FOR LE ACCESS PANEL

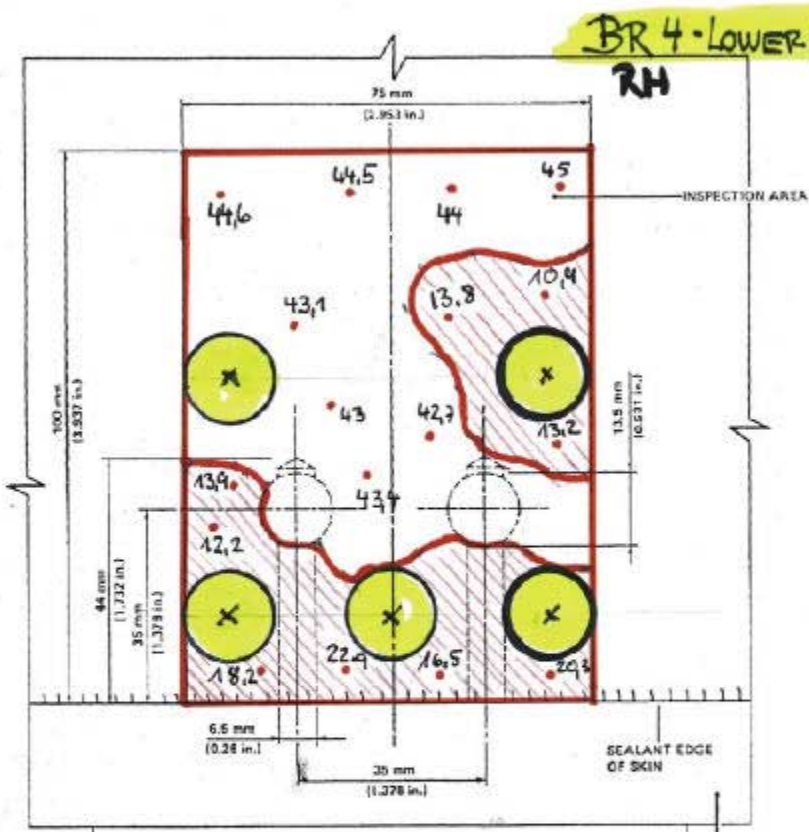
**BR 4 - LOWER PART**

FWD  
X - Rivets/bolts  
(are already repaired)

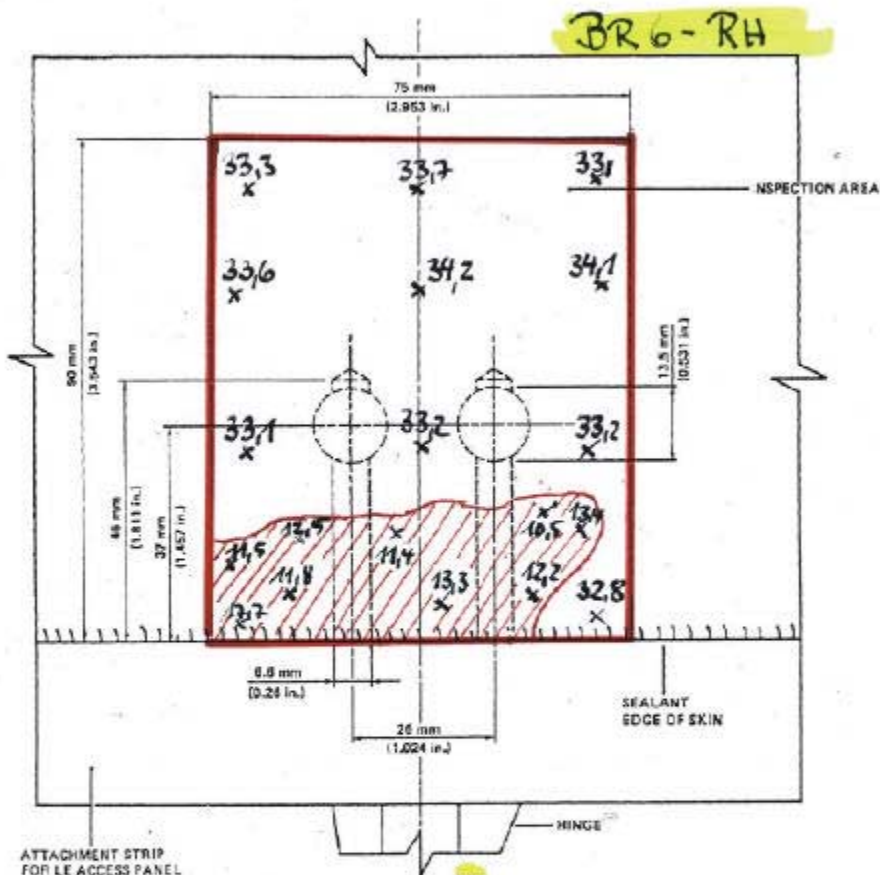
Record Sheet - Hinge Attachment Area BR6/67  
PART 4  
55-40-04  
Figure 414  
Page 420

DEBONDING/DELAMINATION  
xxx mm [ in. ] = DEPTH OF INDICATION

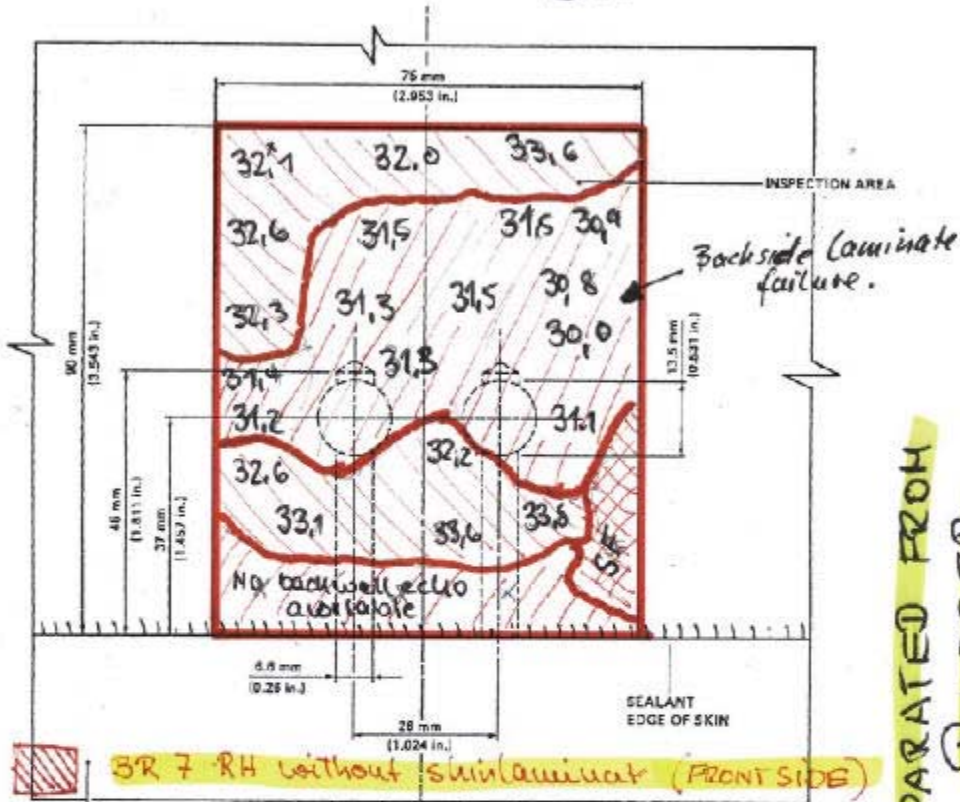
BR7 - RH

SF = SURFACE FAILURE

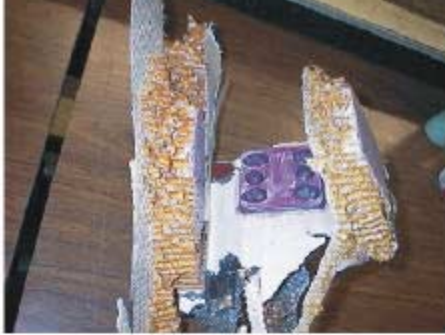
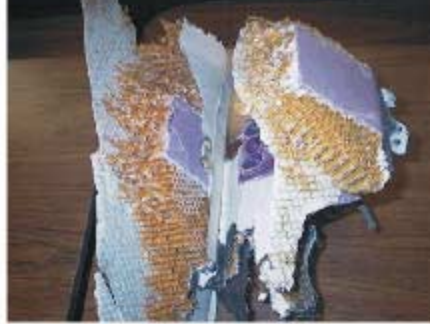
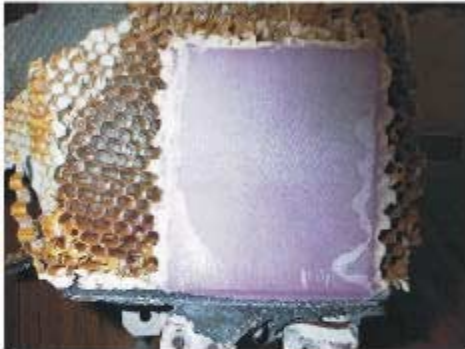
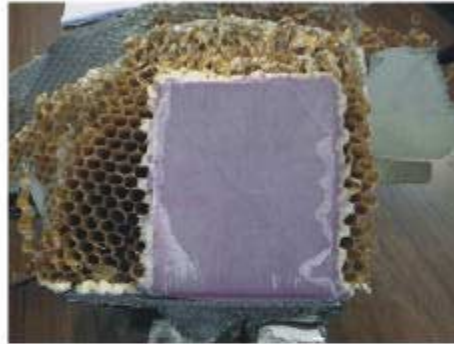
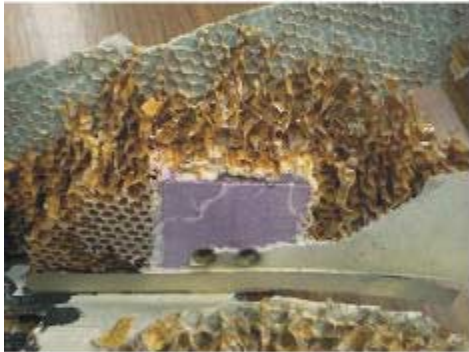
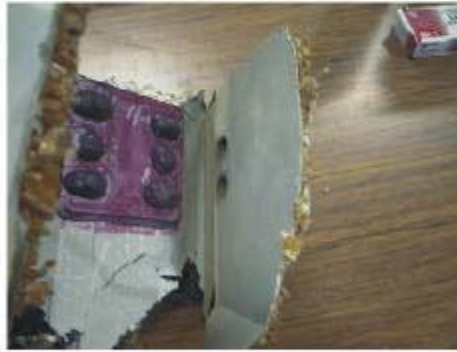
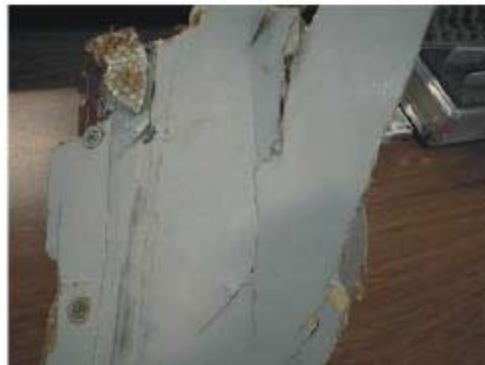
Photo documentation of glass fiber blocks BR1 – 7 LH/R

Debondings, delaminations and damages were found in and at fiber glass hinge attachment blocks

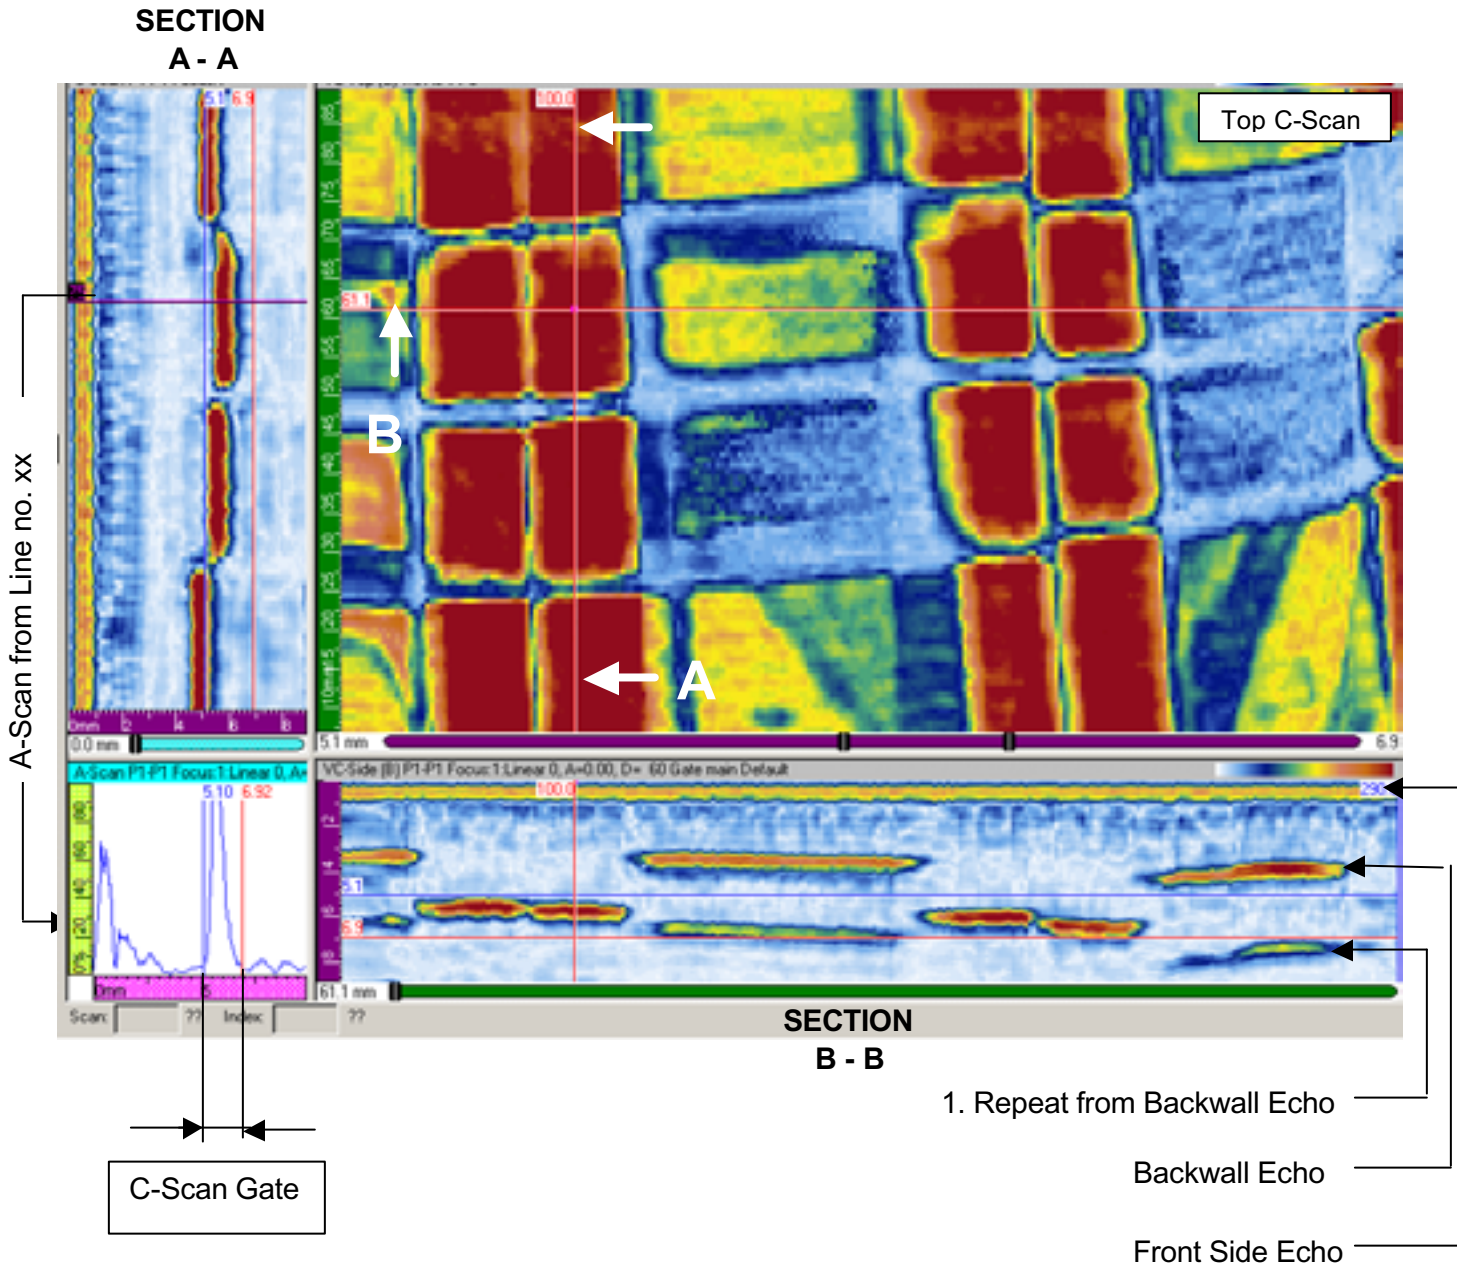
Example for an area without indication
