SECY-03-0036

SUBJECT: REPORT TO CONGRESS ON ABNORMAL OCCURRENCES FOR
FISCAL YEAR 2002

02-1 Reactor Vessel Head Degradation at Davis-Besse Nuclear Power Station in Oak Harbor, Ohio

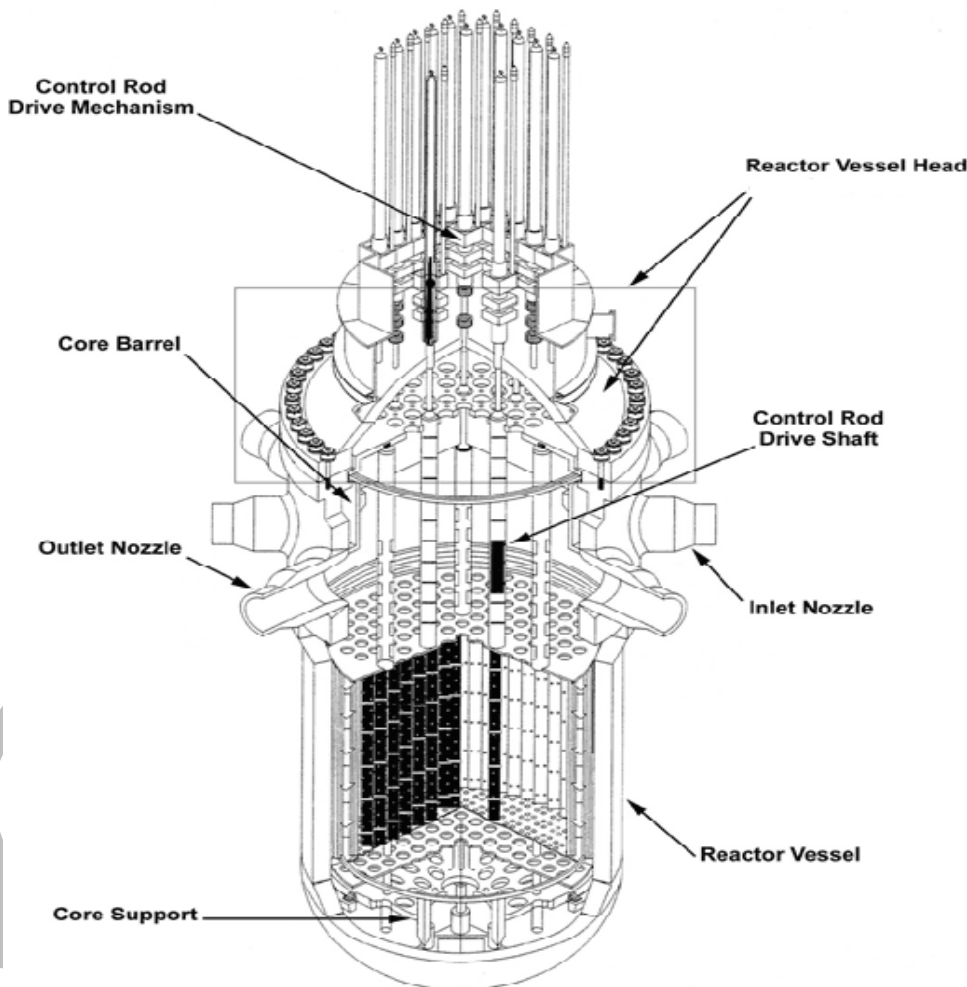
Figure 1. Typical Pressurized Water Reactor (PWR)

Nature and Probable Consequences — On February 16, 2002, the Davis-Besse facility began its 13th refueling outage, which included inspections of the control rod drive mechanism (CRDM) nozzles in accordance with NRC Bulletin 2001-01, "Circumferential Cracking of Reactor Pressure Vessel Head Penetration Nozzles," issued on August 3, 2001. These nozzles penetrate through the reactor pressure vessel (RPV) head and are attached by welds. Nozzle cracking was first discovered in the industry in the late 1980s. The concern with cracking is the potential loss of control rod drive function (rod ejection) and the resultant loss of coolant accident (LOCA) should the cracks reach a critical size and orientation. Also of concern is the potential for the reactor coolant to leak through small cracks in CRDM nozzles and cause boric acid corrosion of the RPV head. The RPV head is an integral part of the reactor coolant pressure boundary (Figure 1) and loss of its integrity can likewise result in a LOCA.
