Water Operation and Maintenance Bulletin

No. 212

June 2005

Always Brush Your Teeth on a Regular Basis

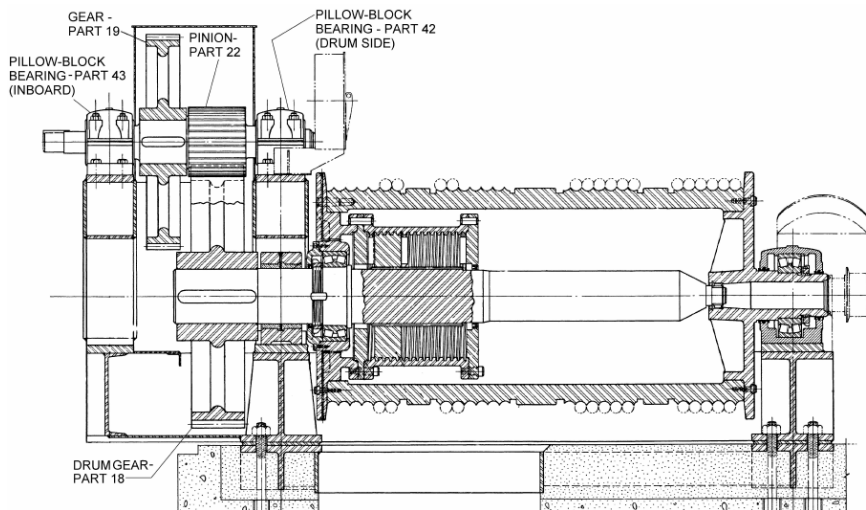
Cover photograph –Section through drum gearing.

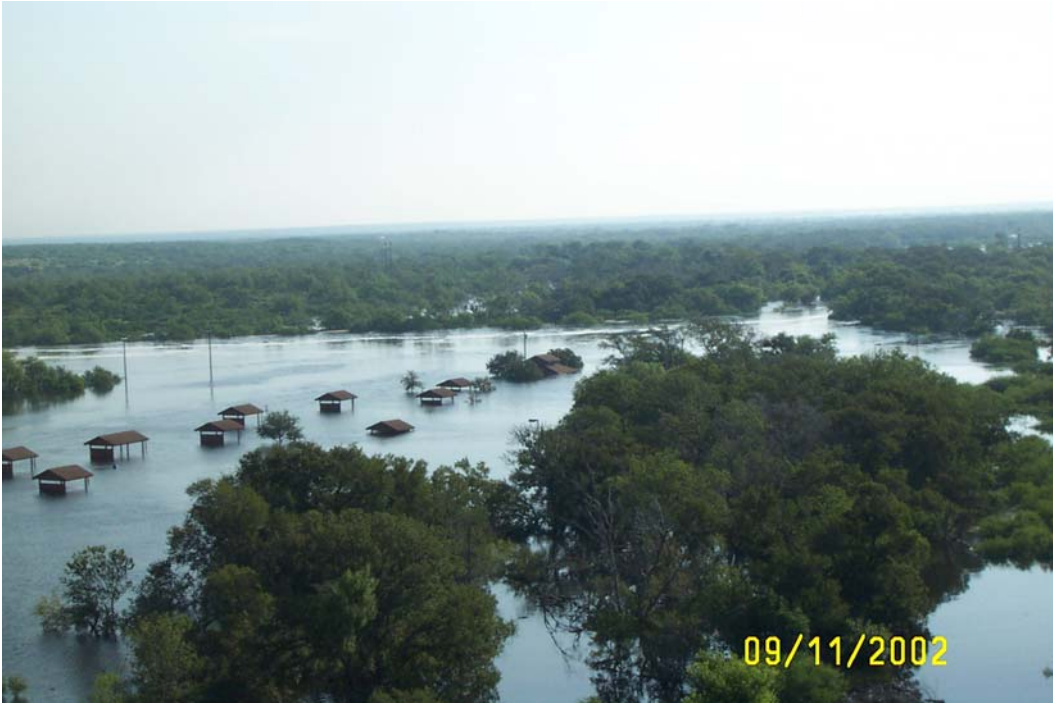
Looking downstream from the crest of Choke Canyon Dam during a September 2001 event. The inundated structures are part of the South Shore Unit recreational facilities of Choke Canyon State Park.

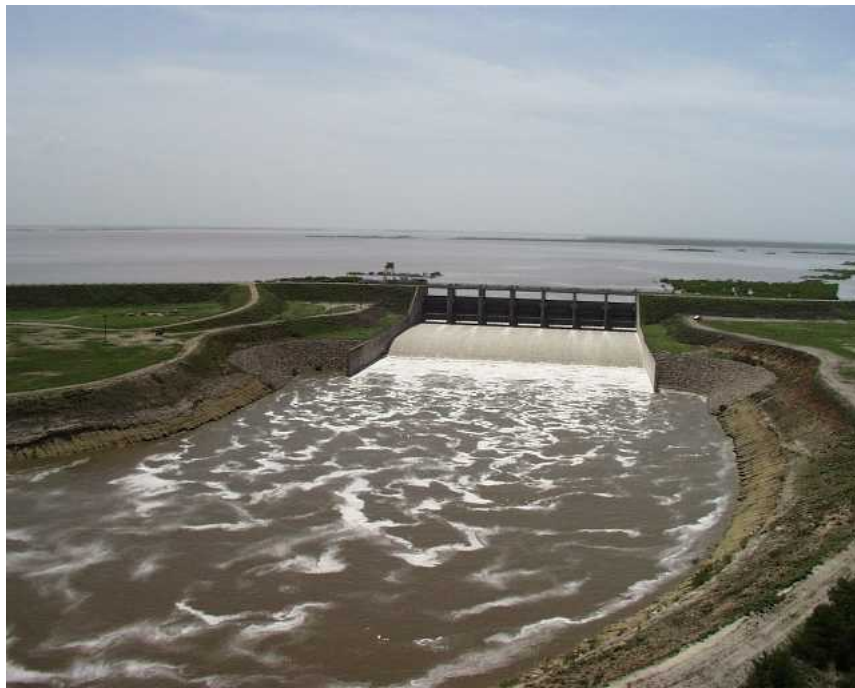
Choke Canyon Dam surcharge releases being made during a July 2002 event.

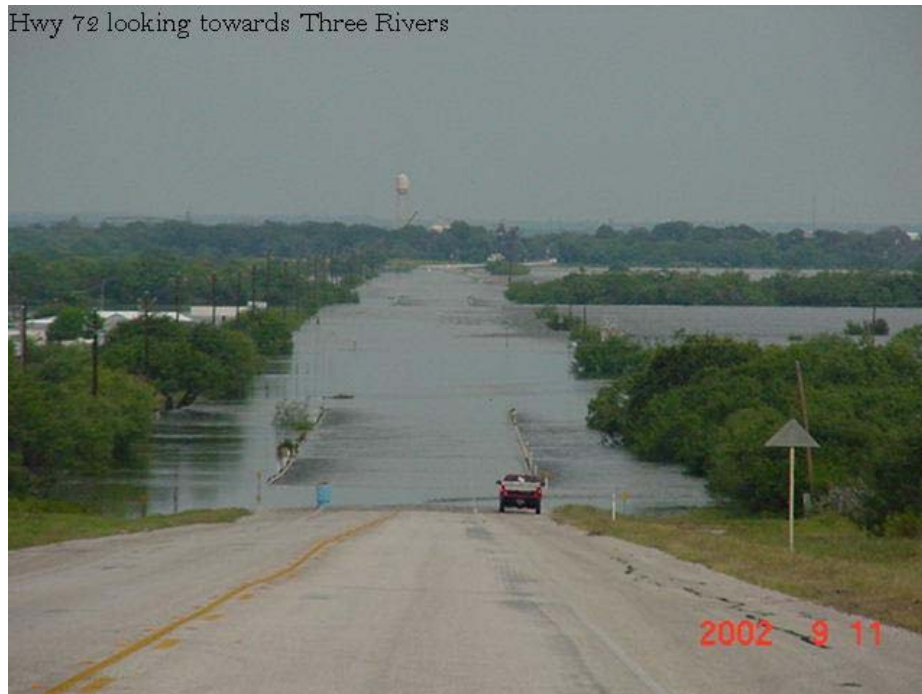
Downstream of Choke Canyon Dam during surcharge operations at State Highway 72 looking (east) towards the city of Three Rivers, Texas, September 2002. Normally, this section of the highway is 1 to 2 miles from the Frio and Atascosa Rivers.

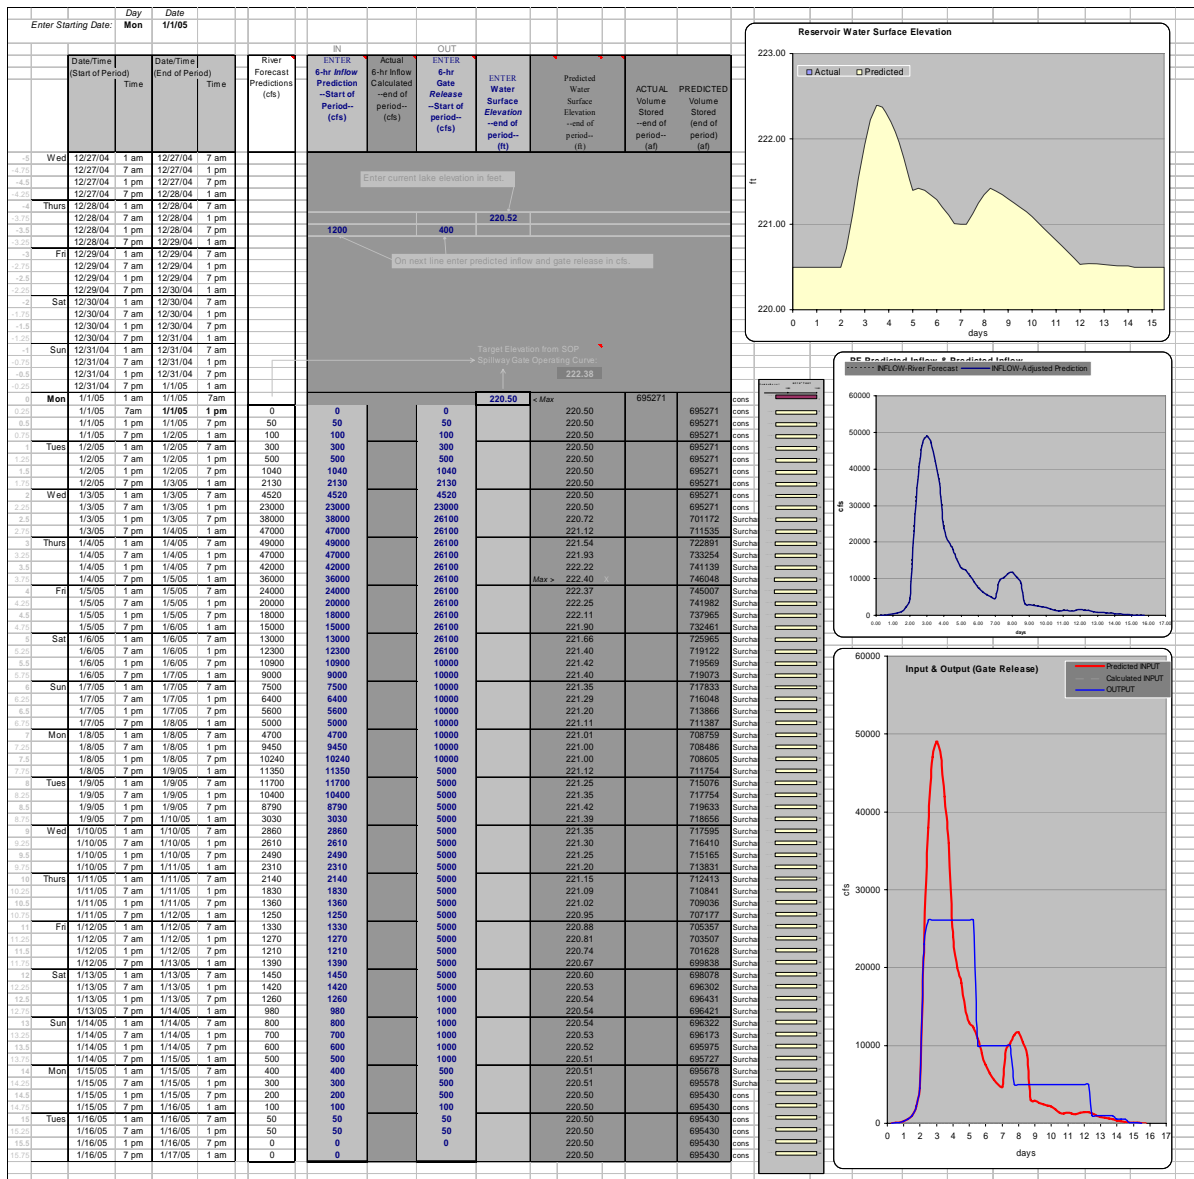
Below is a view of a spreadsheet model used to (1) determine the target reservoir elevation, (2) predict the reservoir crest, (3) and monitor an event. As an event develops, actual inflows and recorded reservoir elevations are entered into the spreadsheet so that adjustments may be made as necessary. The spreadsheet generates graphic representations of predicted and actual values. A similar spreadsheet is used to route inflows through a reservoir as if releases were being made based only on observed reservoir rise and to determine the target elevation.
