WATER OPERATION AND MAINTENANCE

BULLETIN NO. 75

MARCH 1971

CONCRETE PIPE JOINT LEAK REPAIR

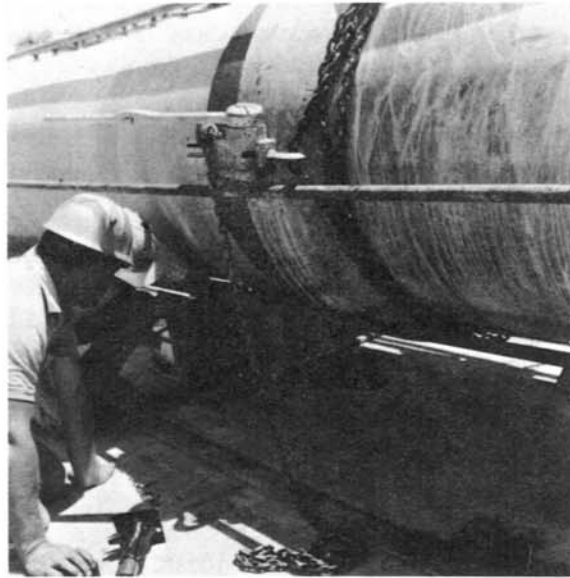
Photograph 3. Photo CN805-243-1169 NA

The first steel ring tested was one that could be clamped about the spigot end of the pipe. This ring is shown in Photograph 2 below, and in the drawing in Figure 2, page 5. "Come-a-longs" were used to pull the ring against the gasket to seal the joint, as shown in Photograph 3 on the next page. Two ears were welded on the semicircular rings in order to draw the ring against the gasket to compress it. With the gasket in place and the ring clamped, the pipes were filled with water and the pressure was slowly increased. At 20 psi the pipe began to leak. The leak occurred between the gasket and the face of the bell. Experimentation indicated that even if sufficient compression of the gasket could be developed to prevent leakage small settlement of the pipe would relieve the pressure on the gasket on one side of the ring enabling a leak to reoccur. This ring was therefore abandoned.

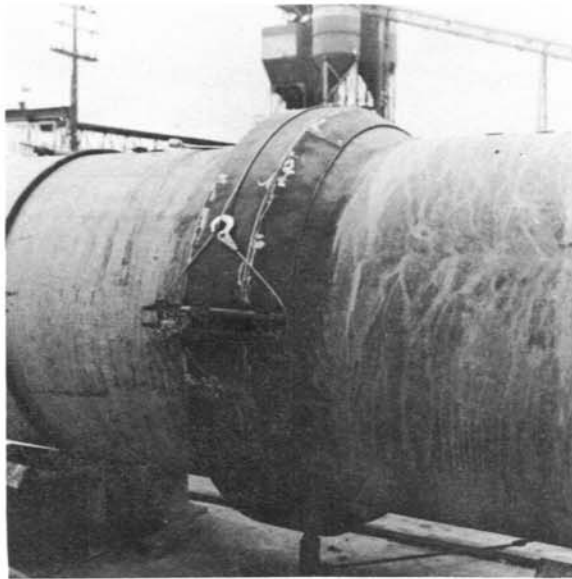
Photograph 4. Photo CN805-243-1190 NA

The second ring shown in the drawing in Figure 3, page 7, was then tested. An attempt was made to install the semicircular bell rings, but they dug into and stretched the gasket at the ring connections, Photograph 4, page 9, making it impossible to clamp the ring about the pipe. To remedy this problem, the ring was cut into four 90° pieces for easy assembly. Several views of this four-piece ring are shown in Photographs 5, 6, 7, and 8.

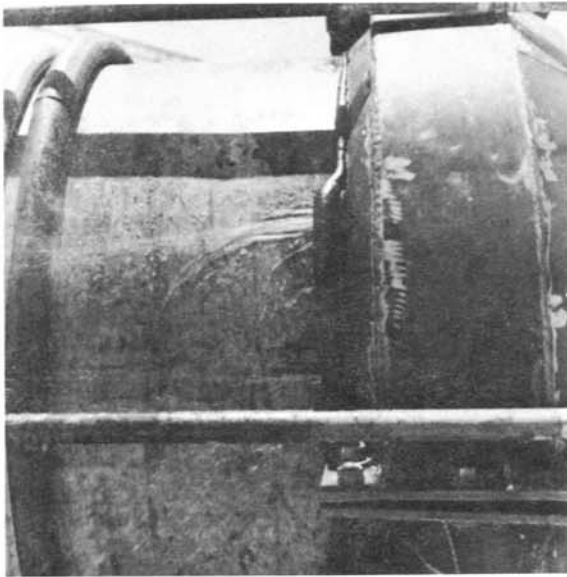
Photograph 11. Photo CN805-243-1195 NA

rubber could be pressed together without gluing to form a continuous ring. The 2-inch-diameter soft rubber gasket was tested next. A pressure was raised, the gasket extruded from beneath the ring, Photograph 11 below. At this point the soft rubber materials were abandoned.

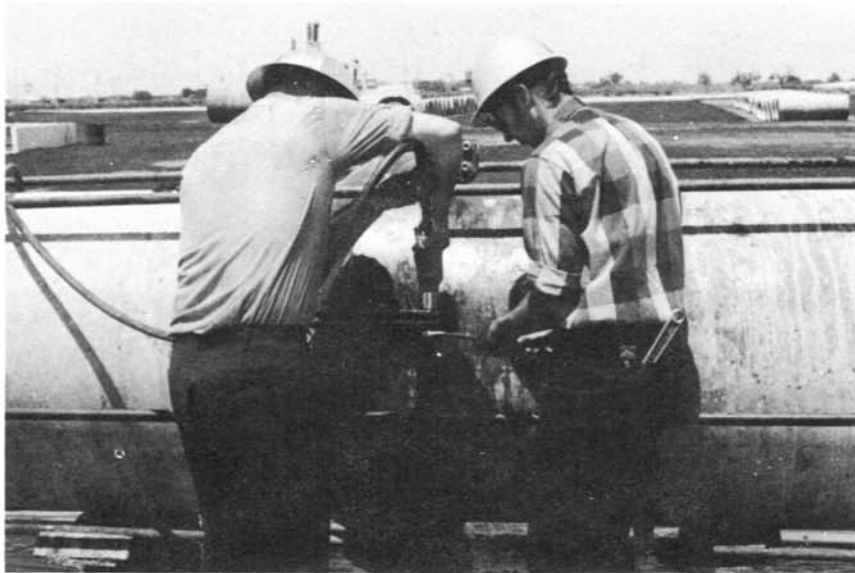
Photograph 12. Photo CN805-243-1182 NA

about the pipe before the tension rods were fastened. The ring was held loosely about the pipe with one bolt in each of its four connections. A pressure of 25 to 30 psi was the maximum pressure that could be developed with the pipe leaking. The ring was gradually tightened about the pipe, Photograph 12, beginning with the set of bolts closest to the shoulder of the bell. This moved the ring back along the bell exerting a lateral and downward pressure on the gasket. The bolts were progressively tightened around the pipe keeping the flanges equi-distant apart. The tightening was continued until the leaking stopped. The pressure on the pipe gradually increased from 25 psi as the ring was tightened to 52 psi at the stoppage of the leak, Photograph 13 on the next page.
