WATER OPERATION AND MAINTENANCE

BULLETIN NO. 152

June 1990

**UNITED STATES DEPARTMENT OF THE INTERIOR
Bureau of Reclamation**

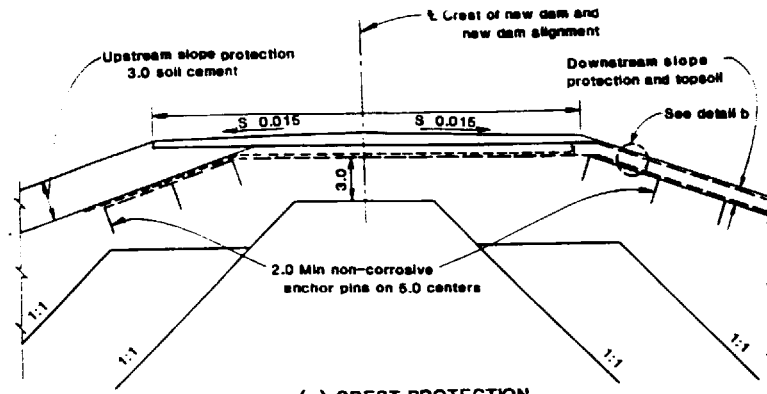
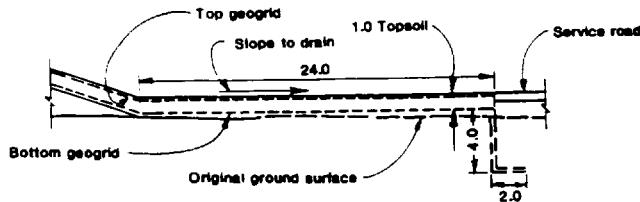
FIGURE 1. JACKSON LAKE DAM
(DIMENSIONS IN UNITS OF FEET)

On the basis of durability, environmental impact, overall cost, and constructibility, a reinforced grass slope was selected to provide overtopping protection to Jackson Lake Dam (see figure 1). A 0.3-m (1-foot) layer of topsoil was placed on the downstream face of the dam to support a grass cover, and for overtopping protection, an erosion control geogrid was placed on the topsoil and pinned down to be in firm contact with the dam face (figure 1a.). Between adjacent layers of geogrids there was an overlap of at least 50 mm (2 inches). In addition, a separate geogrid was placed between the embankment material and the topsoil as a second line of defense should the reinforced grass layer fail and be washed away (figure 1b.). This geogrid was secured to the embankment with noncorrosive pins, and a minimum overlap of 150 mm (6 inches) was specified. The geogrid was laid across the crest and down the upstream face under the upstream slope protection. At the downstream toe of the dam, both the underlying geogrid and surface erosion control material was extended 8 m (26 feet) or about four times the tailwater depth beyond the embankment toe (figure 1c.).

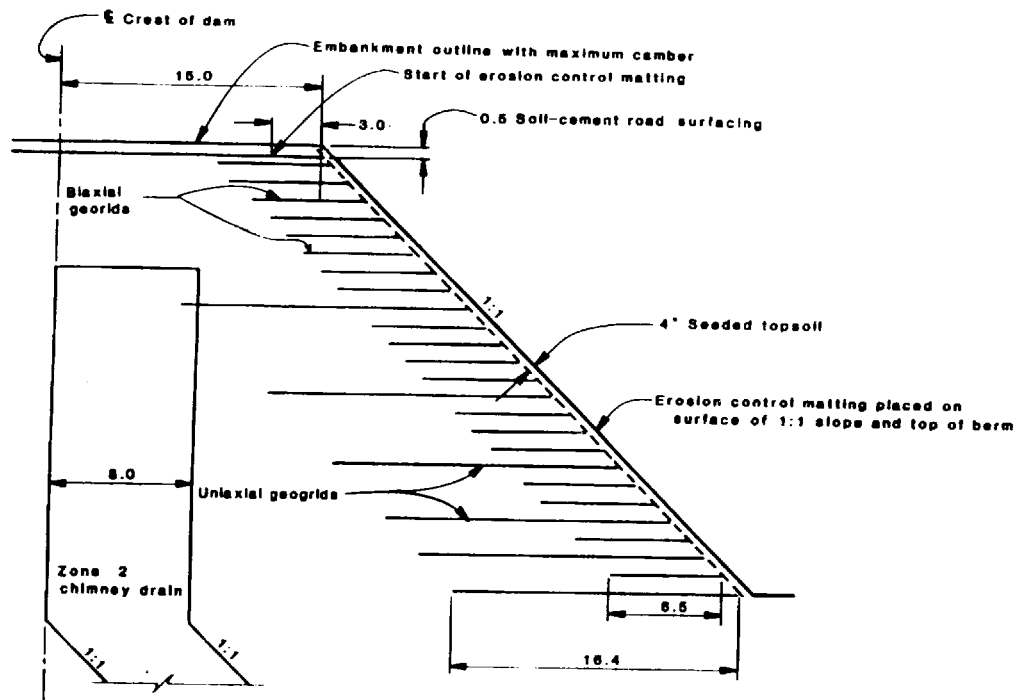
FIGURE 2. DAVIS CREEK DAM GEOGRID REINFORCEMENT
(DIMENSIONS IN UNITS OF FEET)

outer edges of the slope and permit hauling, placement, and compaction equipment to operate all the way to the edge of the slope (figure 2). The finished slope will be covered with topsoil, seeded, and protected by an erosion control matting in order to cultivate a grass cover and root system that will provide long-term slope protection.

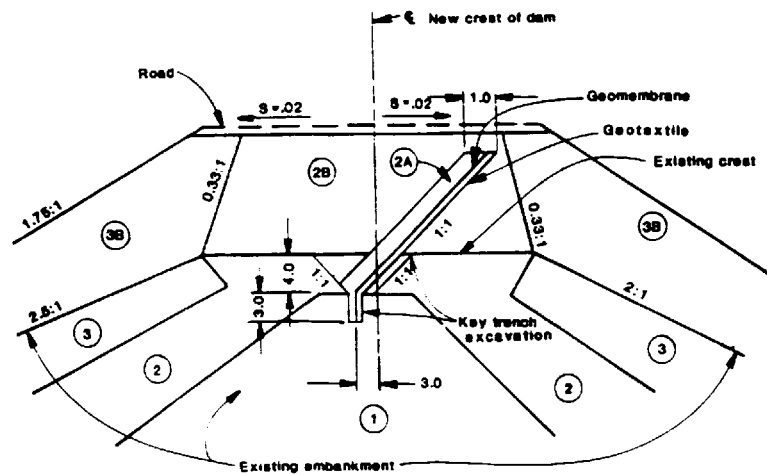
FIGURE 3. PACTOLA DAM CREST RAISE
(DIMENSIONS IN UNITS OF FEET)

Pactola Dam.—Pactola Dam needed to be raised to accommodate a revised probable maximum flood. To facilitate handling of the high traffic volume, reduce the number of construction seasons, and avoid unsightly borrow area construction, a geomembrane was selected as the impervious barrier for the raised embankment (figure 3). Use of a membrane significantly reduced the volume of the graded sand filter zone, for which a 96-km (60-mile) haul was anticipated. The geomembrane also replaced the clay core eliminating the need for borrow area development in the scenic Black Hills National Forest. To ensure embankment stability, a 0.3-m- (1-inch-) wide graded sand zone was placed upstream of the membrane to serve as a filter for the rockfines upstream of the sand. The sand and geotextile backing acted as cushions between the rockfines and membrane as the fill was compacted.

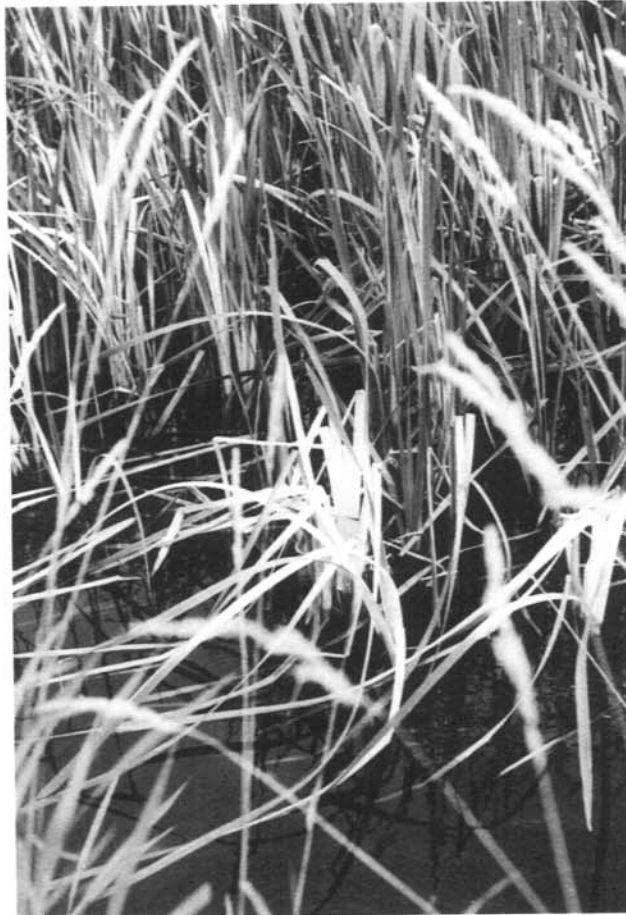
Affected plants turn white. Only 10 percent of the cattails and reed canarygrass showed any sign of injury.

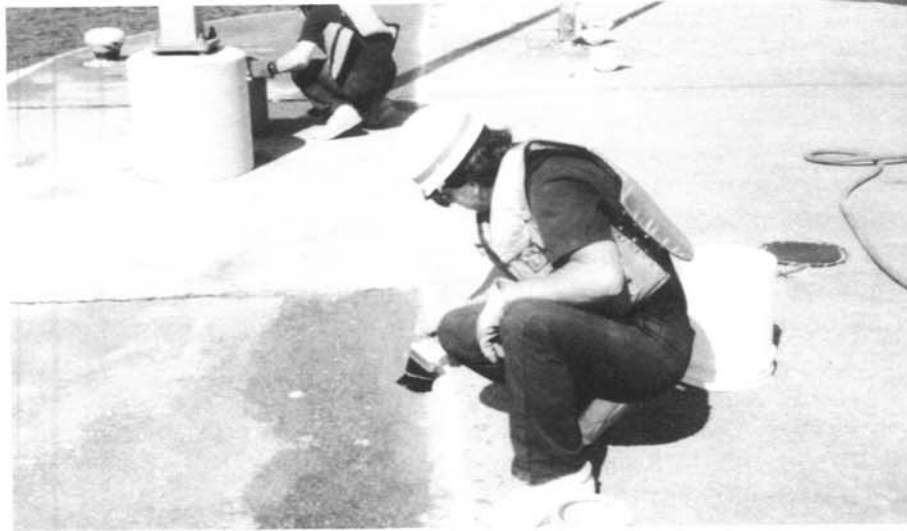
Field testing of a penetrating concrete sealer, Brandon Road Lock and Dam, Rock Island District, Illinois.

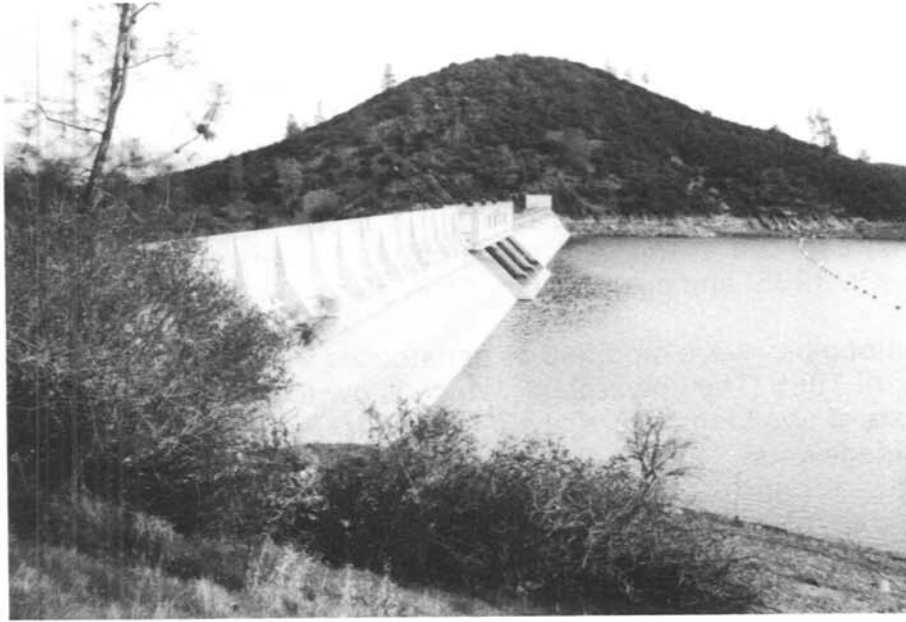
Figure 1. – Upstream view of Stony Gorge Dam from the left abutment showing the counterfort wall to the left of the spillway gatehouse. Photo by Joan Goodwin. 10/26/89

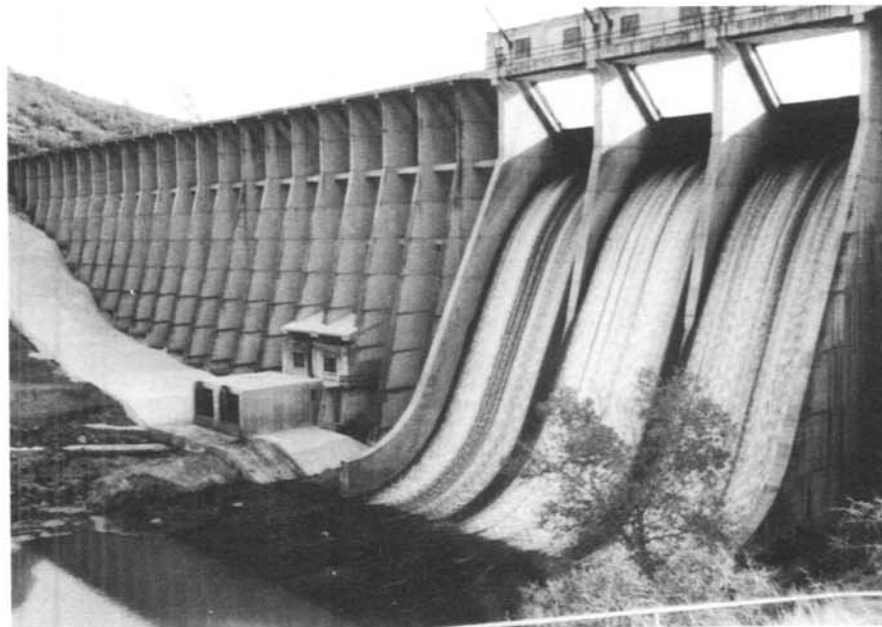
Figure 2. – Downstream view of Stony Gorge Dam showing the overtopping protection at the base of the dam. Photo by Joan Goodwin. 10/26/89

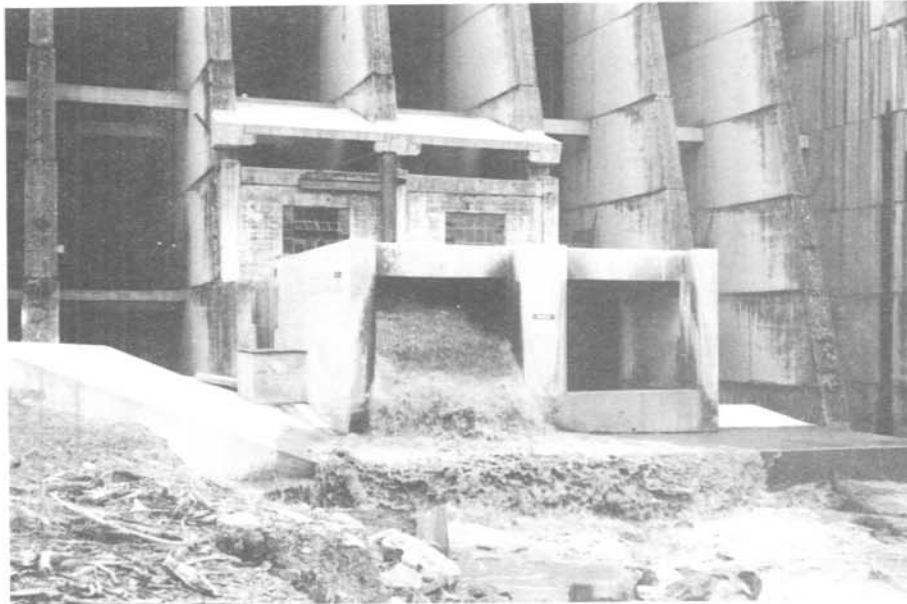
Figure 4. - Discharge from right fixed-cone valve flowing from the energy dissipation chamber. Photo by Bill Bouley. 10/26/89.
