# **WATER OPERATION AND MAINTENANCE**

**BULLETIN NO. 157**

September 1991

# METHODS FOR THE REPAIR OF CAVITATION DAMAGE TO METAL SURFACES

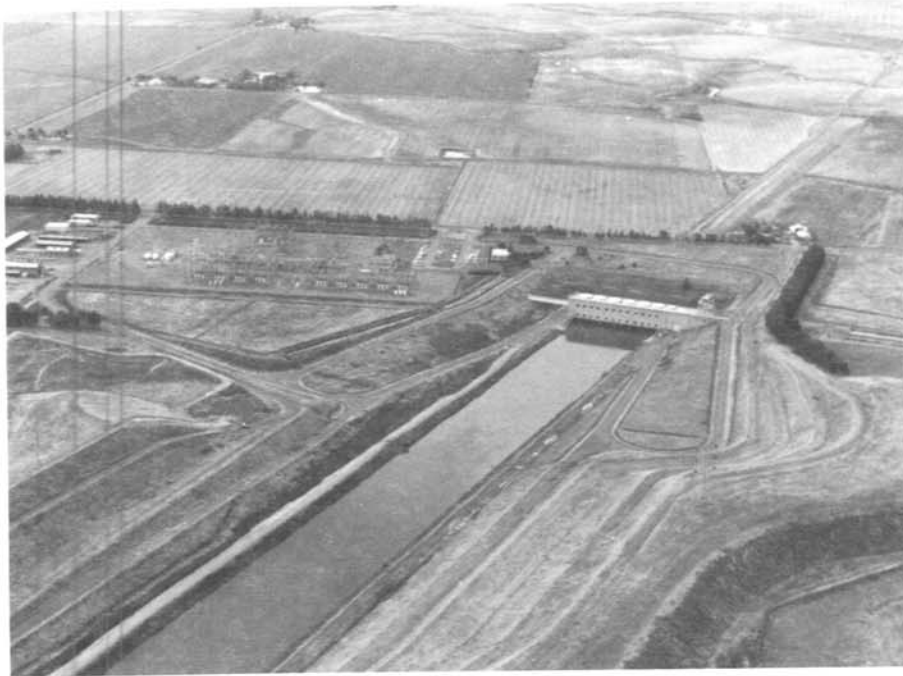
Photo 1. - Aerial view of Tracy Pumping Plant Complex looking upstream showing office area, switchyard, and pumping plant. Water is lifted by this plant 197 feet into the Delta-Mendota Canal. The plant has six pumps, each powered by 22,500-hp electric motors and capable of pumping at the rate of 767 ft<sup>3</sup>/s. Power to run the plant is supplied by Central Valley Project powerplants. 4/12/89

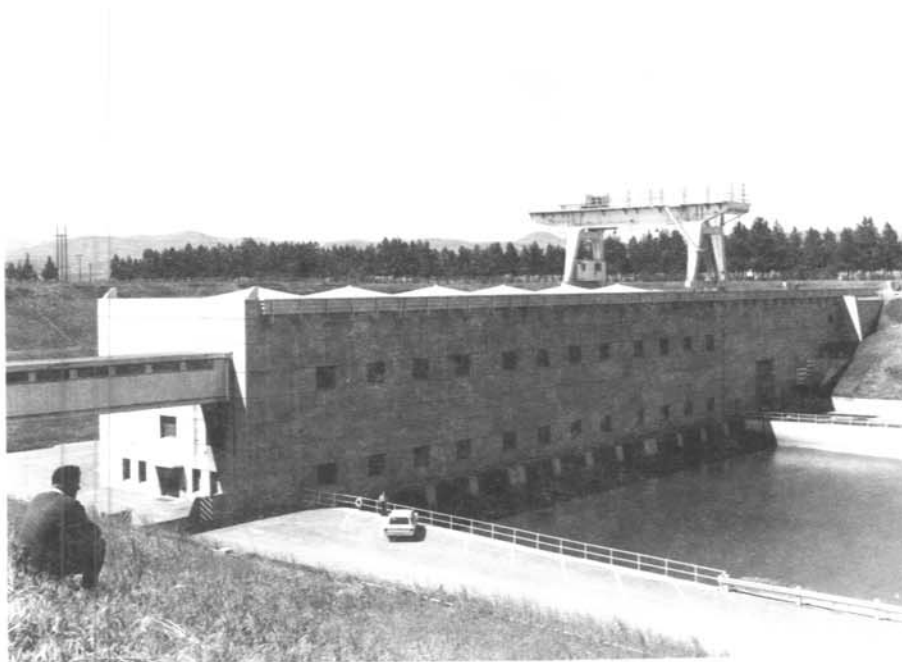
Photo 2. - General view of pumping plant structure from intake side. 4/14/66
